Successful stuck plug remediation restores well to normal production

Customized milling and retrieval equipment allows operator to restore production in new well.

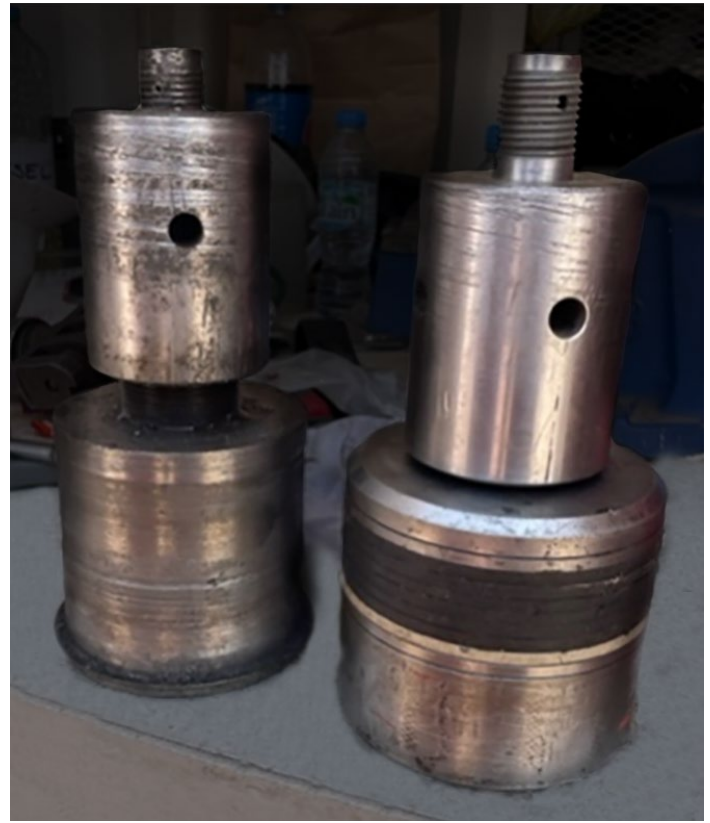
Original plug (right) and after milling and retrieval (left)

jetting tool to remove debris. They successfully milled through the lower metal ring and part of the plug body with a new 120 mm cutter. Despite the usage of a 15-ksi BPV lubricator with an overshot at 3,000 lbf force, the plug remained stuck, though measurements show it had moved. Finally, they backed off the dart assembly and recovered the assembly and seat. Once recovery was made, they used a dry rod and J-slot tool to install the retrieval sleeve and milled through the plug with an annual cutter. The team pulled the mill from the tree and confirmed successful recovery of the plug.
