Innovative well remediation with support frame technique achieves rapid, safe, and cost effective return to production

Surface casing failure repaired and well returned to production

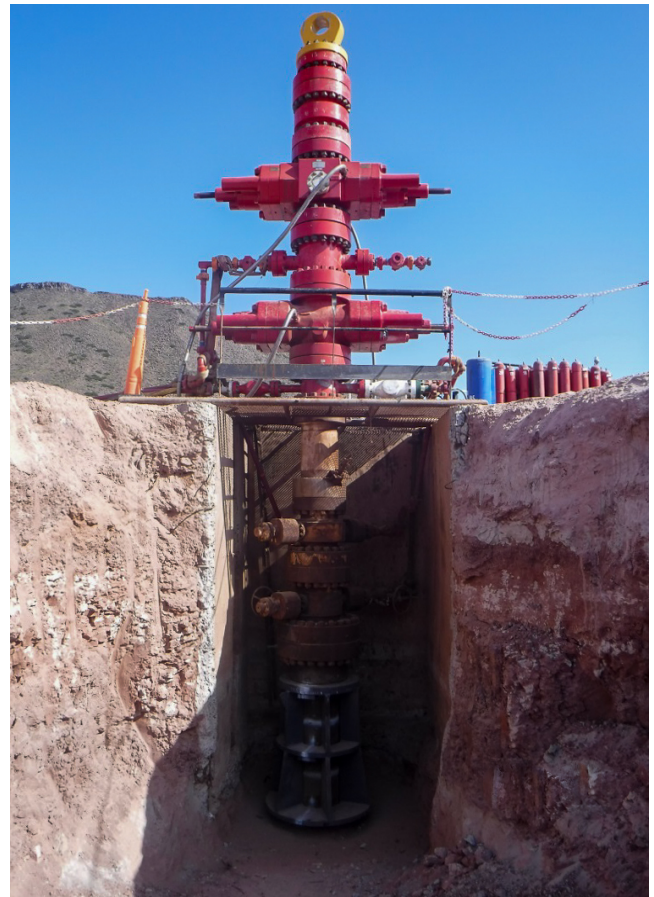
During a cellar cleaning campaign, the operator observed the 20-in. casing parted at the cellar level below the start of the casing head with evidence of corrosion. The cut was buried in sediment for an unknown period and the operator suspected prolonged exposure to water and sediment accumulation in the cellar. The customer reported wellhead movement caused by thermal expansion (axial and lateral). Additionally, Annulus B (formed by the 13 3/8-in. casing × 9 5/8-in. casing annulus) was pressured with 16 bars. The wellhead was not supported by the landing base and axial/torsional force cycles during production/shutdown periods. This generated fatigue on the 20-in. casing. This load combination, combined with a lack of inspections and cellar cleaning, resulted in casing failure at the surface.

20-in. casing repair: Trench and cellar view with tensioning/capping system and strand jack installed.

- Install downhole plugs, monitor annular pressure, and perform bleed-off operations
- Remove surface installations: cellar floor and wall (trench excavation)
- Cut the corroded section of 20-in. casing 50 cm below cellar excavation
- Built concrete foundations and rig up strand-jack lifting equipment. Installed and closed a BOP to secure the well. Install the tensioning spool, the system, and all casing and tubing strings to 465 kips to achieve 34-mm displacement and compensate for thermal retraction (perform engineering calculations using WELLCAT™ computer software)
- Replace the 20-in. corroded section with two new, half-moon 20-in. casing sections (welded)
- Installed support frame (designed with Finite Element Analysis FEA software)
- Release tension on the custom-designed support frame
