Middle East

Boots & Coots® resolves critical hydrocarbon leak with two-phase execution plan

C-clamp casing integrity remediation helps operator overcome challenge

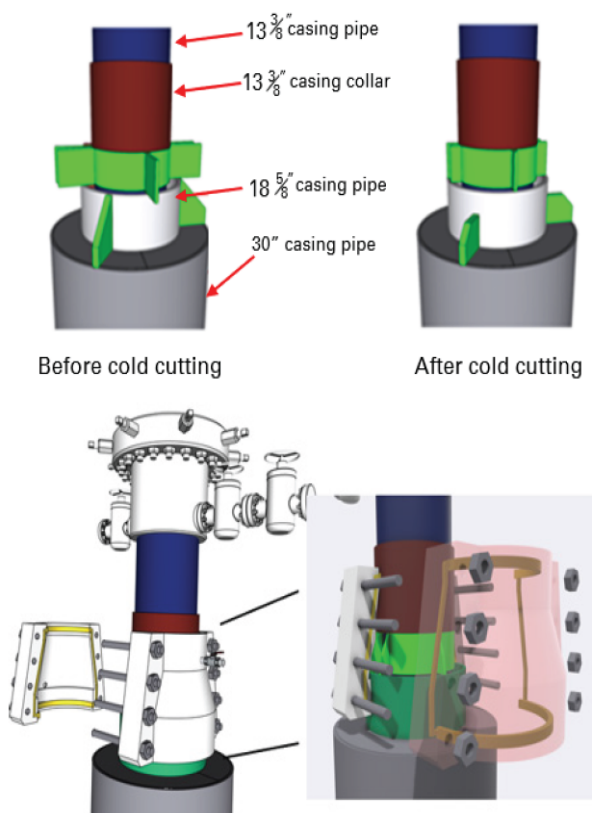
Observed leak

Dual bore clamp

Strong back

Boots & Coots performed an initial site assessment and completed the first phase as planned. After the initial site assessment, the team conducted three additional site visits to locate the adequate 18 5/8-in. casing to seal against. They then installed the c-clamp and filled the clamp void with the WellLock® resin system. The repair was successful, and the operator was able to proceed with the workover plans.
