Full-Scale Floor System Field and Laboratory Fire Experiments

Steve Kerber, PE
Research Engineer, Corporate Research
Bob Back strom
Research Engineer, Corporate Research
James Dalton
Contractor, Corporate Research
Daniel Madrzyk owski, PE
Fire Protection Engineer, NIST

January 2012

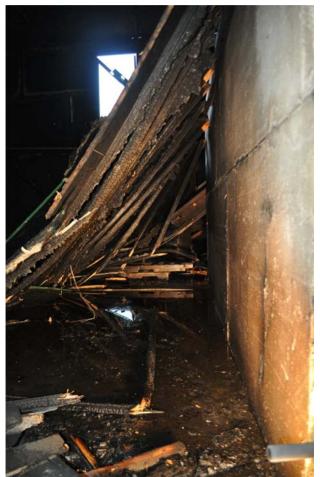
The primary structural failure occurred at the rear section of the floor system, local to the initial fire location. A secondary collapse of the center and front sections occurred moments later (Figure 116). The failure mode for the engineered I-joists was due to burn-out of the web members (Figure 119). The web burn-out induced separation of the top and bottom chord members, in some cases causing complete rupture of the chord members (Figure 117). Engineered I-Joists most remote from the initial fire location collapsed due to a stability failures. Mechanical separations local to initial burn thru areas and stress concentrations were also noted in the front section joists (Figure 119 and Figure 120). The floor system began to progressively deflect from approximately 250 seconds until the end of the test. Experiment 3 induced a collapse of approximately 100% of the total floor structure (Figure 118). The collapse time for the Experiment 3 was 6:00 after ignition. The collapse time respective of the structural element fire involvement for Experiment 3 was 2:45.

Figure 116 Web burn-out induced separation of the top and bottom chord members inducing collapse at rear span.

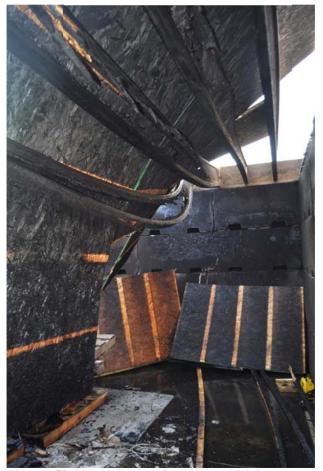
The primary structural failure occurred at the rear section of the floor system, local to the initial fire location. The failure mode for the engineered I-joists was due to burn-out of the web members (Figure 158 and Figure 159). The web burn-out induced separation of the top and bottom chord members, in some cases causing separation of the subfloor due to fastener mechanical separation (Figure 160). Rupture of the chord members was also noted throughout the collapsed area (Figure 161 and Figure 162). Internal hinges developed at web member butt joint locations for some framing members (Figure 163). The floor system began to progressively deflect from approximately 300 seconds until the end of the test. Experiment 5 induced a collapse of approximately 33 % of the total floor structure (Figure 164). The collapse time for the Experiment 5 was 8:27 after ignition. The collapse time respective of the structural element fire involvement for Experiment 5 was 4:42.

Figure 158 Web burn-out of engineered I-joists at rear section of floor area.

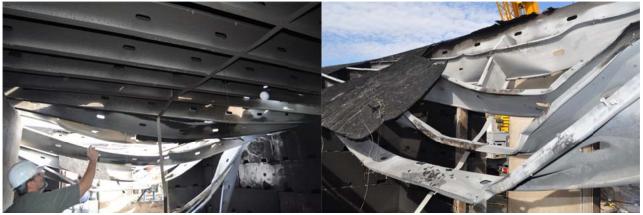
The primary structural failure occurred at the rear section of the floor system; local to the initial fire location. Steel C-Joists experience a loss in strength when exposed to high temperatures. This loss of strength then induces progressive deformations, which lead to excessive deflection (Figure 204), flame passage through the gaps created in the floor sheathing, fastener mechanical separation of the floor sheathing, rupture of the lateral bracing (Figure 226), failure of joist blocking, and progressive torsional warping until the point of collapse (Figure 227 and Figure 228). The collapse also produced a collapse local to the C-joist bearing condition (Figure 230). The rear section of the floor system began to progressively deflect at approximately 190 seconds until the end of the test. Experiment 8 induced a collapse of approximately 33 % of the total floor structure (Figure 230). The collapse time for the Experiment 8 was 14:04 after ignition which was defined as the barrels utilized for loading falling through the floor system. There was excessive deflection and flame passage seen prior to fall through of the barrels. The collapse time respective of the fire involvement of the subflooring local to the structural elements for Experiment 8 was 10:32.

Figure 225 Steel C-Joists collapse.

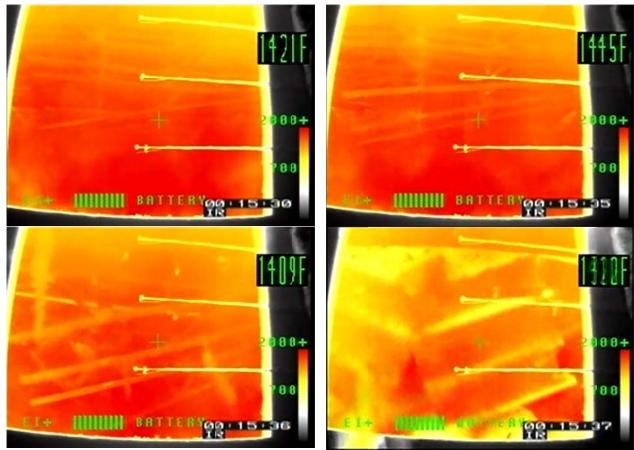
Figure 375. Experiment D Infrared views of rear floor failure.

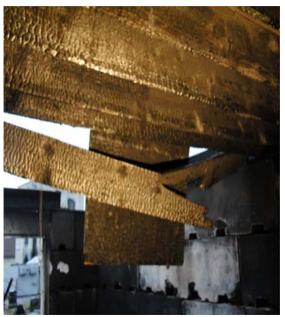
Figure 421. Dimensional Lumber Joist Fracture

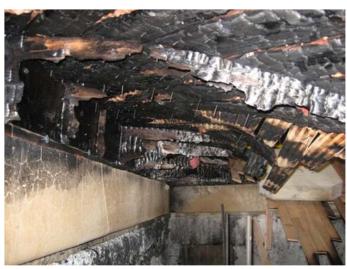
Figure 422. Dimensional Lumber Complete Joist Burn Through
