Caelus Energy Alaska avoids costly workover and saves USD 3 million

Leak and flow detection service identifies low-rate gas leak in production casing

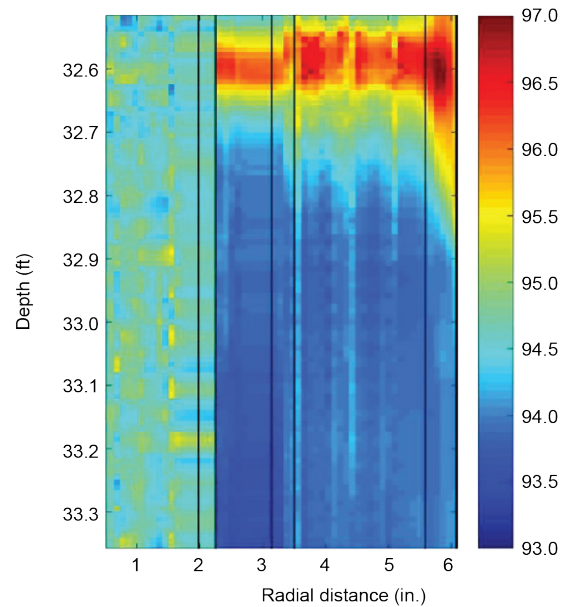
The gas-only leak was activated by pressurizing the IA while bleeding pressure from the OA. The entire well was logged with the leak and flow detection service, and additional stationary readings were taken at zones of interest. One such zone was near the production casing hanger, which is where the leak was identified by using high-definition waveforms and flow map processing. This same processing was able to rule out several other zones of interest by using radial location, which other ultrasonic technologies cannot do. An additional leak (IA to tubing) was located at a gas lift mandrel and was confirmed to be repaired on a subsequent leak and flow detection service run after the Halliburton Slickline group changed out the dummy valve.

The flow map is clearly illustrating a leak from the inner annulus (IA) to the outer annulus (OA) only 32 ft from surface. The gas injection was in the IA.

Since the leak was identified near surface, Caelus Energy Alaska plans to use a sealant repair method and avoid a USD 3 million workover operation.
