# Technical Bulletin for Envelope Sealing with Aeroseal®

## AeroBarrier Select Freezing Temperature Protocols

Number: 2024-006 | Date: December 2024 | Category: Critical Notification

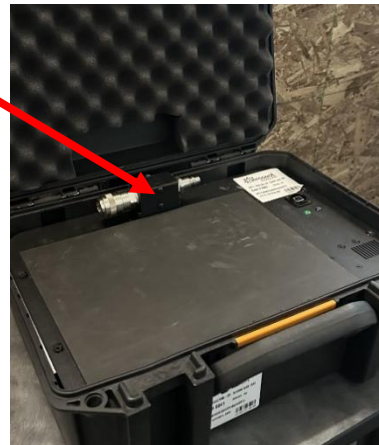
Location of Transducer in  
AeroBarrier Select MCU

Dealers who operate or store AeroBarrier Select machines in freezing temperatures may experience a Low Compressed Air alarm and, worst-case, transducer failure.

This failure occurs when water collects in the pressure transducer, freezes and expands, fracturing the diaphragm in the transducer.

If the transducer has been exposed to freezing temperatures, let the equipment thaw in a warmer environment and watch for compressor air readings of 80 psi. If compressed air reading is zero, or air is leaking from the transducer, the transducer may need to be replaced.

**Overnight and when the system is not in use:** Bring the LoPro MCU into a conditioned space to prevent any residual water from freezing inside the pressure transducer.

**During transit to the job site:** Keep the LoPro MCU in the cab of your vehicle to avoid exposure to freezing conditions.
