Italy

# Tailored cement solution helps ensure integrity for CCUS well in Adriatic Sea

CorrosaCem™ cement system provides long-term isolation in CO<sub>2</sub> storage environment

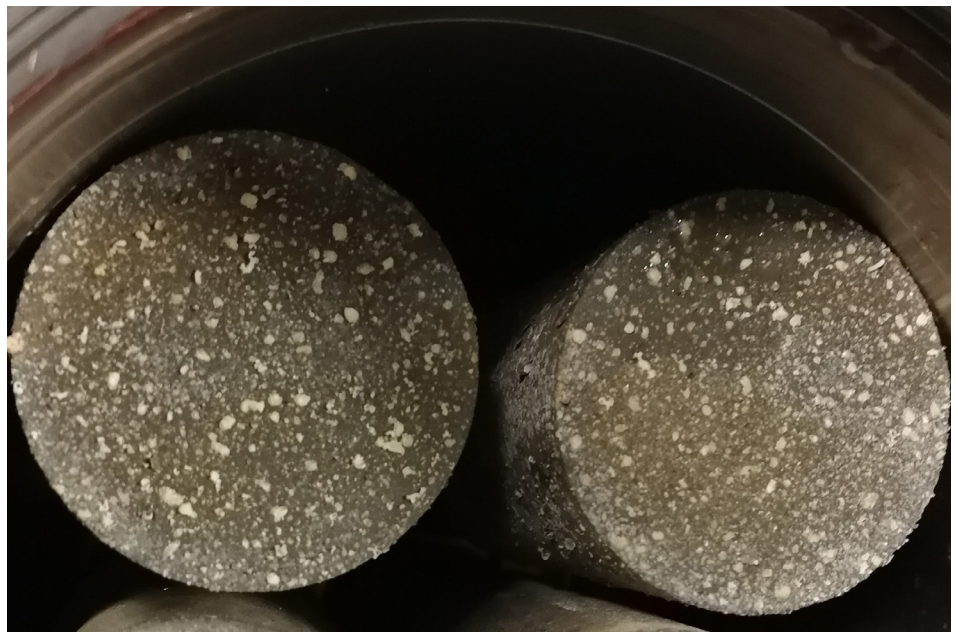
Tailored CorrosaCem™ cement system design improved resistance to cyclic loading.

Halliburton deployed the CorrosaCem™ cement system to isolate the injection zones and resist CO<sub>2</sub>-induced corrosion. The blend incorporated additives to reduce permeability and improve mechanical strength. WellLife® software performed finite element stress analysis to determine the cement properties required for long-term integrity under expected operational loads. iCem® cementing service 3D hydraulics software simulated and optimized displacement efficiency throughout the entire cemented interval to help ensure complete radial cement coverage. Laboratory tests validated the cement's mechanical properties, integrity, and permeability before and after CO<sub>2</sub> exposure.
