# Understanding and Fighting Basement Fires

Daniel Madrzykowski  
Craig Weinschenk

UL Firefighter Safety Research Institute  
Columbia, MD 21045

August 3, 2018

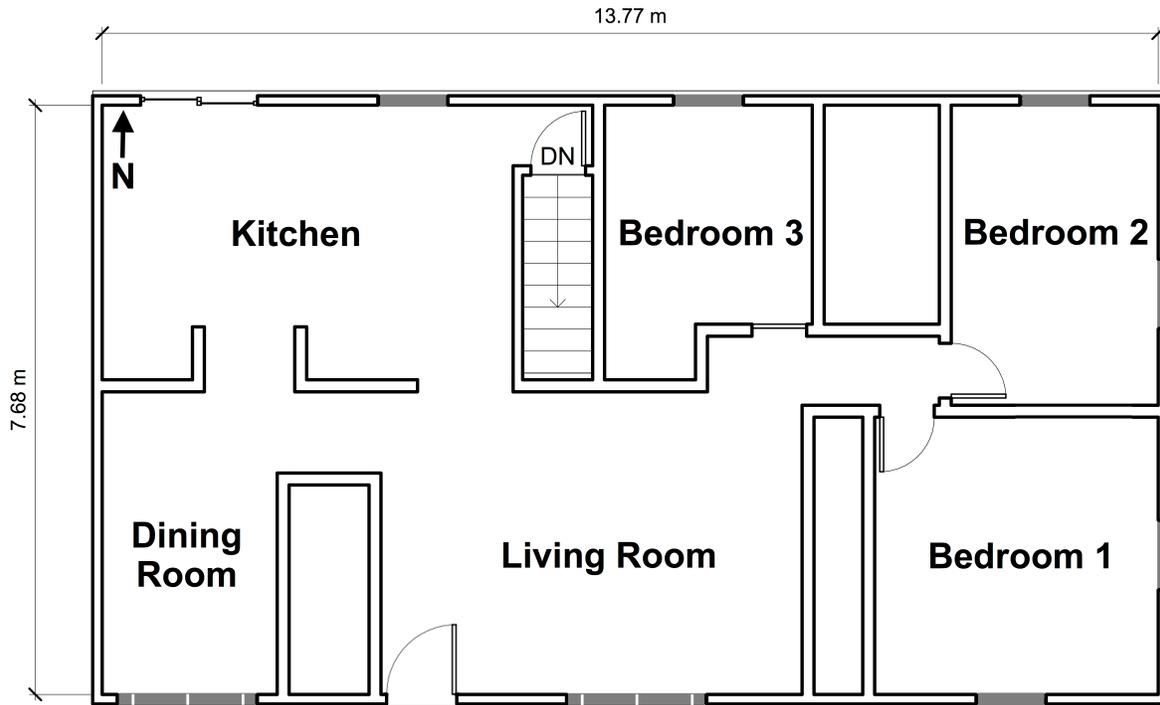
Figure 3.2: Plan view of the first floor with major dimensions and locations of vents. The dimensions (area and sill height) appear in Table 3.2.

with a 2.44 m (8 ft) ceiling (cf. Figure 3.2). Table 3.2 defines the size of the vents (area and sill) in Figure 3.2.

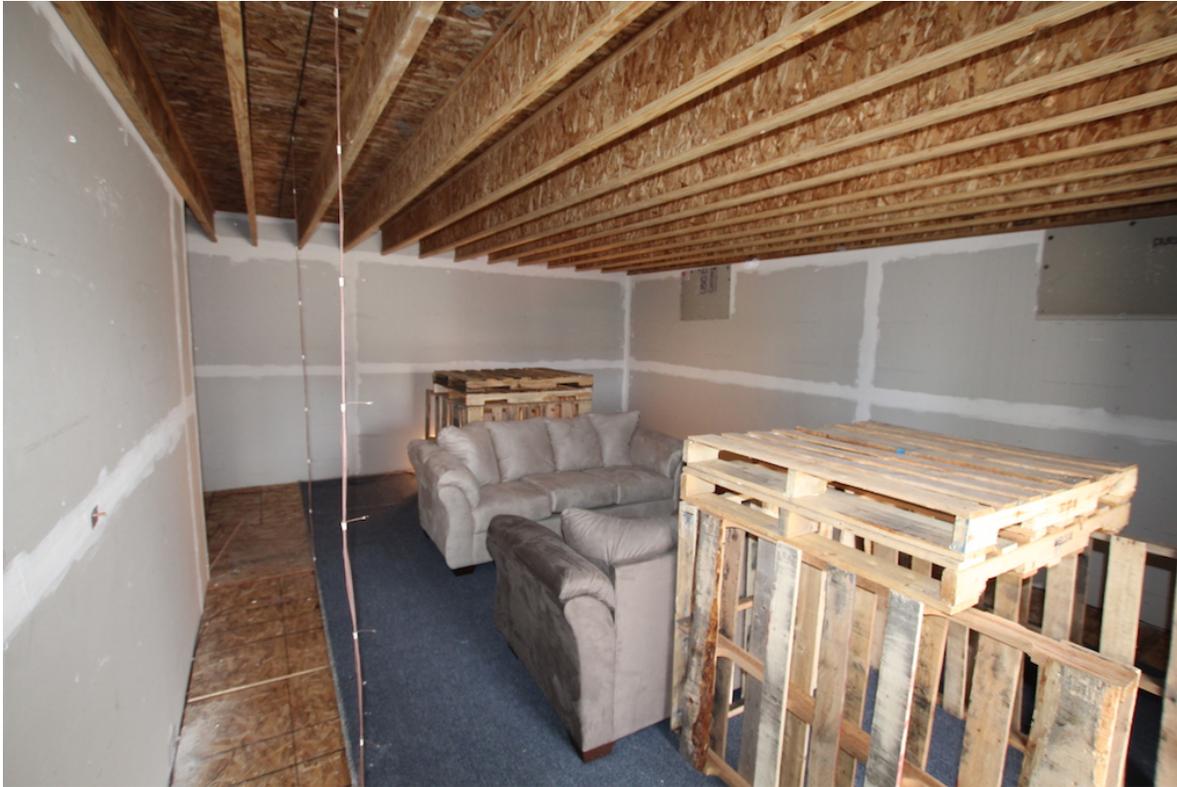
Figure 3.6: Photograph of installed fuel package on the west side of the basement.

In total, this fuel package was composed of wood, engineered wood, flexible PU foam, polyester (PE), and PP. Figure 3.6 shows the padding, carpet, sofas, pallets, OSB ceiling, and I-joists as they were installed during the experiments. All totaled, each side of the basement had a fuel load of approximately 900 kg (1,980 lb). On average, the fuel load for the basement was 27.3 kg/m<sup>2</sup> (5.6 lb/ft<sup>2</sup>). This did not include the OSB panels on the floor of the basement.

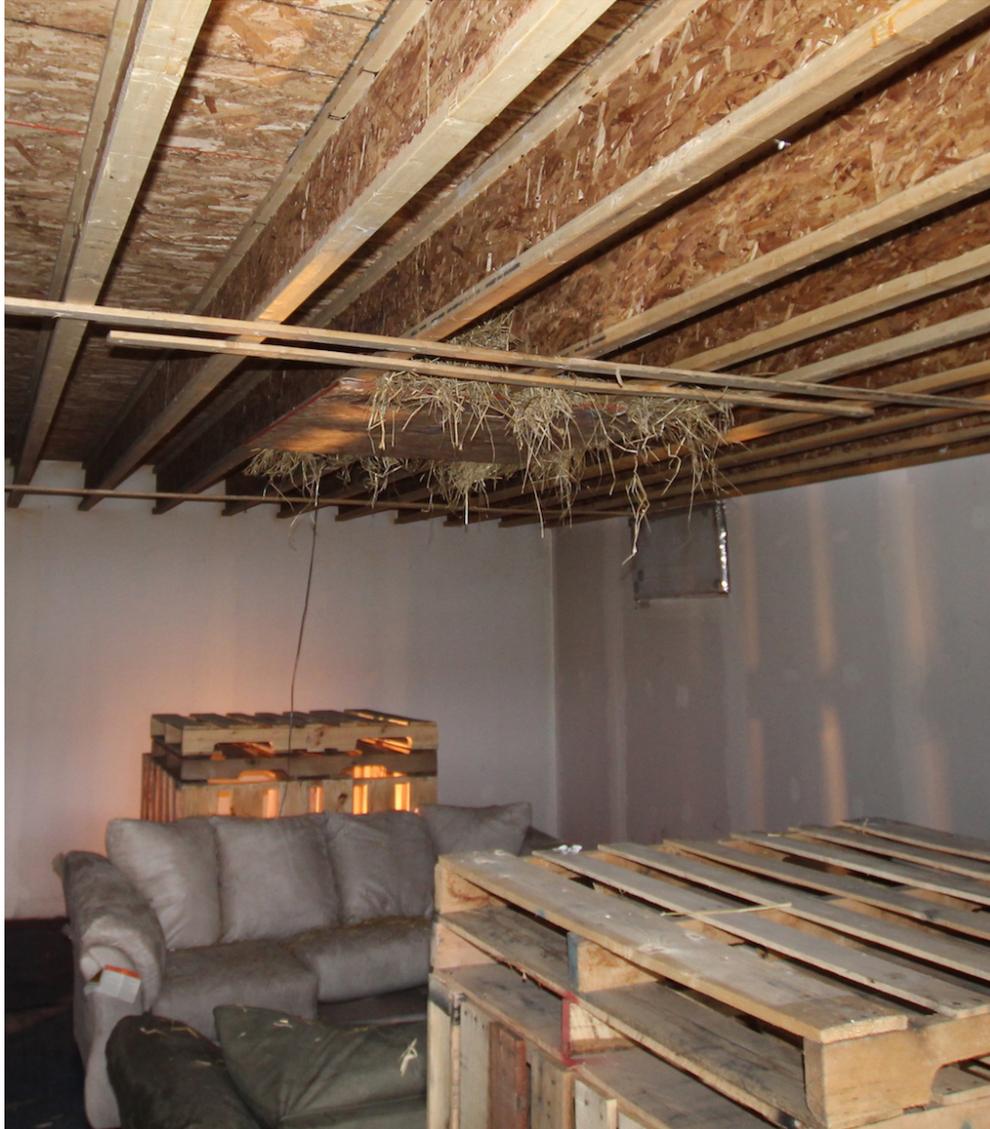
Figure 3.7: Photograph of hay and OSB installed between I-joists for an experiment with a ceiling ignition.

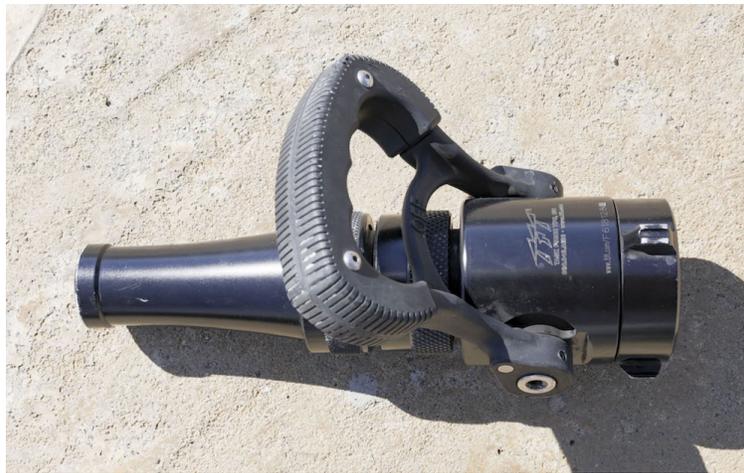
A 15/16 in. diameter smooth bore nozzle was used during these experiments. The nozzle was capable of flowing 180 gpm with 50 psig water pressure at the nozzle. This nozzle was used when there was no or limited exterior access to the basement. Hence, the nozzle was flowed down through a hole in the floor assembly or through a small basement window. In the case of the small windows a fire department-fabricated basement window pipe was used. Figure 3.9 shows the smooth bore nozzle used in these experiments.

Figure 3.9: Example of smooth bore nozzle used in experiments.

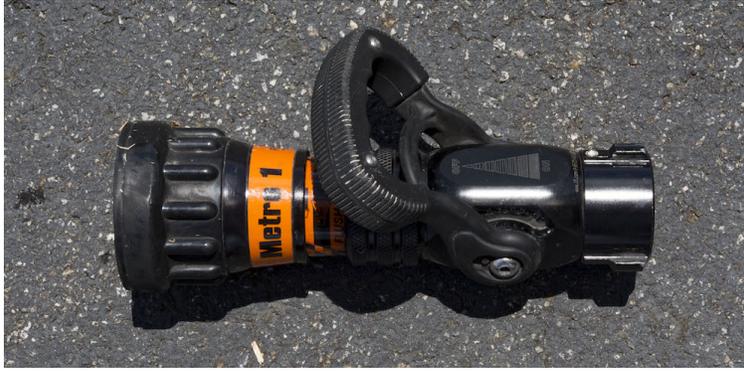
A combination or adjustable spray pattern nozzle was used in all three types of basement access experiments. The nozzle was set to flow 150 gpm with a pressure at the nozzle of 75 psig. For cases in which there was no exterior access to the basement, suppression occurred through the floor or at the top of the stairs with the nozzle set to a fog stream. For the cases in which there was limited access (through basement windows) or direct access to the basement, the nozzle was set to straight stream. The combination nozzle used in these experiments is shown in Figure 3.10.

Figure 3.10: Example of combination nozzle used in experiments.

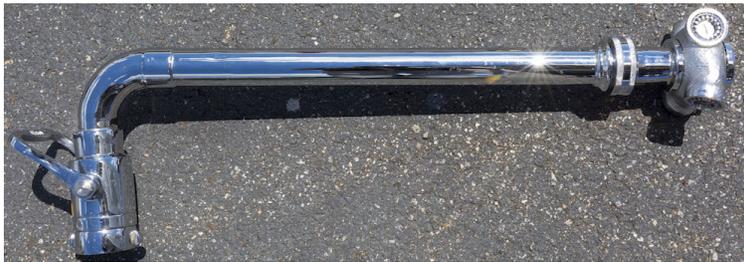
The cellar nozzle was connected to a pipe with a 90° bend and an extension with a bail to allow it to connect to fire hose and remain controllable while the nozzle end was through the floor. The cellar

nozzle used (see Figure 3.11) was set to flow 140 gpm at 100 psig. This nozzle was used when there was no exterior access to the basement and suppression occurred through a hole punched through the floor.

Figure 3.11: Example of cellar nozzle used in experiments.

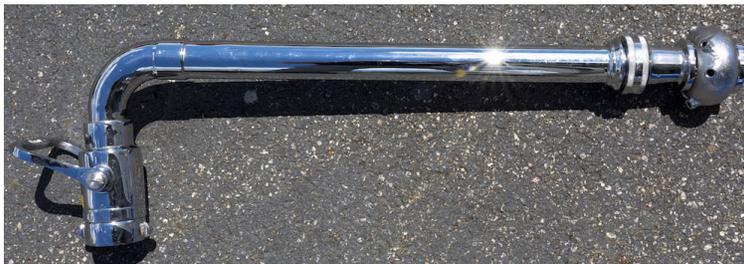
The Bresnan distributor nozzle was used in a similar fashion as the cellar nozzle; it was connected to an extension pipe as shown in Figure 3.12. The Bresnan distributor flowed 160 gpm at 100 psig. This nozzle was used when there was no exterior access to the basement. The Bresnan distributor was used in experiments in which suppression took place through the floor.

Figure 3.12: Example of Bresnan distributor nozzle used in experiments.

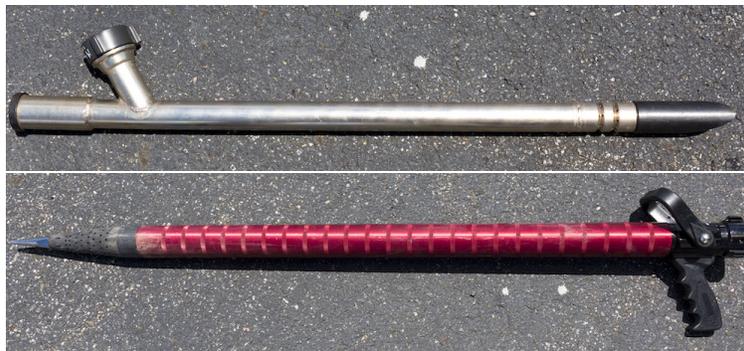
Two types of piercing nozzles were used. One nozzle flowed 125 gpm at 100 psig (Figure 3.13 (top)) and the other flowed 150 gpm at 100 psig (Figure 3.13 (bottom)). The 125 gpm piercing nozzle had a spray pattern that discharged small water droplets from a small ring of holes around the tube. The water spray extended approximately 3 m (10 ft) away from the nozzle on all sides (Figure 3.14). The larger piercing nozzle was flowed at 150 gpm for these experiments to provide comparisons to several of the other nozzles with similar water flow rates. This nozzle had a series of holes in a conical shaped tip that discharged water streams that tended to flow around and down from the nozzle more so than straight out horizontally from the nozzle (Figure 3.14). This resulted in the spray having a smaller area of interaction with fire gases and other fuels near the basement ceiling than the 125 gpm piercing nozzle. This nozzle has the capability with a higher nozzle pressure to flow 300 gpm or more.

The piercing nozzles were used in the experiments where there was limited or no exterior access to the basement. This resulted in suppression applications through the floor or through the large basement window.

Figure 3.13: Examples of piercing nozzles: 125 gpm (top) and 150 gpm (bottom) used during experiments.

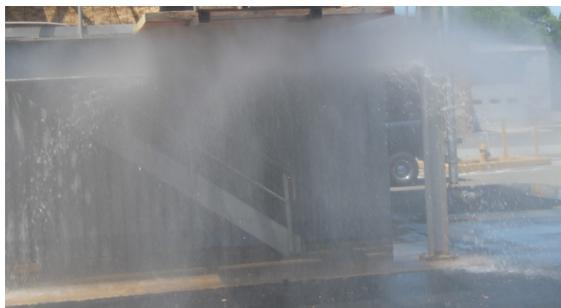
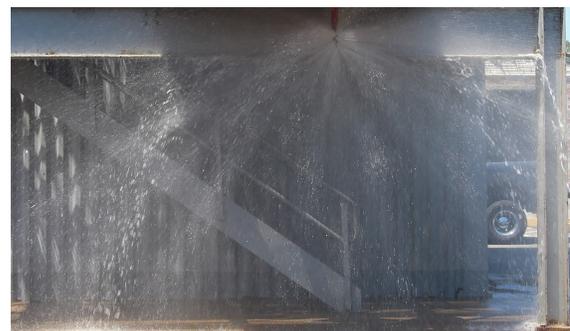
Figure 3.14: Examples of piercing nozzles: 125 gpm (left) and 150 gpm (right) spray patterns.

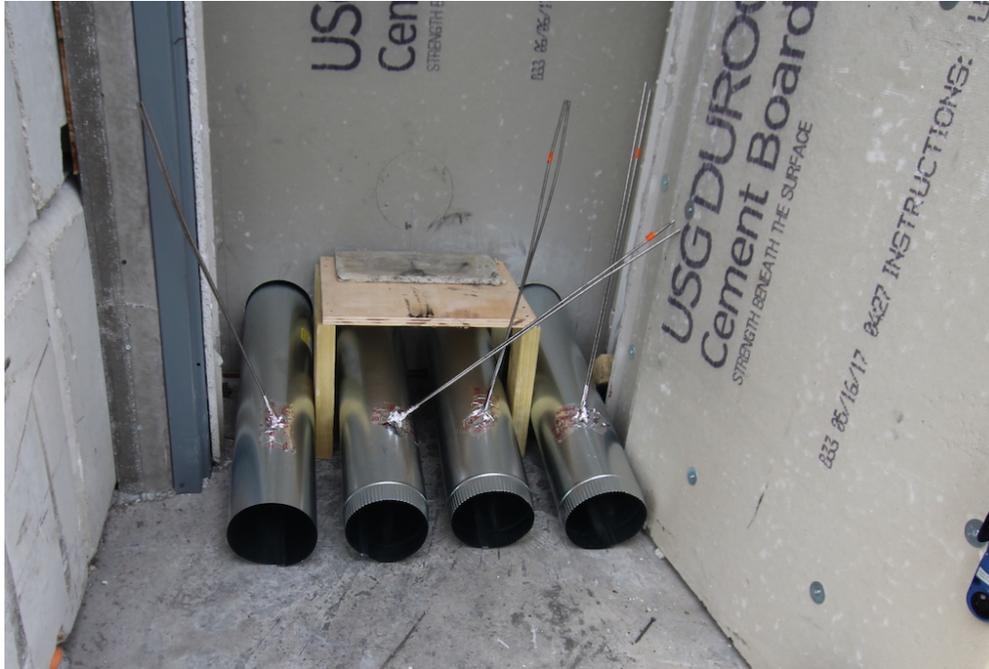
Figure 4.1: Leakage pipes (0.15 m (6 in.) diameter) installed in the side A wall of the basement.

The total area of the basement leakage when all four pipes were opened was approximately 735 cm<sup>2</sup> (114 in.<sup>2</sup>) (Section 3.1). The pipes were installed in the wall at an access point between the concrete blocks on the south (side A) side of the basement (see Figure 3.1). Figure 4.1 shows the leakage pipes as they were installed for relevant experiments.

Experiments 10, 11, and 12 all featured the same pre-ignition ventilation as Experiment 4, except that for these three experiments, all four basement leakage pipes (see Figure 4.1) were open prior to ignition. A residential sprinkler system was installed in the basement for Experiment 10.

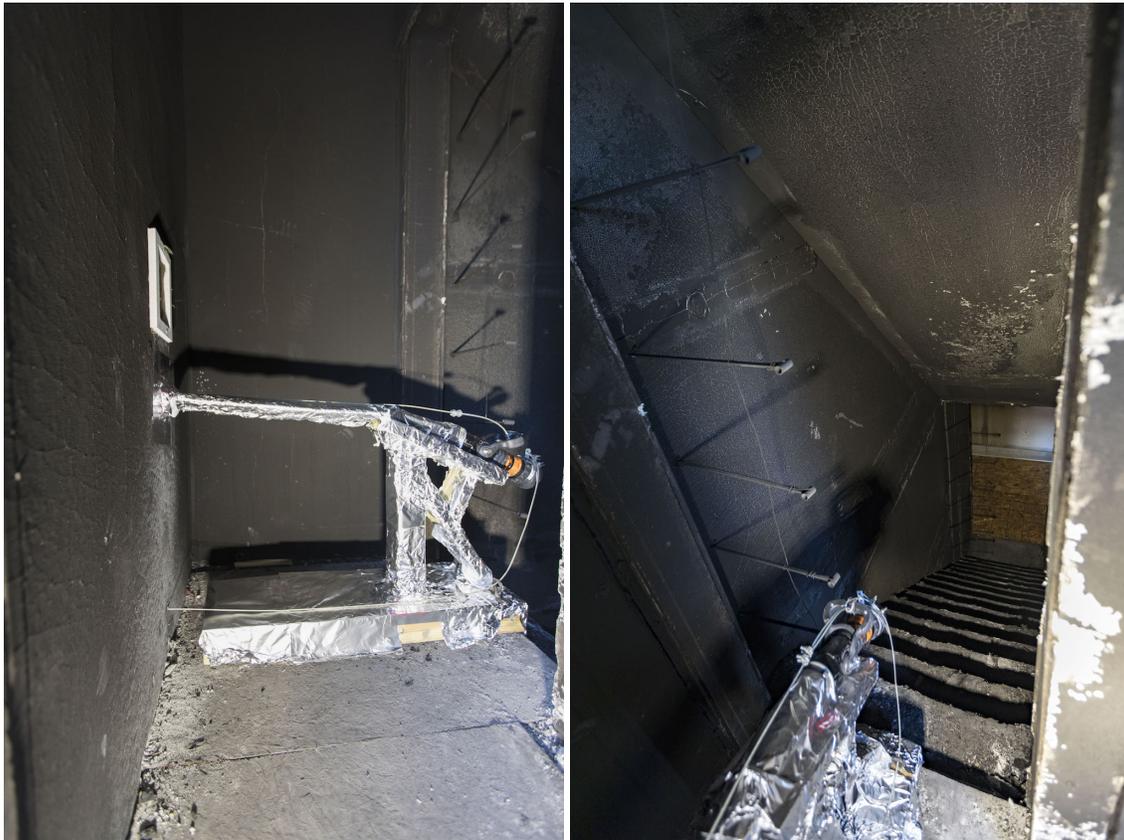
Figure 4.3: Photographs of the nozzle at the top of the stairwell from the side (left) and looking down the stairs (right) in Experiment 12.

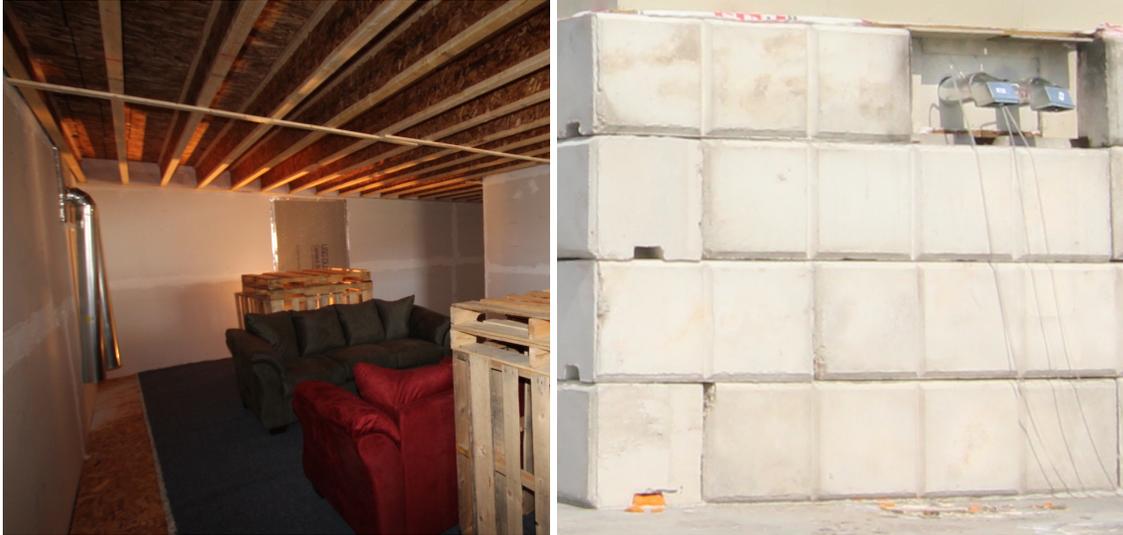
Figure 4.4: Photographs of installed dryer vent from the inside of the basement (left) and outside the structure (right).

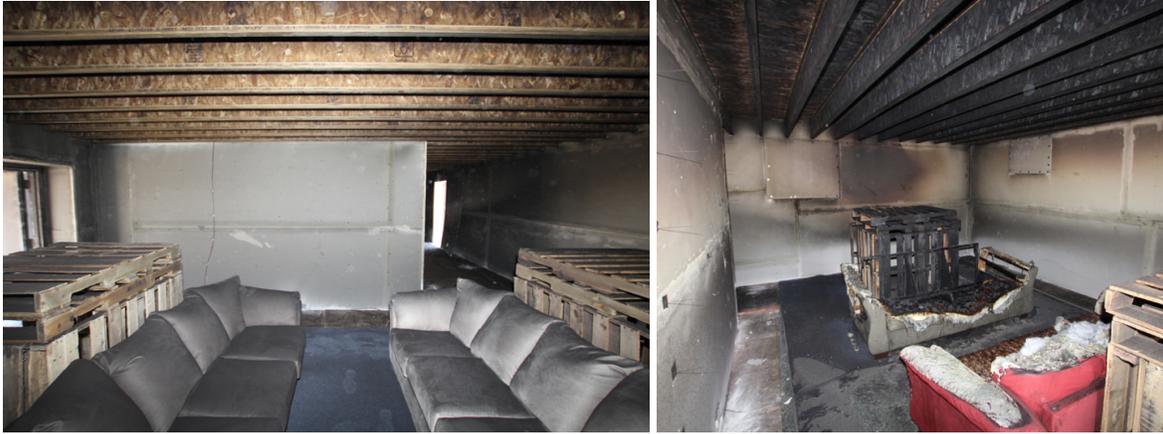
Figure 5.2: Photographs of the post-fire fuel packages on the non-ignition side (left) and ignition side (right).

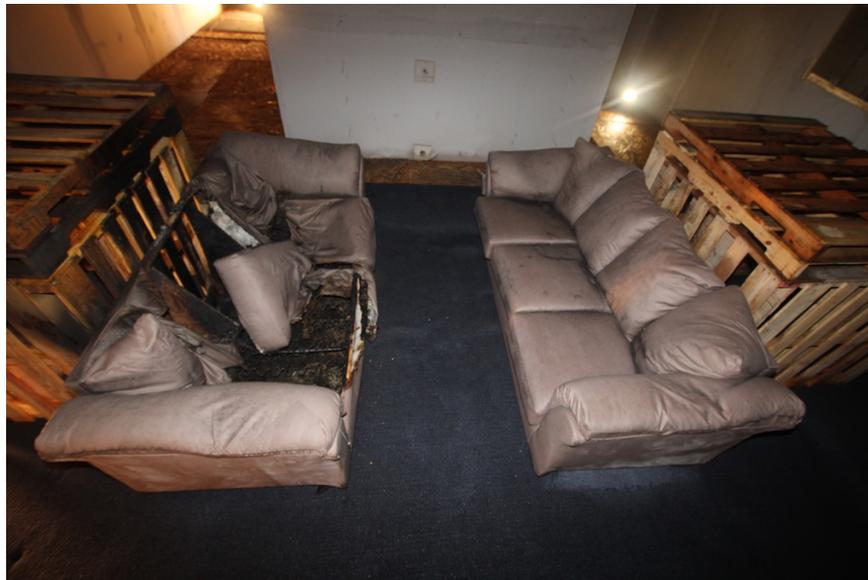
Figure 5.28: Photograph of the post-fire fuel packages on the ignition side.

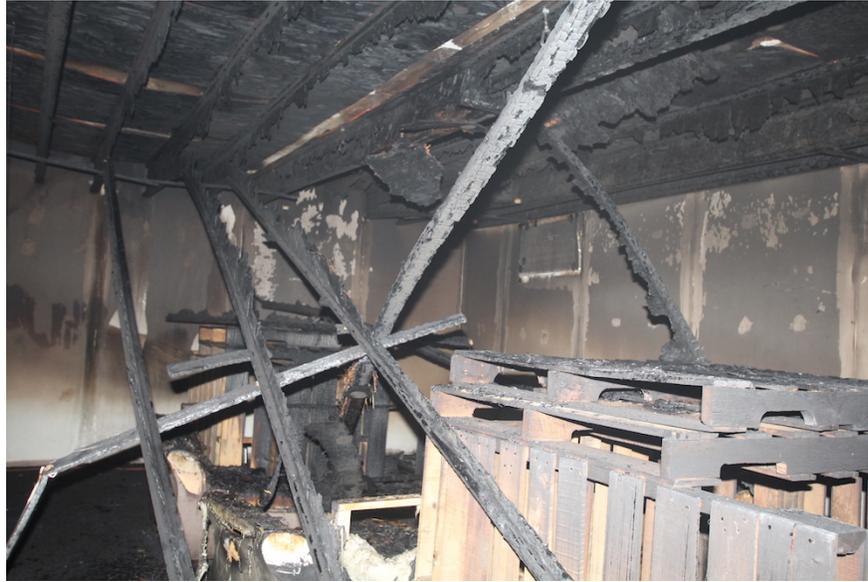
the post-experiment fuel on the fire side. Despite the fire starting between the joists, both sofas on the west side of the basement were partially consumed. Suppression was initiated with a 125 gpm

piercing nozzle through the floor. Full flow rate occurred 940 s after ignition and the nozzle was shutdown 1,114 s after ignition.

Figure 5.32: Photograph of the post-fire fuel packages on the ignition side.

The initial drop in oxygen concentration relates to the rise in temperature from the first fire growth. As the oxygen decreased to a low of 5 %, the fire entered a decay phase. As the fire decayed, combustion products exited the structure through the open interior stairwell and open front door. Oxygen was replaced through the open vent pipes in the basement. Once oxygen recovered to above 15 % approximately 575-600 s after ignition, the fire was able to regrow. Figure 5.32 shows

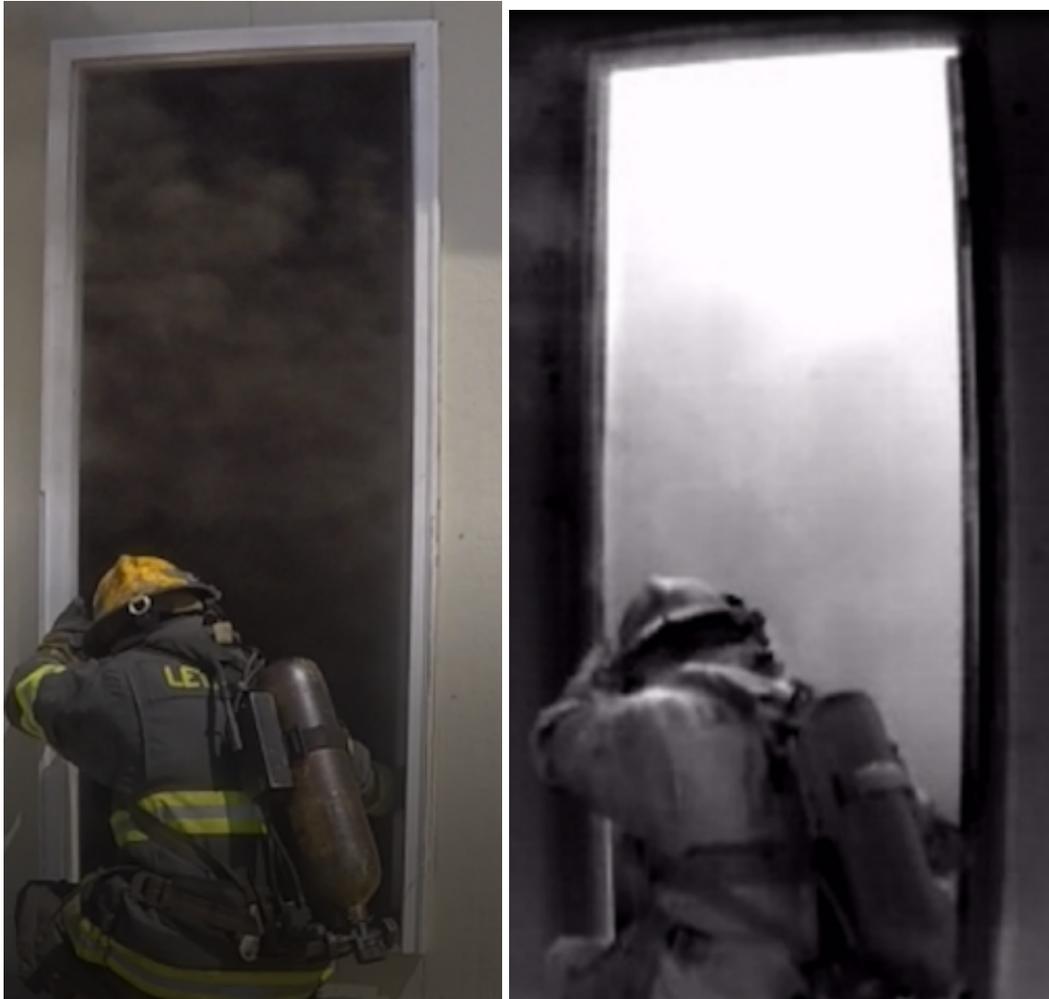
Figure 6.2: Comparison images of a open door with a standard camera (left) and an IR camera (right).

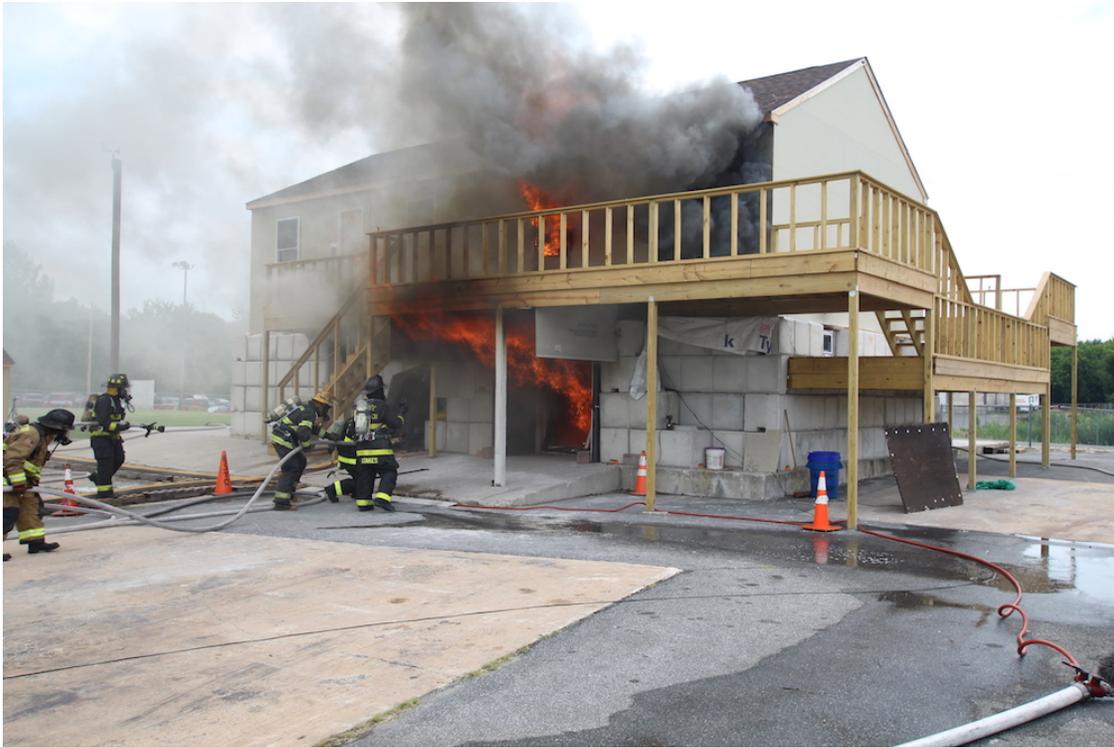
Figure 6.11: Photograph of flaming combustion extending outside of the structure indicating the presence of a ventilation-limited structure fire during Experiment 8.

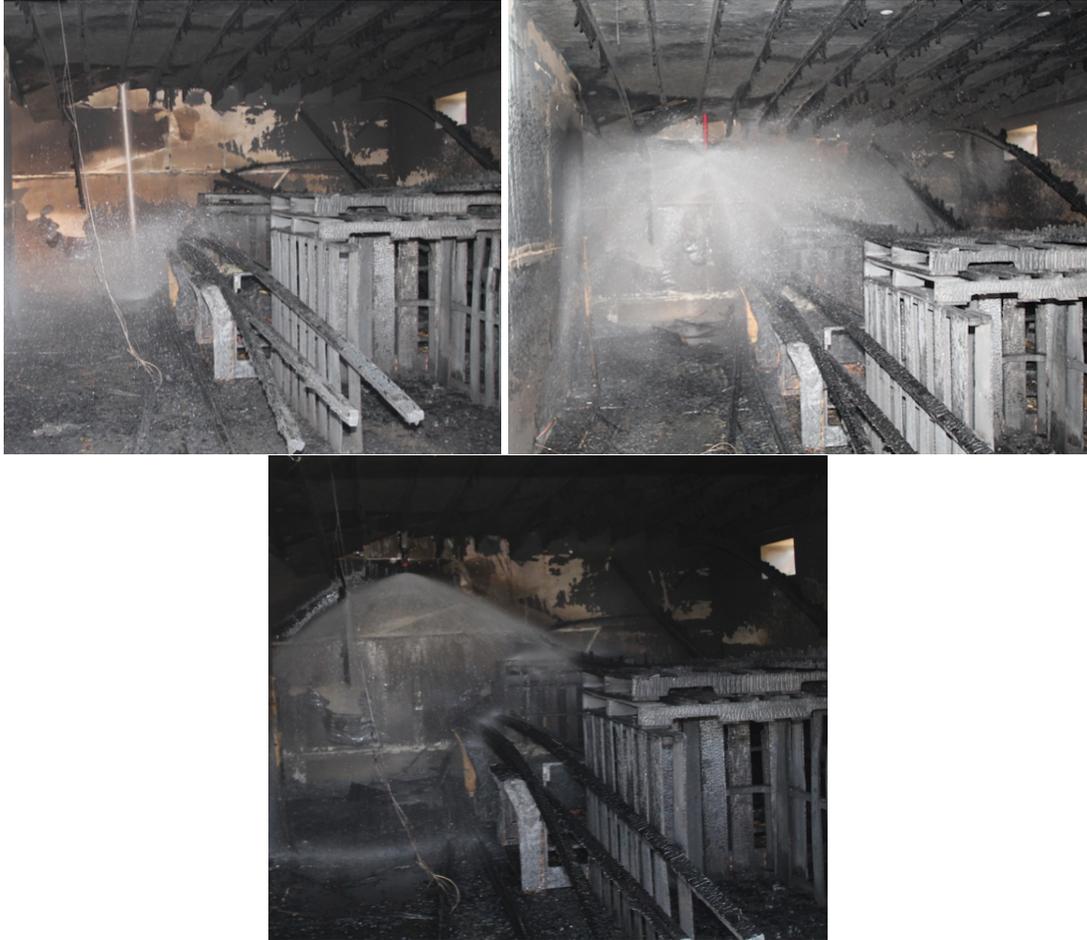
Figure 6.14: Photograph of straight stream (top left), the 150 gpm piercing nozzle (top right), and fog stream (bottom) flowing through a hole punched through the floor.

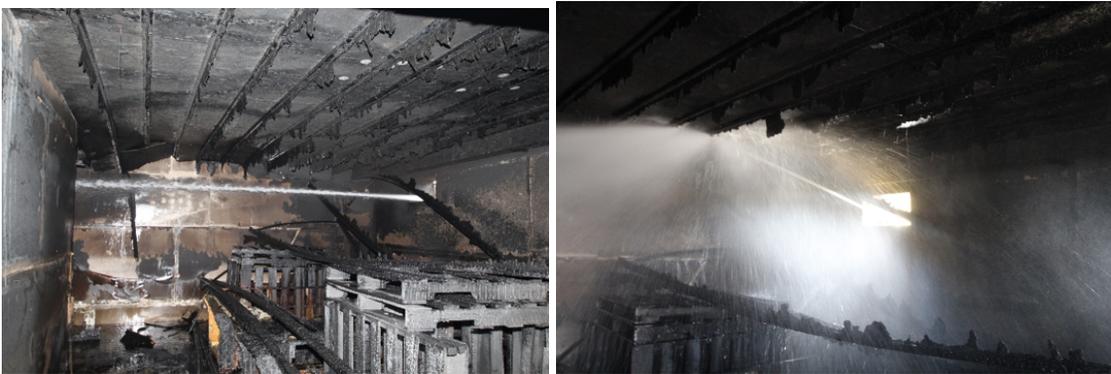
Figure 6.16: Photograph of straight stream through a window (left) and the broken stream produced by angling the stream off the ceiling (right).
