# BODY ARMOR 4X4

# LEVELING KITS

**PRODUCT: 50506-FD 2004-2008 FORD F150 2WD /4WD & 2009-2014 FORD F-150 (EXCEPT RAPTOR) 2WD 3.0 INCH STRUT SPACER**

**PART NUMBER: 50506-FD, 50508-FD**

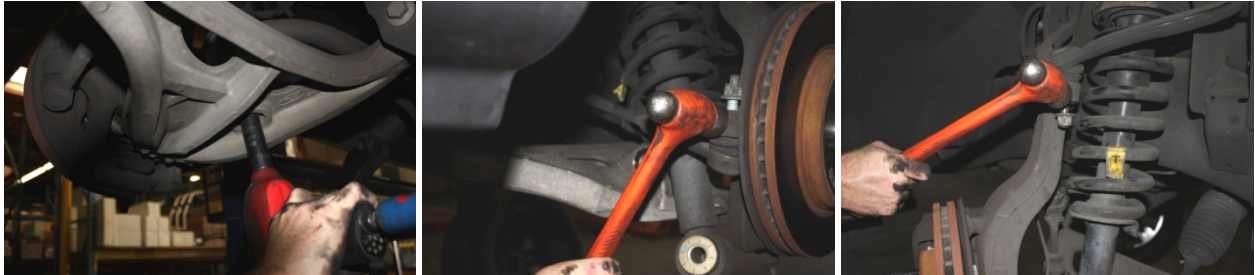
1. Jack up the front of the vehicle, and support it with jack stands on the frame, allowing the suspension to droop out.
2. Remove the tire and unbolt the tie rod end at the spindle. Break the tie rod loose by hitting the side of the spindle with a hammer. (Do not hit the tie rod on the threads)
3. Remove Sway Bar end links.
4. Loosen upper ball joint nut, but do not remove. Break the upper ball joint loose by hitting the side of the spindle with a hammer. The nut will catch the spindle, then remove nut and separate the ball joint from the spindle. (Do not hit the ball joint on the threads)

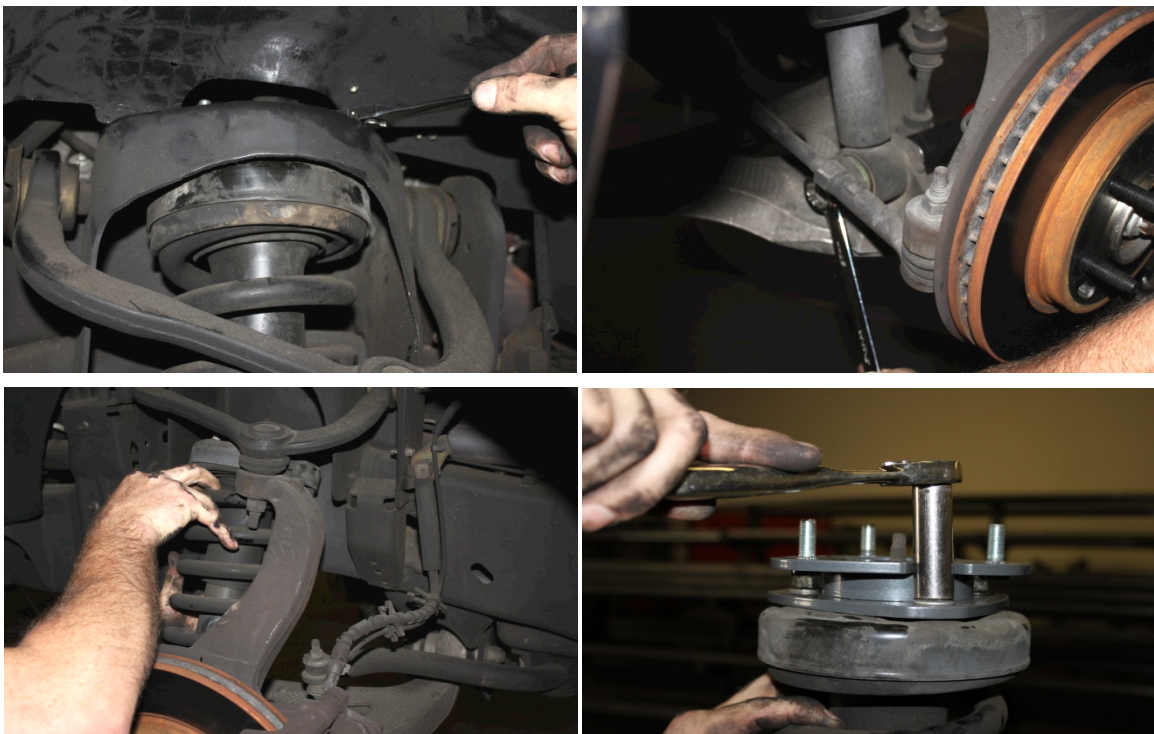
5. Remove the 3 nuts holding the top of the strut to the strut tower and the bolt which holds the strut to the lower control arm, then remove the entire strut assembly. **NOTE: 2014 and newer models have 2 long studs at the bottom of the strut, it is recommended to either punch out the studs or remove the spindle completely to ensure safe removal of the strut.**
6. Bolt the new strut spacer to the top of the strut using the factory hardware.
7. Re-install the strut and reverse steps 1-6, then repeat on the other side of the vehicle.

**NOTE: 2015-UP MODELS WILL USE THE PROVIDED STOVER NUTS TO ATTACH THE SPACER TO THE STRUT. THE FACTORY FLANGE NUT IS TOO BIG AND WILL HIT THE SPACER TUBE**
