Successful stuck plug remediation restores well to normal production

Customized milling and retrieval equipment allows operator to restore production in new well.

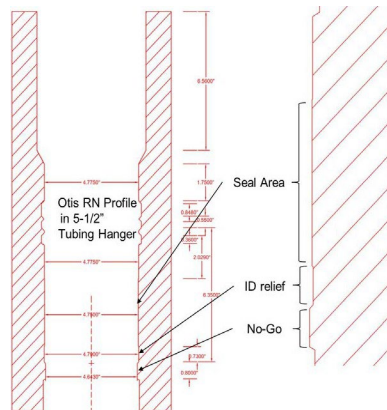
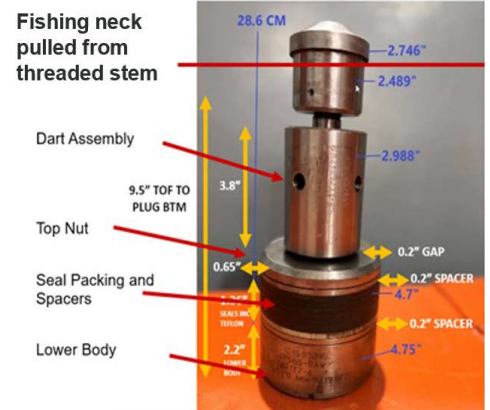
Option 2

An attempt to jar the plug loose with coiled tubing (CT) with ±26k lbs was unsuccessful and resulted in parting the fishing neck. The mill operation faced several challenges: a sheared brass pin on top of the plug from previous retrieval efforts, a plug with no fishing neck for recovery, a seal stack that included metal rings with a potential to spin during the mill, and unknown pressure under the plug. In addition, there were concerns that the milled plug might drop below the tubing hanger into the production tubing.

No-Go Plug Assembly

To address the issue of the broken 0.5 in. brass pin, the team created AutoCad® drawings of the tubing hanger bore and plug to design and manufacture job-specific mills and retrieval equipment. The custom equipment consisted of 120 mm extended annular cutters with an internal snap latch and a modified short catch overshot with a finger grab, retrieval sleeve, and J-slot tool.

To recover the broken 0.5 in. brass pin from the production tree, we implemented a detailed plan that incorporates specialized equipment. We began by using a 120 mm extended annular cutter to mill 3 inches deep over the stuck plug. Next, we deployed the extended retrieval tool to access the production tree and recover the broken brass pin. Using the extended annular cutter method, the Boots & Coots® 15 ksi Hydraulic BPV unit with a custom-designed overshot with finger grab and J-slot tool would be used to remove the top dart assembly and install the retrieval sleeve. This provided a predetermined fish neck. Finally, we installed an internal latch in the 120 mm extended annular cutter, which allowed us to mill the remaining 0.5 in. plug while the coupon would be captured inside the annular cutter.
