Innovative well remediation with support frame technique achieves rapid, safe, and cost effective return to production

Surface casing failure repaired and well returned to production

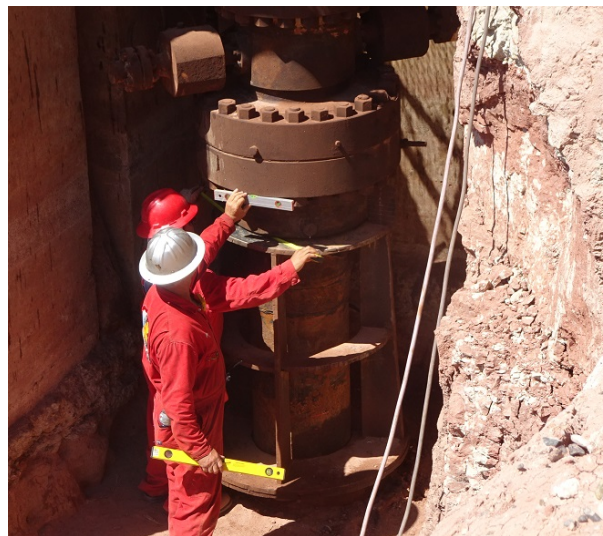
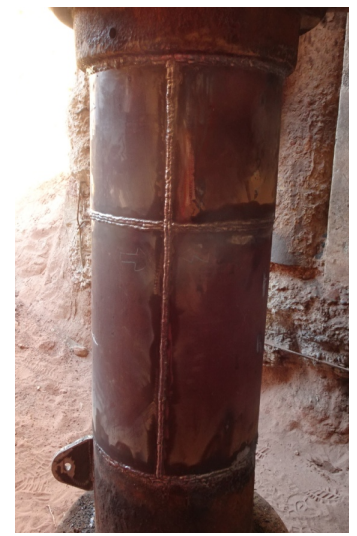
During a cellar cleaning campaign, the operator observed the 20-in. casing parted at the cellar level below the start of the casing head with evidence of corrosion. The cut was buried in sediment for an unknown period and the operator suspected prolonged exposure to water and sediment accumulation in the cellar. The customer reported wellhead movement caused by thermal expansion (axial and lateral). Additionally, Annulus B (formed by the 13 3/8-in. casing × 9 5/8-in. casing annulus) was pressured with 16 bars. The wellhead was not supported by the landing base and axial/torsional force cycles during production/shutdown periods. This generated fatigue on the 20-in. casing. This load combination, combined with a lack of inspections and cellar cleaning, resulted in casing failure at the surface.

- Install downhole plugs, monitor annular pressure, and perform bleed-off operations
- Remove surface installations: cellar floor and wall (trench excavation)
- Cut the corroded section of 20-in. casing 50 cm below cellar excavation
- Built concrete foundations and rig up strand-jack lifting equipment. Installed and closed a BOP to secure the well. Install the tensioning spool, the system, and all casing and tubing strings to 465 kips to achieve 34-mm displacement and compensate for thermal retraction (perform engineering calculations using WELLCAT™ computer software)
- Replace the 20-in. corroded section with two new, half-moon 20-in. casing sections (welded)
- Installed support frame (designed with Finite Element Analysis FEA software)
- Release tension on the custom-designed support frame
