Full-Scale Floor System Field and Laboratory Fire Experiments

Steve Kerber, PE
Research Engineer, Corporate Research
Bob Back strom
Research Engineer, Corporate Research
James Dalton
Contractor, Corporate Research
Daniel Madrzyk owski, PE
Fire Protection Engineer, NIST

January 2012

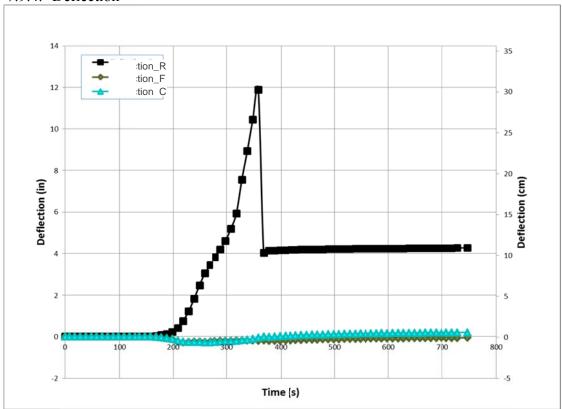
Figure 246. Experiment 9 - Floor System Deflections

The primary structural failure occurred at the rear section of the floor system; local to the initial fire location. The failure mode of the parallel chord metal plate connected trusses was due to steel/wood connection failures (Figure 248). Connection failures were noted at various truss panel points (Figure 249 and Figure 250) and tension splice locations (Figure 251 and Figure 252). The floor system began to progressively deflect from 190 seconds until the end of the test. Experiment 9 induced a collapse of approximately 50 % of the total floor structure. The collapse time for the Experiment 9 was 6:08 after ignition. The collapse time respective of the structural element fire involvement for Experiment 9 was 3:42.

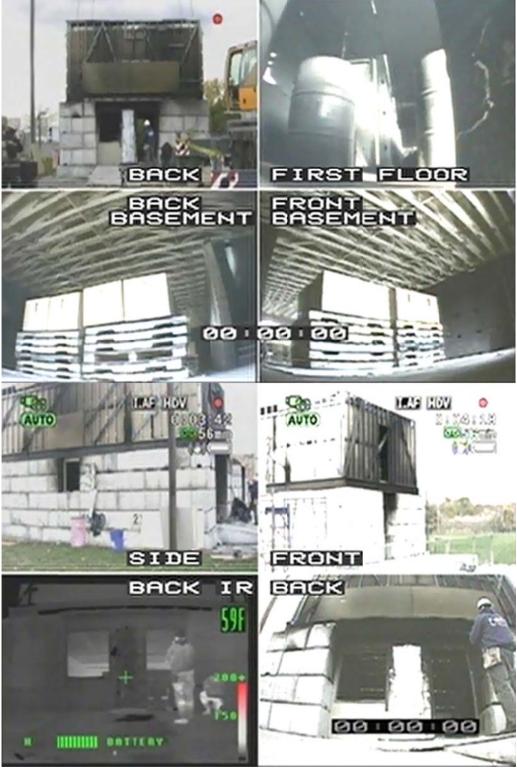
Figure 253. Experiment 10 video views at 0:00.

The observations are presented as a series of images captured from eight camera locations, seven were video cameras and one was a thermal imaging camera. The views were captured at the start of the experiment (0:00, Figure 253), once flames attached to the floor system (1:38, Figure 254), when flames are seen exiting the doorway to the first floor (1:59, Figure 255), and 5 seconds before collapse (3:23, Figure 256).

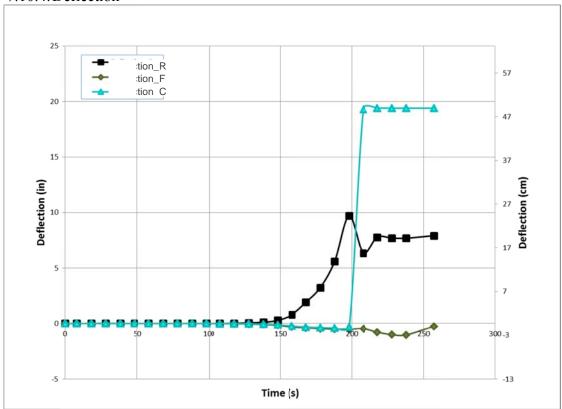
Figure 268. Experiment 10 - Floor System Deflections

The primary structural failure occurred at the rear section of the floor system; local to the initial fire location and extended to the center section as well. The failure mode of the parallel chord metal plate connected trusses was due to steel/wood connection failures. Connection failures were noted at tension splice locations (Figure 271) and at various truss panel points (Figure 272 - Figure 273). The floor system began to progressively deflect from 150 seconds until the end of the test. Experiment 10 induced a collapse of approximately 65 % of the total floor structure (Figure 270). The collapse time for the Experiment 10 was 3:28 after ignition. The collapse time respective of the structural element fire involvement for Experiment 10 was 1:50.

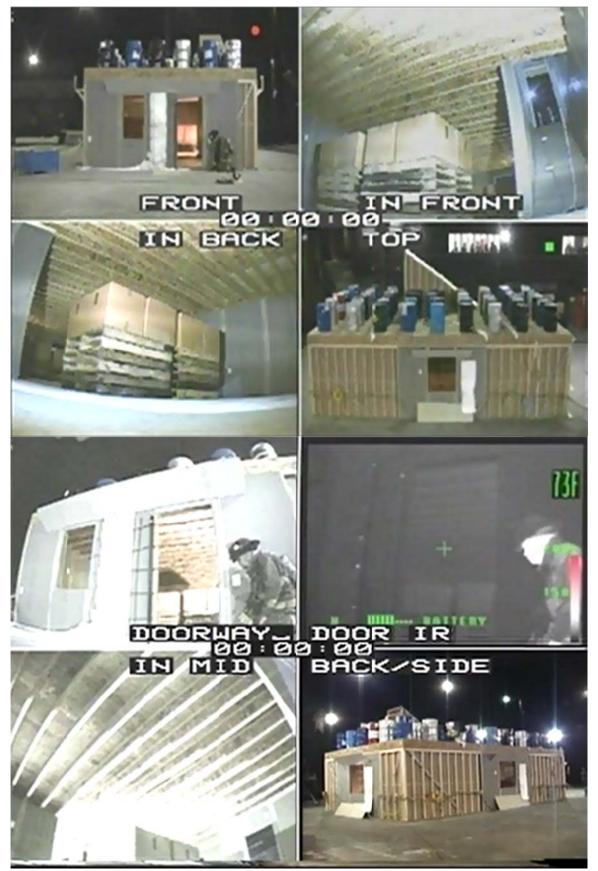
Figure 307. Experiment A video views at 0:00.

The observations are presented as a series of images captured from eight camera locations, seven were video cameras and one was a thermal imaging camera. The views were captured at the start of the experiment (0:00, Figure 307), once flames attached to the floor system (2:20, Figure 308), when there was sustained flames coming from the stairwell doorway on the first floor (2:40, Figure 309), 5 minutes after ignition (5:00, Figure 310), and 5 seconds before collapse (6:15, Figure 311).

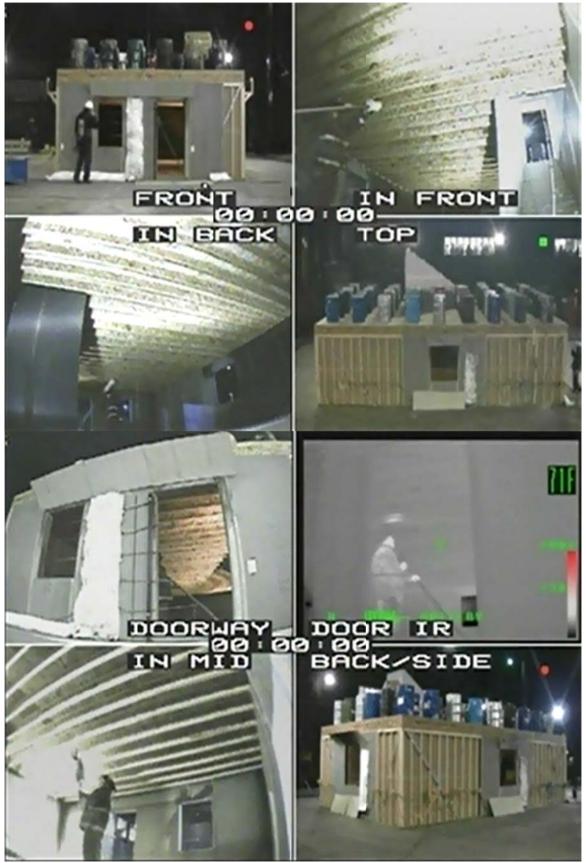
Figure 326. Experiment B video views at 0:00.

The observations are presented as a series of images captured from eight camera locations, seven were video cameras and one was a thermal imaging camera. The views were captured at the start of the experiment (0:00, Figure 326), just after the torch was removed (22:02, Figure 327), once flames attached to the floor system (25:55, Figure 328), when there was sustained flames coming from the stairwell doorway on the first floor (27:28, Figure 329), and 5 seconds before collapse (31:20, Figure 330).

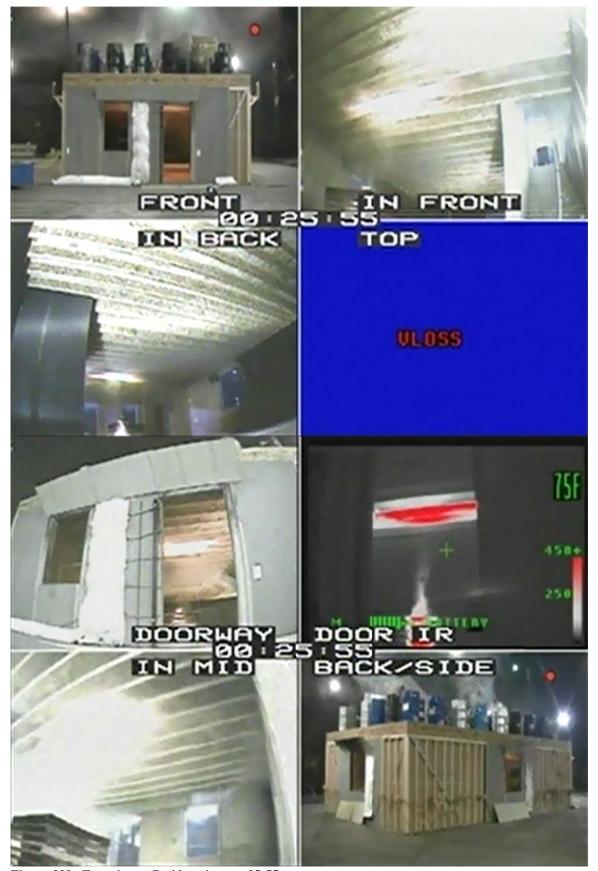
Figure 328. Experiment B video views at 25:55.

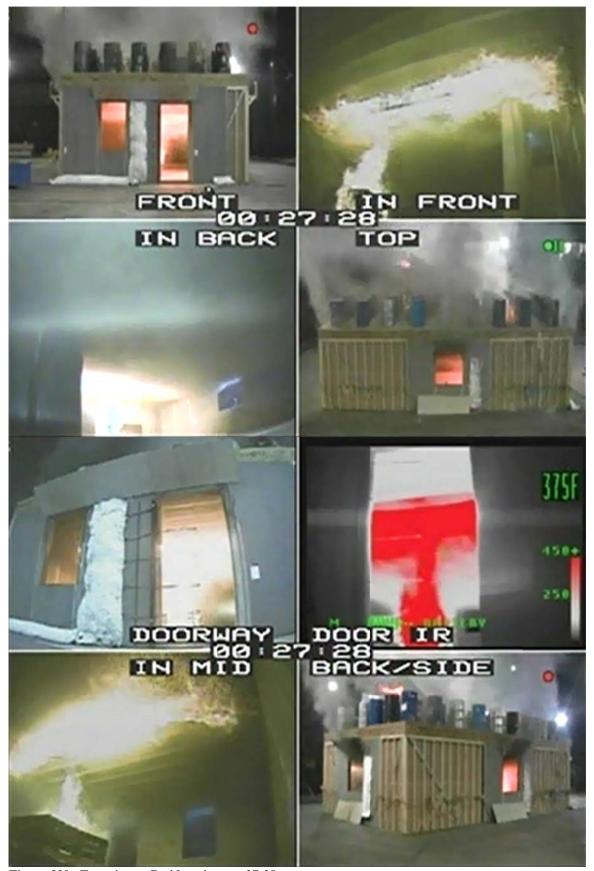
Figure 329. Experiment B video views at 27:28.

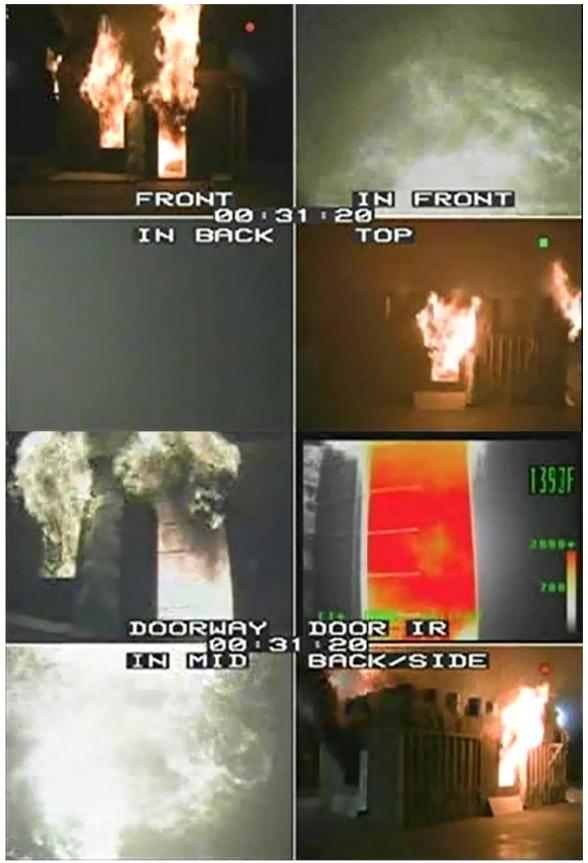
Figure 330. Experiment B video views at 31:20.

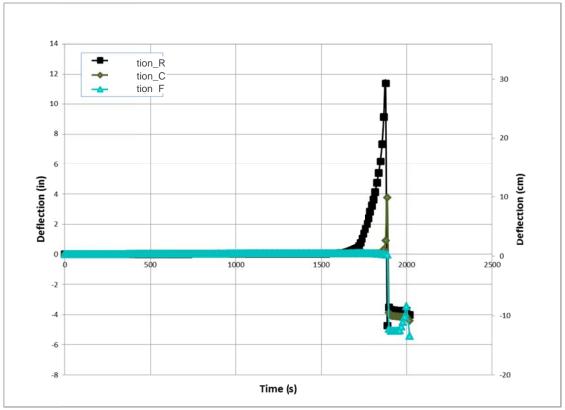
Figure 340. Experiment B - Floor System Deflections

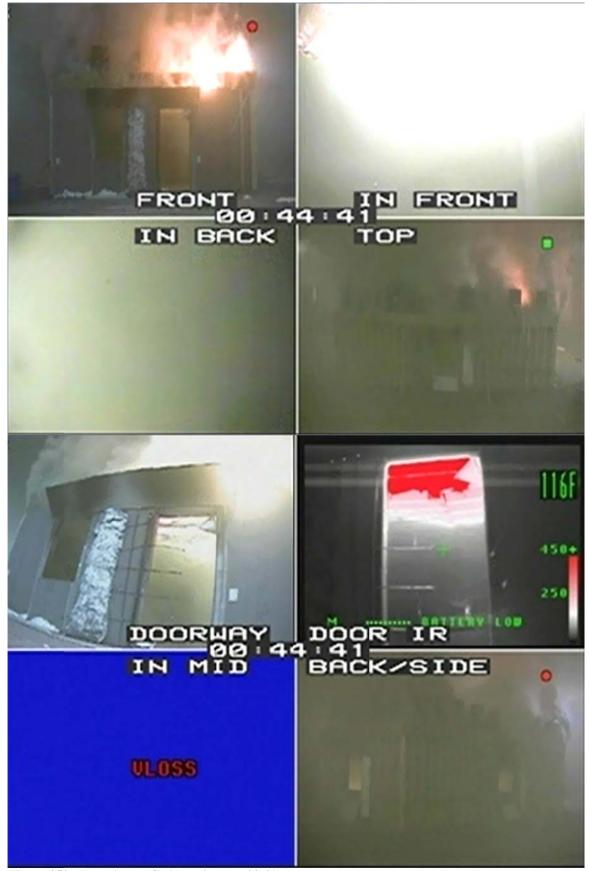
Figure 350. Experiment C video views at 44:41.

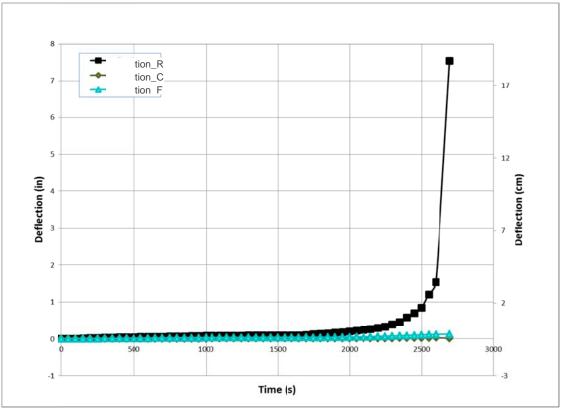
Figure 360. Experiment C - Floor System Deflections

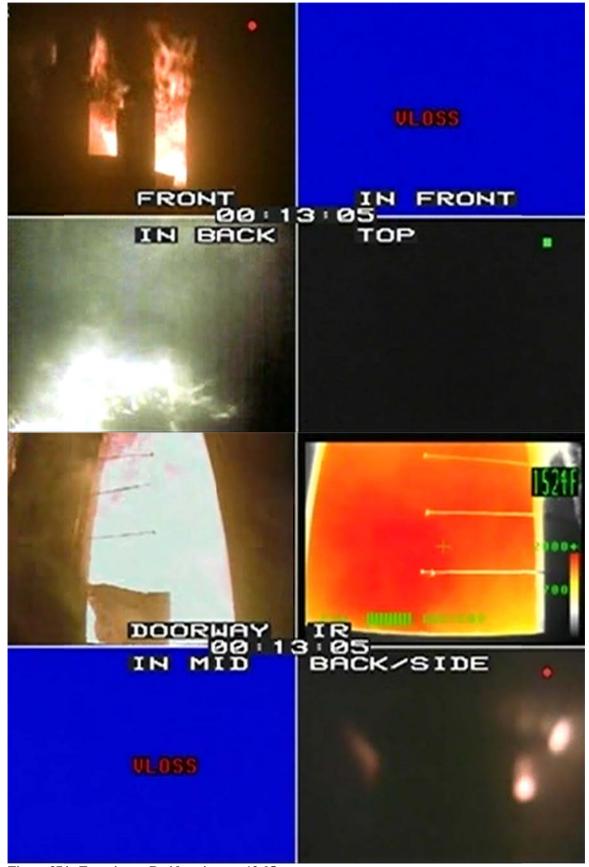
Figure 374. Experiment D video views at 13:05.

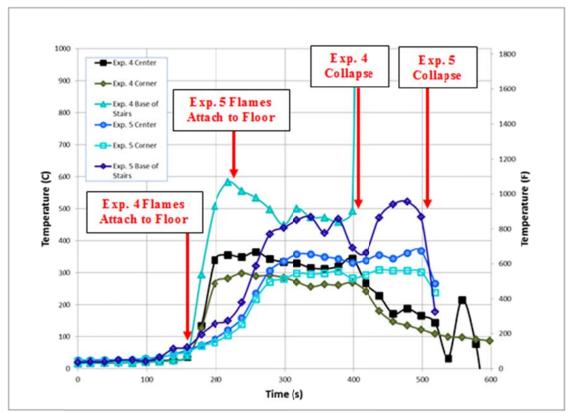
A common misconception when analyzing the collapse of wood floor systems is neglecting the impact the floor system itself plays in the fuel load needed to grow the fire. Usually the focus is on the fuel load in the room and not necessarily on the amount and geometry of wood available to burn. Two sets of experiments can be compared from this experimental series based on different fuel loads. The first is experiments 4 and 5, where the floor system (Engineered I Joist) was the same, the loading was the same, but the fuel load was different. Experiment 4 had the full fuel load consisting of wood pallets with cardboard boxes of expanded polystyrene trays on top of them. The impact of the reduced fuel load in Experiment 5 was a 62 second delay in fire spread to the floor system. Experiment 5 had just the wood pallets and no boxes. Figure 392 shows the 3 temperature measurement locations in the basement at 6 ft. above the floor or 3 ft. below the decking. It also shows the time of collapse for each experiment which was within 100 s of each other. If you compare the time from ignition of the floor system above the fuel load to collapse time both experiments are within 36 seconds of each other. Table 46 shows the peak temperatures and temperatures 10 seconds before collapse of each experiment and they are all with 10% of each other demonstrating that the temperatures in the basement are independent of the change in fuel load. Experiment 4 with the larger fuel load did not burn hotter than Experiment 5.

Figure 392. Basement temperatures at 6 ft above the floor for Experiments 4 and 5

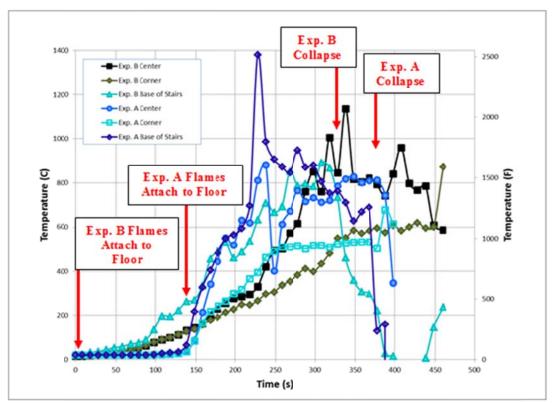
The second comparison was between Experiment A and Experiment B. All variables were the same with the exception of the fuel load. Experiment A had the standard fuel load consisting of the pallets and the cardboard boxes and Experiment B had no fuel load and was ignited with a propane plumber's torch. Figure 393 shows the basement temperatures at 6 ft. above the floor and the collapse times for Experiments A and B. In the graph time zero for Experiment B was when the floor system was ignited by the torch and sustained burning. Table 47 shows the peak temperatures and temperatures 10 seconds before collapse of each experiment. Temperatures at the corner location, remote from the fire are similar between experiments while Experiment A had higher center temperatures and Experiment B had higher base of stair temperatures. Fire development in both experiments was dictated by the burning of the floor system and not the fuel load in the basement. Comparing the time from floor system ignition to collapse in both experiments yields collapse times within 90 seconds of eachother.

Figure 393. Basement temperatures at 6 ft above the floor for Experiments A and B

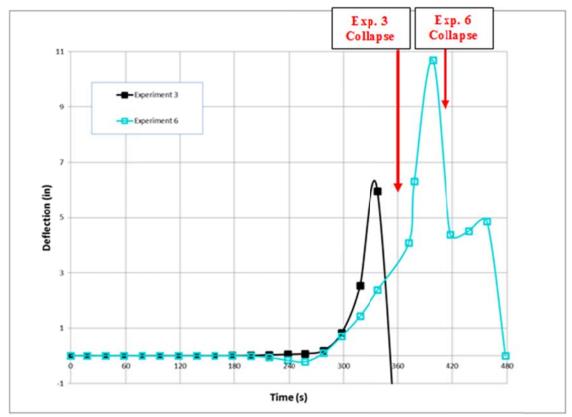
Figure 410 shows the deflection during Experiments 3 and 6. Both Experiments have approximately the same time to onset of deflection. Due to the smaller load Experiment 6 had a slightly slower rate of deflection leading up to collapse which accounts for the 49 seconds difference in collapse times. Ultimately the load on the floor system did not play a significant role in determining the time to collapse but rather the degradation of the floor system as it was consumed and weakened by the fire.

Figure 410. Deflection versus time for Experiments 3 and 6

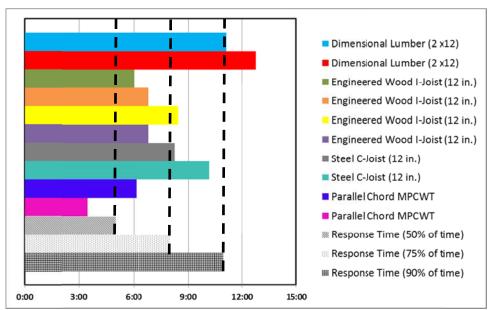
In the best case, the slowest collapsing floor system was the dimensional lumber floor that was ventilated in the sequence that could be done by the fire service. The simulated operations of the fire department began at 8 minutes after ignition and the collapse occurred at 12 minutes and 45 seconds. This could be interpreted to mean that the fire department would need to eliminate the hazard in less than 5 minutes to avoid the collapse. This emphasizes the importance of protecting all types of flooring systems, including dimensional lumber. However, note that 5 of the 8 engineered floor assemblies collapsed prior to the 8 minute mark, which emphasizes the importance of size-up by the arriving fire department.

Figure 411. Collapse Time versus Response Time, assuming dispatch at the time of flaming ignition.

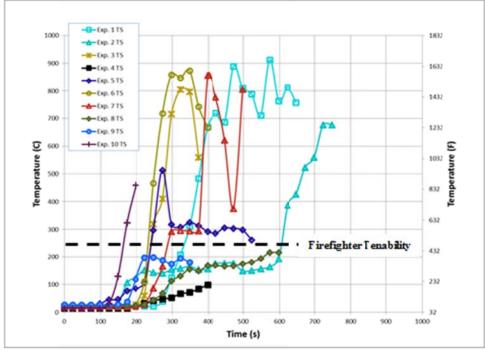
Both figures show that temperatures are lower for the unventilated experiments however once ventilation openings are made such as in experiment 2, conditions change quickly. Temperatures at the top of the stairs change from less than 200 °C (390 °F) to over 400 °C (750 °F) in less than 30 seconds, exceeding firefighter tenability limits. Ventilating the basement while firefighters are attempting to descend the stairs or ventilating while firefighters are at the top of the stairs could be very dangerous.

Figure 412. Temperatures 3 ft. above the floor at the top of the stairs

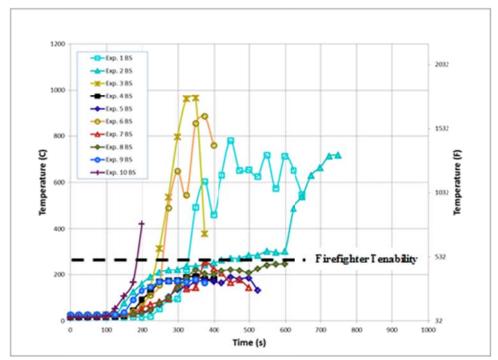
Figure 413 shows the temperatures at the bottom of the stairs up through the time of floor system collapse. It also demonstrates that if the fire is ventilated then the temperatures at the bottom of the stairs are also not tenable for firefighters. The thought that if it is hot at the top of the stairs

during a basement fire then relief may be found at the bottom of the stairs is not supported by the data from these experiments. Furthermore when basement fire conditions reach the severity to create these conditions, unprotected basement structural elements are being rapidly damaged by the fire.

Figure 413. Temperatures 3 ft. above the floor at the bottom of the stairs

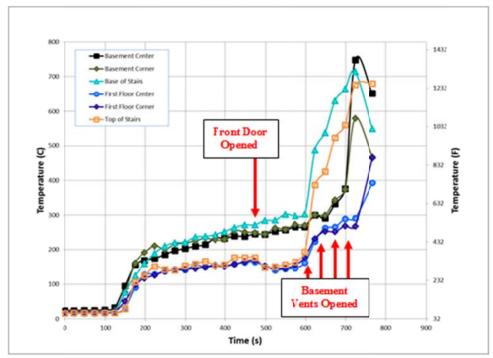
This series of experiments demonstrates the importance of coordinated ventilation. While most of the floor systems collapsed prior to fire department intervention, experiment 2 did not and it highlights the importance of flow paths. As the ventilation openings in the basement were made it created a flow path from the basement to the front door of the structure. Anyone in this path would have to move quickly to survive. Figure 414 shows the impact of making ventilation openings on the temperatures in the structure, 3 ft. above the floor. Opening the front door had little impact on the temperatures and even lowered the temperatures on the first floor slightly. However, once the basement ventilation openings were created, a flow path from the basement to the front door was created and the temperatures increased dramatically throughout the structure. Figure 415 shows the velocities of the gases traveling up the basement stairs. Average velocities increase from 3 m/s (7 mph) to 6 m/s (13 mph) once the basement door was opened. Since the ventilation of the basement is not being done by the crew on the first floor it becomes paramount for the crew that wishes to ventilate the basement to be in communication with the crew on the first floor and to coordinate the action.

Figure 414. Experiment 2 Temperatures at 3 ft. above the floor

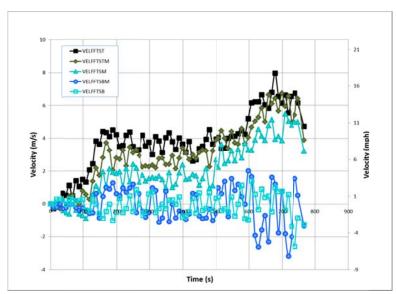
Figure 415. Experiment 2 Velocities at the top of the stairs

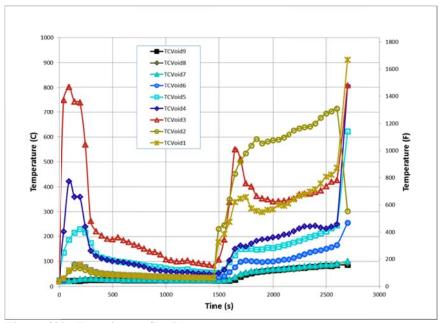
The temperatures in the basement never exceeded 60 °C (140 °F) for the entire experiment leading up to collapse even though the temperatures in the void space exceeded 700 °C (1300 °F). The fire did burn up through the OSB floor decking well into the experiment. This could ignite a fire on the first floor which could mask the fact that the fire is in the floor system. The crew checking the basement could experience cool temperatures in the basement but should still

Figure 430. Experiment C void space temperatures.
