PROBLEMS, CAUSES, AND CURES

Wood Distortion

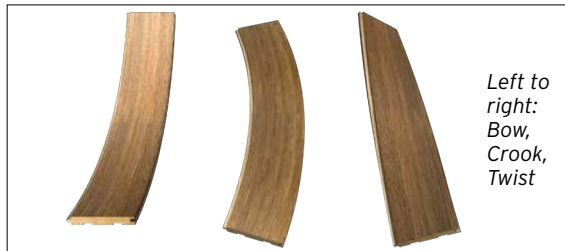
Warp

DEFINITION: Any variation of the intended shape of a piece of wood flooring from a true or flat plane.

Bow - A deviation in the lengthwise flatness of a board, measured end to end.

- Solid wood flooring: Bow occurs when one side of the floor board shrinks more in length than the other. It causes the lengthwise curvature of the plank that resembles a bow used in archery. Because longitudinal shrinkage in solid wood is minimal, bow is normally not an issue that affects installation.
- Engineered wood flooring: Bow occurs when the wear layer and the core begin to shrink in opposing lengthwise directions, forcing the uninstalled planks to bow. Manufacturer and industry standards (HPVA) dictate tolerances and milling requirements for the amount of bow allowed in an engineered wood floor at the time of manufacture. This may or may not coincide with uninstalled flooring at the jobsite due to change in moisture content as a result of jobsite conditions.

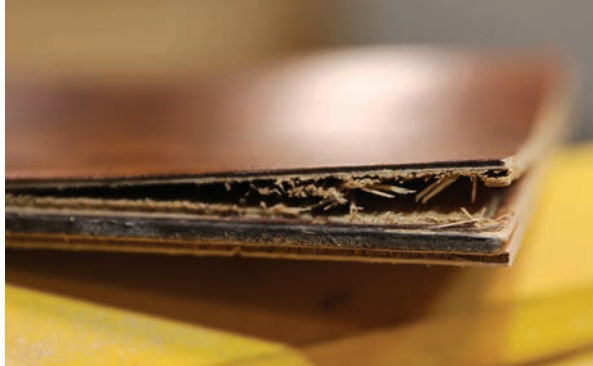
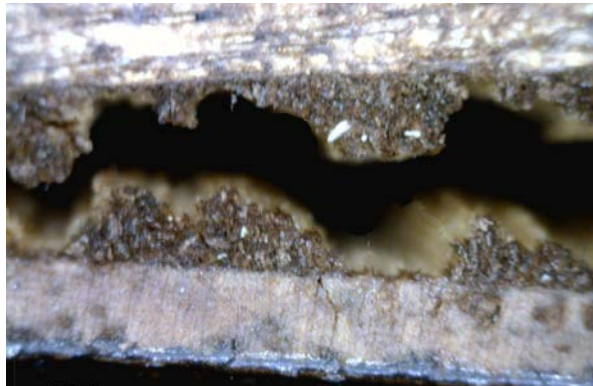
Wood Shear (Engineered Flooring)

DEFINITION: External stresses exceeding the strength of the wood fibers within an individual plank of engineered flooring, resulting in the wood fibers being torn apart. When examining this type of failure in an engineered wood flooring plank, wood fibers will be visible at the point of separation, remaining bonded to the adhesive layer.

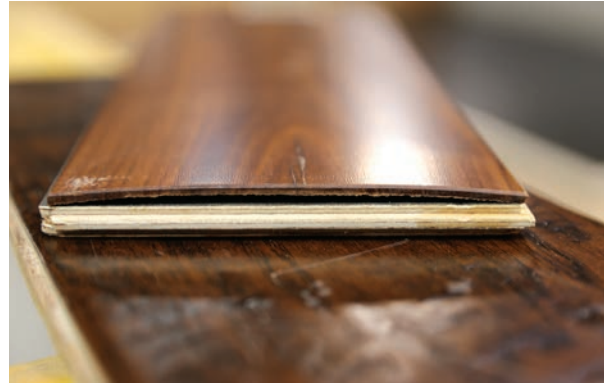
Delamination/ Glue-Line Separation (Engineered Flooring)

DEFINITION: Engineered flooring is manufactured by adhering several layers/plies together. The separation of two layers/plies within a piece of engineered flooring due to the lack of an adhesive bond is typically identified as a clean separation at the glue-line. Adhesive bond failure is unrelated to inadequate relative humidity levels.

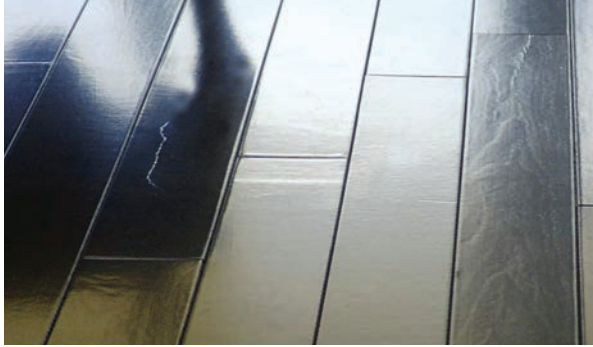
Telegraphing Core Material (Engineered Flooring)

DEFINITION: Visible patterns on the surface of the wood floor plank that resembles variations in the engineered flooring core material.

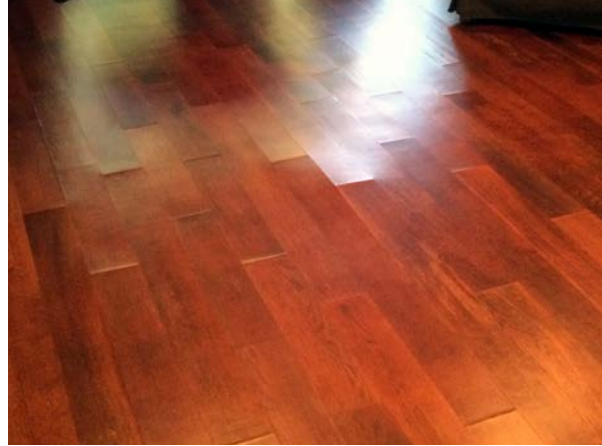
Endlift/Ski (Engineered Flooring)

DEFINITION: A condition where the ends of installed engineered wood flooring boards deviate from the flat plane and appear raised or curved upward.

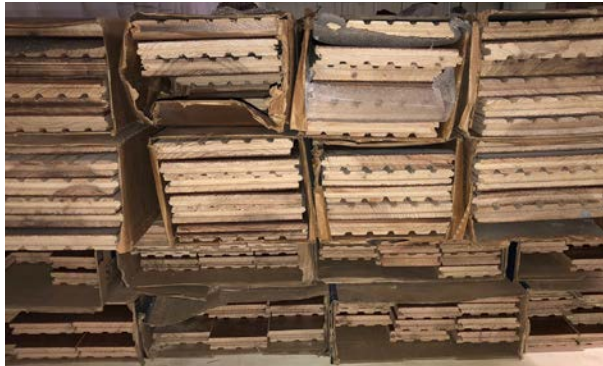
End-Swell/Flared-Ends (Solid Flooring)

DEFINITION: A condition where the ends of solid wood flooring boards deviate from the flat plane and/or parallel plane, and may appear wider or thicker than the rest of the board.

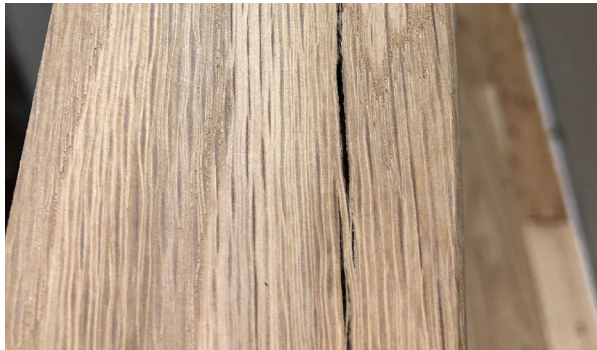
Surface-Checks - Surface checks are separations in the wood fibers that usually occur in, or adjacent to, the wood rays on the faces of plainsawn (flatsawn) boards. These separations occur during the early phases of the drying process where the external and internal stresses cause the wood to tear itself apart.

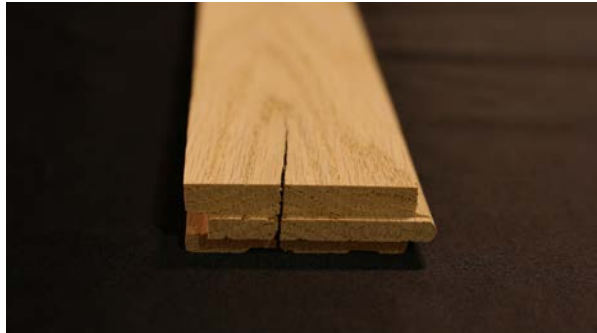
End-Checks - Like surface checks, end checks occur in, or adjacent to, the wood rays, but on the ends of the boards rather than the face. These separations occur due to the normal movement of moisture along the length of the boards, where the ends of the boards dry more rapidly leading to stress fractures on the ends of the boards.

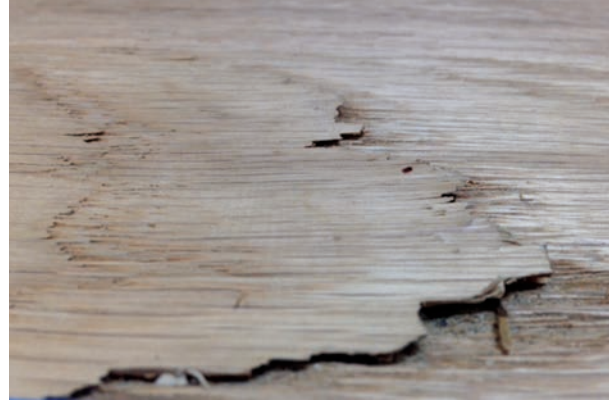
Shake (Ring Shake/Ruptured Grain)

DEFINITION: A separation of the wood's fibers along the grain (parallel to the growth rings), that usually occurs between the rings of annual growth.

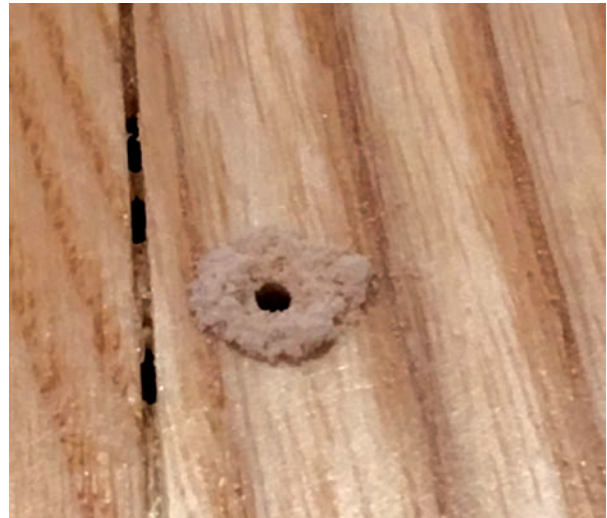
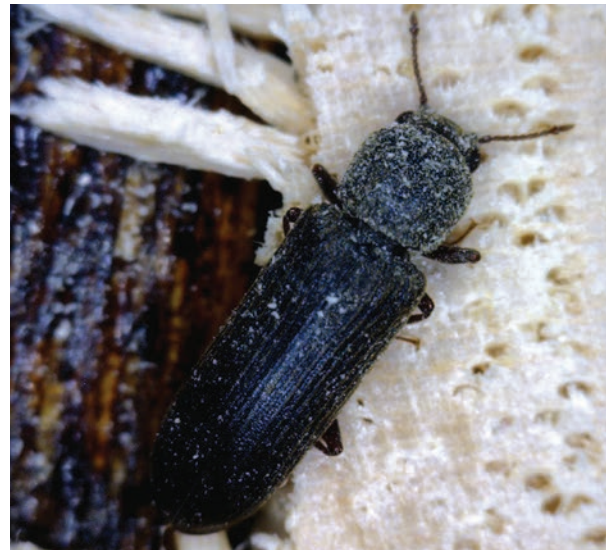
- **Powderpost (Lyctid/Anobiid) Beetle** - The larvae of wood-eating insects bore in and feed on the wood fibers causing damage to both hardwoods and softwoods. Properly kiln-dried lumber will normally eliminate powderpost beetles, but infestations can occur at any point after the kiln-drying process, including during storage, transport, or from other wood products.

- Infestation often occurs long before, but can even occur after the wood floor is installed. Female beetles lay their eggs within the pores of the bare, unfinished wood. The larvae feed on the wood, creating tunnels that fill with a powdery substance called frass. Later, when the larvae mature, they exit the wood, creating small pinholes, generally measuring 1mm-3mm (1/16"). In active infestations, the holes will be surrounded by this frass (light-colored powder). This frass material is very fine and will feel like talcum powder when rubbed between two fingers. The presence of an actual beetle, beetle larvae, or frass is the only way to absolutely confirm an active infestation.

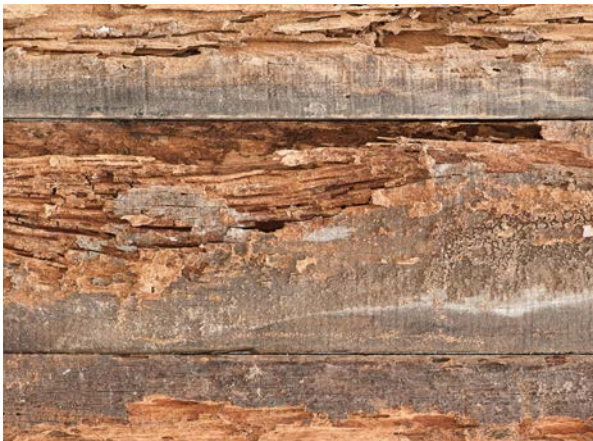
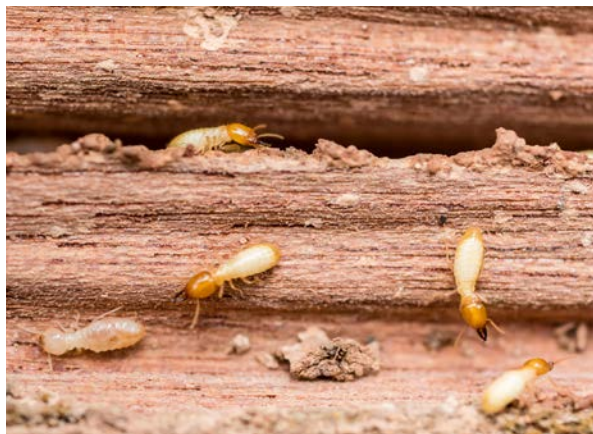
- **Termites** - Termites are attracted to areas where moisture accumulates in and around your home, including damp basements, laundry rooms, bathrooms, and leaky foundation walls.
 - Termites will eat any kind of wood including mulch, rotting wood, new wood, painted wood, and treated wood.
 - Stagnant, moist air in the home provides the perfect breeding ground for termites.
 - Termite-damaged wood is usually hollowed out along the grain, with bits of dried mud or soil lining the feeding galleries. Wood damaged by moisture or other types of insects will not have this appearance.
 - Termite infestations are a site-specific condition.

- Improperly dried or stored lumber.
- Lyctid Powderpost Beetles are usually brought into the house in wood products that contains eggs or larvae that may have been in furniture, firewood, untreated reclaimed lumber, joists or framing, molding, trim, wood paneling, cabinets, or even the pallets used to transport the flooring.
- Termites and Anobiid Powderpost Beetles normally prefer to infest wood that is damp; therefore, infestations usually begin in moist, poorly ventilated areas such as in unconditioned crawl spaces or basements.

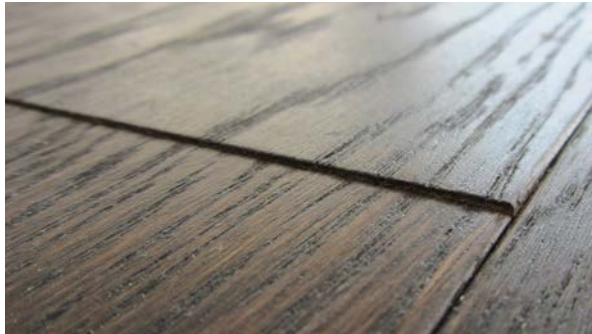
Overwood/Underwood

DEFINITION: A vertical offset that exists between two adjoining installed floorboards.

- Manufacturing defect. Can be determined with destructive testing or on uninstalled wood flooring boards. Solid and engineered wood flooring manufactured tolerances outside of the applicable industry manufacturing standards (NWFA/NOFMA, HPVA, or similar).

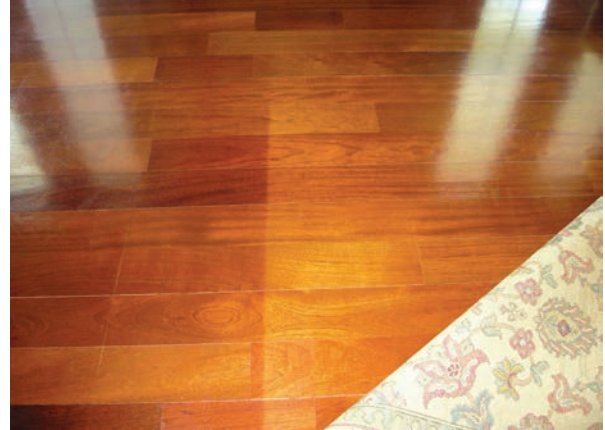
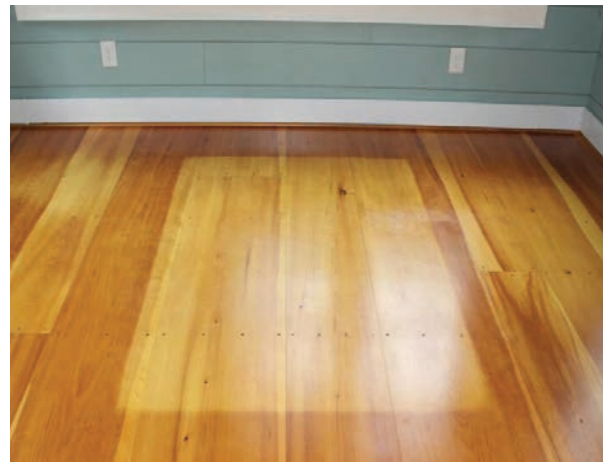
Wood Discoloration

DEFINITION: The wood itself changes color over time (darkens or lightens).

- Wood changes color through oxidation and/or photochemical exposure, which is a change that cannot be prevented. This is a naturally occurring phenomenon. All woods will change color, but some more drastically than others. This is a natural change, and should be taken into account when selecting flooring from sample boards.

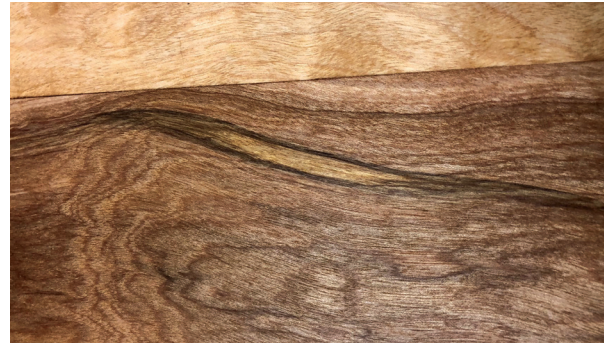
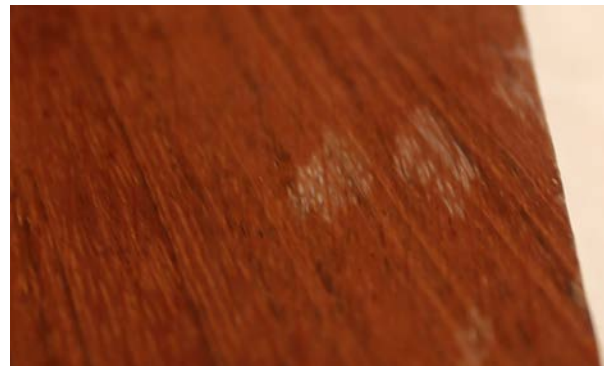
Mineral Streaks/Deposits

DEFINITION: A discolored line, spot, or band in the wood that may range in color from light gray to tan, olive green, brown, purple, blue, or black. Mineral streaks/deposits are naturally occurring and they are often considered to add value and appeal to the wood.

- The source of these mineral streaks/deposits is often undetermined, and is considered a naturally occurring characteristic of living trees. These deposits may develop as the tree absorbs and deposits minerals from the surrounding soil such as limestone, sulfur, nitrogen, phosphorus, potassium, silica, gypsum, or any other mineral found in the region where the tree was grown.
- Some mineral deposits such as silica are often mistaken for chemical stains in some imported species, because of how they may appear as spots or blotches.
- Some mineral streaks may be caused by normal cell physiology occurring from wounds caused by insects, animals, weather, or logging.

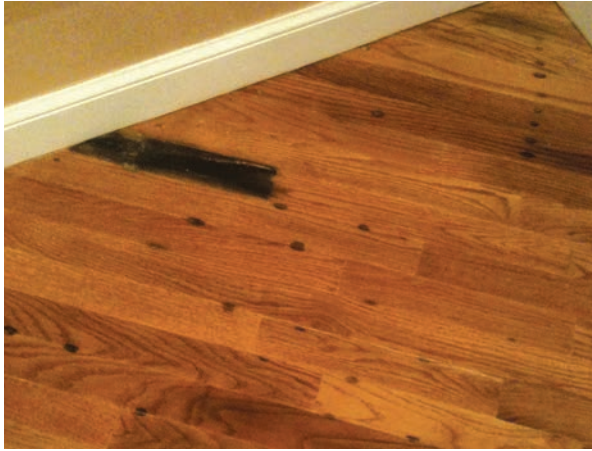
Iron Stains

DEFINITION: A result of a chemical reaction between wood tannins, water, and iron.

- A chemical reaction between extractives in the wood and iron in steel products, such as nails, screws, and other fasteners and appendages.
- Floor scraper filings/shavings left on the flooring surface that reacts with water or water-based products.
- Residual from some types of abrasives left on the flooring surface that reacts with water-based products.
- In extreme moisture condition cases, substrate exposure to moisture leaching into the wood floor from below (iron fasteners or from within the slab).
- Metal containers or objects (such as paint or watering cans) in direct contact with the floor, which have been exposed to moisture.

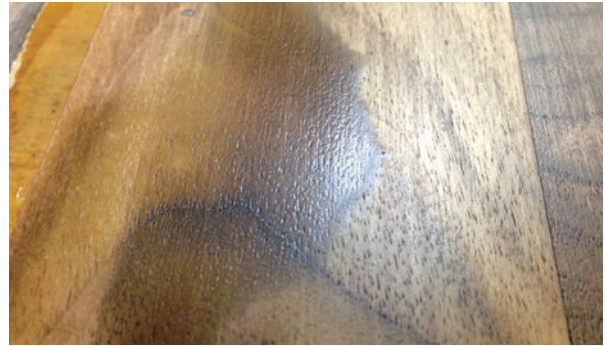
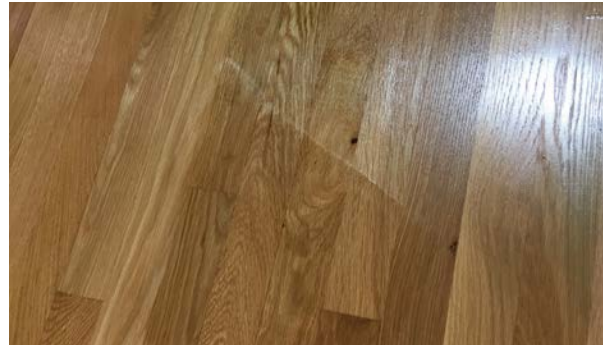
Tannic Acid Discoloration/ Tannin-Pull

DEFINITION: Tannic acid includes various naturally occurring soluble astringent complex phenolic substances found in trees (and plants) as a way of protecting the tree from insects, fire, and bacteria. High levels of tannic acid present in woods like oak, walnut, and mahogany can produce a dark discoloration when coming in contact with some products used in the finishing and maintenance of wood floors.

- Tannic acid is water-soluble and may discolor when it comes in contact with iron and water, which usually appears as a bluish/grey discoloration on the wood.
- Tannic acid discolors when it comes in contact with materials that are alkaline by nature, such as ammonia. Most water-based finishes are manufactured with pH adjusters (such as ammonia), which can cause a green/brown discoloration on the surface of the wood, and may also partially bleed into the finish.
- Unevenly applied water-based coatings, especially heavy spots, puddles or streaks.
- Not using or improper application of a tannin-blocking sealer.
- Application of a top-coat over a sealer that has not adequately dried.

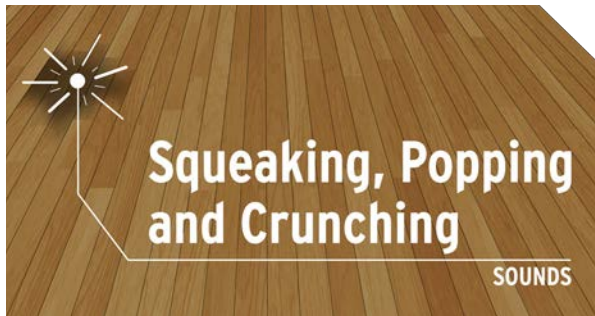
Squeaking/Popping/ Crunching Sounds

DEFINITION: Audible squeaking, popping, or crunching noises in an installed wood floor or within the floor system. Squeaks are not a direct concern with the installed wood floor as long as movement accompanying the audible squeak does not affect the performance of the installation. An occasional squeak within any properly installed wood floor system is not abnormal.

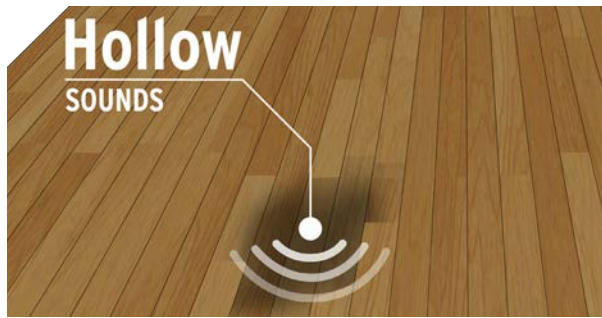
Hollow Sounds

DEFINITION: An audible hollow sound in the installed wood flooring. When no deflection is present, this may be considered normal with many installation methods provided that the installation followed proper installation procedures. Hollow sounds are not a direct concern with the performance of an installed wood floor as long as there is not movement accompanying the audible hollow sound.

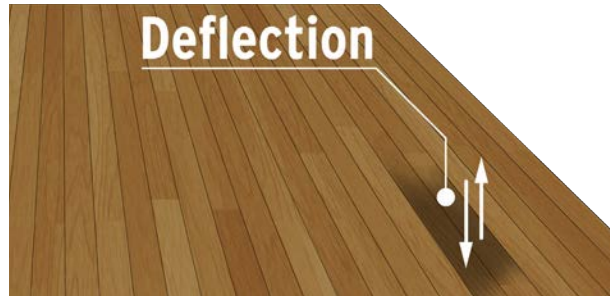
Deflection

DEFINITION: Isolated areas in an installed floor system that exhibit vertical (up and down) movement when pressure is applied.

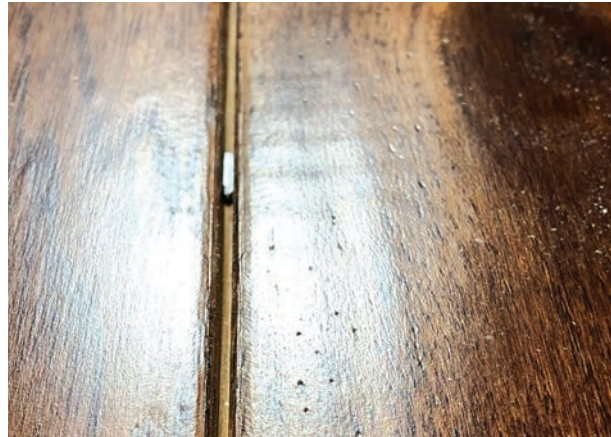
Abnormal Gaps

DEFINITION: Gaps between abutting wood floor boards in the installed floor that were not intentionally placed and remain with seasonal fluctuations in moisture and humidity.

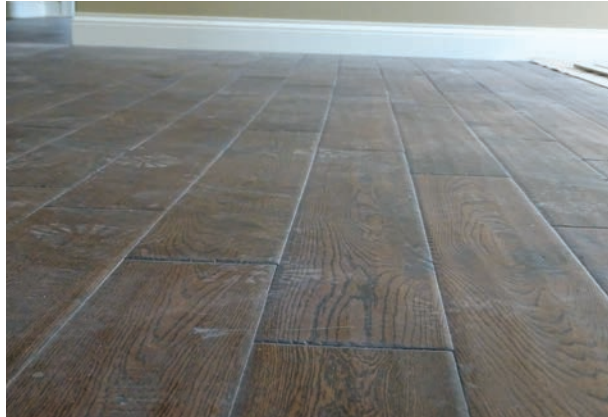
Crooked Installation Discrepancies

DEFINITION: An installed wood floor appearing bowed or out-of-square within the room in which it is installed. No wood floor installation is perfectly straight, parallel, or perpendicular to walls or fixtures. When the straightness of the installed floor takes away from the overall appearance of the floor within the structure, an aesthetic remedy may be necessary. The performance and structural integrity of the wood floor is not normally affected with any floor that has been installed out-of-square or out-of-a-straight-line.

- The existing structure or fixtures within the structure are out-of-square. This is out of the flooring contractor's control.
 - Walls within a structure are never perfectly square, parallel, or perpendicular to one another. The wood floor can quickly highlight a wall that is out of square. During the installation, the floor was laid-out and installed in a relatively straight line, but appears crooked in comparison to adjoining fixtures (walls, floor coverings, cabinets, etc.).
 - One room may be square within the structure, while the next room is not.
 - The new wood floor was intentionally installed to match an existing crooked fixture (walls, floor coverings, cabinets, etc.), or design element within the structure.

- The installation of the wood floor is not in a singular-line-plane from one end of the floor to the other. During the installation, the flooring "drifted" out of a singular-line-plane, resulting in a "crooked" or "bowed" pattern/appearance in the otherwise straight installation. This may be due to many causes:
 - Flooring not installed in a straight line.
 - Floor moving out of a straight line during installation.
 - Premature foot traffic on a glued-down floor that has not yet set-up.
 - Debris between floor boards not allowing boards to be installed tightly together.
 - Mis-milled flooring, flooring that varies in width, warped flooring, or an out-of-square parquet pattern.
 - Tying two floors together that are not aligned.
 - Adding on to an existing crooked floor.
- Customer expectations.

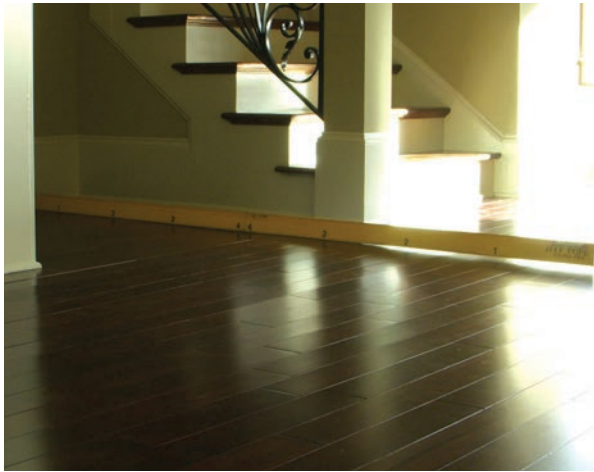
DEFINITION: The installed wood floor system appears to be uneven, wavy, or out of flat. Wood floors may be installed over out-of-level subfloors, but should fall within NWFA floor flatness tolerances. Subfloor flatness cannot be quantifiably measured when a floor covering is in place over it (without potentially extensive destructive testing), however, may give a good indication of what is happening below.

It is the responsibility of the flooring installer to assess substrate flatness, moisture requirements, and panel thickness/joist span combinations prior to installation. Reference NWFA Wood Flooring Installation Guidelines, and the flooring manufacturer installation instructions, for applicable tolerances. Gradual variations in subfloor flatness may not affect the performance of the installed wood floor, but may be considered unacceptable when overwood, vertical movement, slight gapping, squeaking, or noisy floors are present.

- Flooring installed over abrupt variations in elevation/flatness of the subfloor system or screeds within a short distance (refer to NWFA Wood Floor Installation Guidelines or manufacturer instructions for flatness tolerances).
- Improperly installed or inadequate subfloor or subfloor system.
- Improper joist spacing/panel thickness combination.
- Structural conditions.
- Altered subfloor or subfloor system post-installation.
- In a concrete slab system, movement or cracking within an existing slab.
- Flooring installed over improperly applied compounds, improperly installed underlayment materials, or uneven screeds.

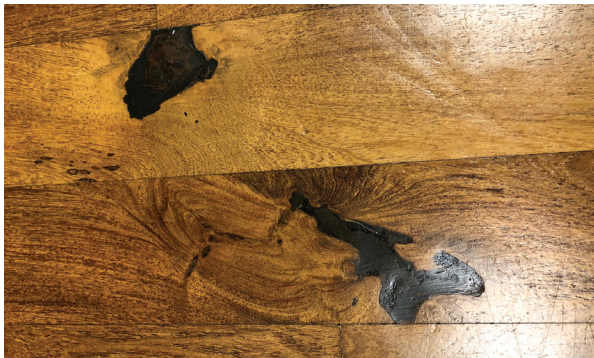
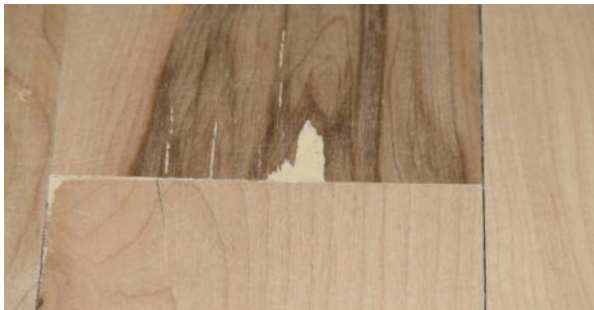
Filler Color Variation

DEFINITION: The wood filler from one area of the floor is different from the overall color tone of the floor. No two trees from the same species are identical, no two boards from the same tree are identical, and color and grain patterns can vary even within one individual plank of wood. Wood filler will never perfectly match, nor is it designed to match every board within a wood floor.

- Filler that doesn't change color with the wood.
- Knot hole and crack filler intentionally colored differently than the overall color of the floor.
- Wrong filler color used on the floor.
- Dirty, contaminated, or improperly mixed filler.
- Installed wood slivers or Dutchmen of different colored species or drastic variation in the grain orientation.
- Customer expectations.
- The drastic variations in many wood species will not always match the filler color used.

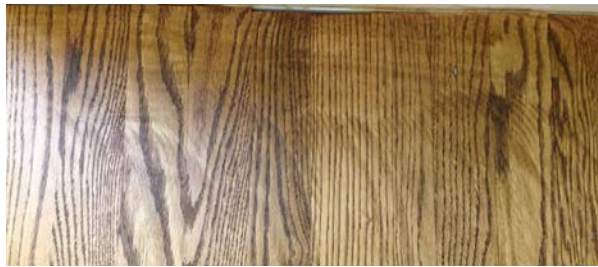
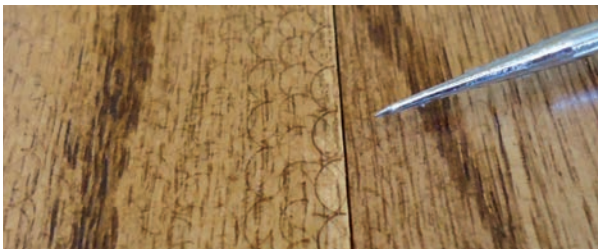
Sanding Marks

DEFINITION: Sanding imperfections seen as drum marks, side cuts, sanding scratches, or swirl marks. Sanding marks should be viewed from a standing position on the floor being assessed, in ambient lighting conditions. Glare from a direct light source must not be used during evaluation. Inspection may take place from floor level and/or with assistance of magnification in order to determine causes of irregularities, but not to determine acceptability.

- Sanding-process related:
 - Poor workmanship/sloppiness.
 - Running the machine in the wrong direction.
 - Running the machine too slow, too fast, or at an inconsistent pace.
 - Inconsistent operator walking speed.
 - Inadequate 1st cut angle.

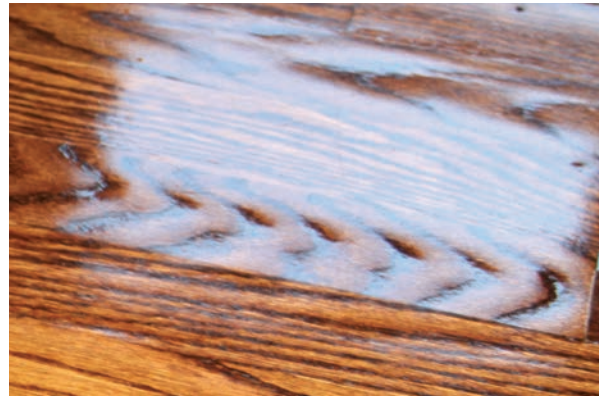
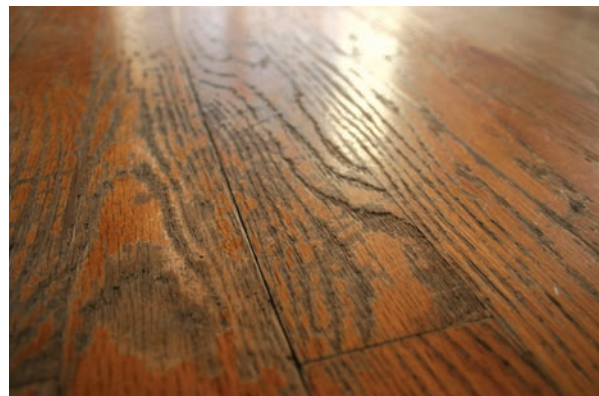
Dishout/Shellout

DEFINITION: Undulations in the surface of individual boards or within the wood floor, resulting from softer areas having been worn, hollowed, or sanded to a lower level than harder adjacent areas.

- May be an intended characteristic of some site or factory-finished floors (such as wire brushing).
- Sanding-process related:
 - Sanding of a floor assembled of mixed species of different hardness characteristics such that material is removed at different rates through the sanding process (for example: borders, feature strips, medallions).
 - Cross-grain sanding (running the belt/drum sander perpendicular to the installed direction) of any area of a wood floor.
 - An incomplete or inconsistent sanding procedure accompanied with an inadequate abrasive grit selection for the floor being sanded.
 - Improper use of the sanding equipment such as:
 - Using too-heavy of drum pressure for the species being sanded.
 - Using thick, compressive, or doubled-up driver pads on the buffer drive plate with the edger during the final sanding processes.

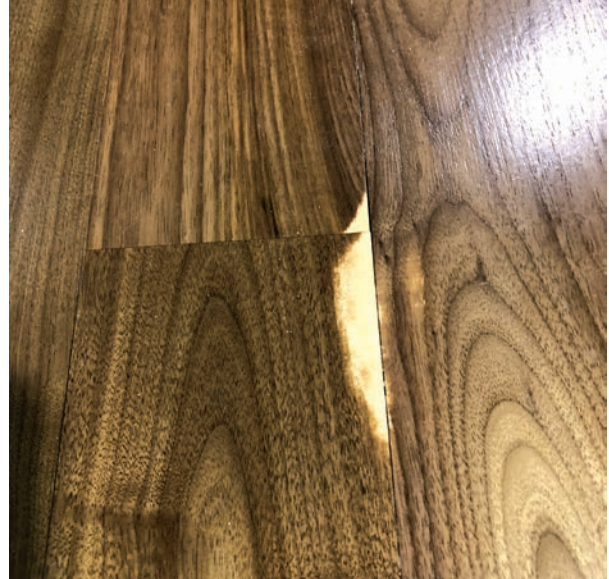
Veneer Sand-Through

DEFINITION: The top/wear layer veneer (lamina) of engineered flooring has been completely sanded through to the core layer.

- Sanding of an engineered wood floor beyond the thickness of the top layer of wood to the core layer.

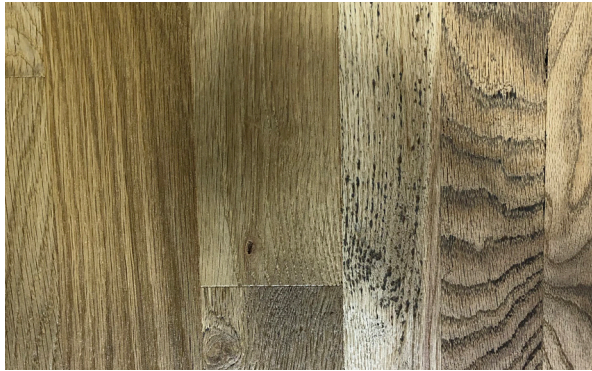
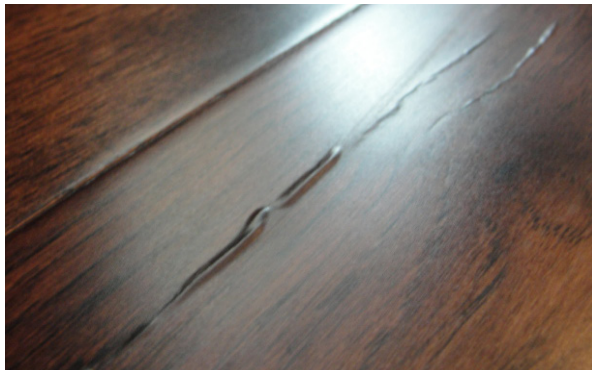
Stain Bleed Back

DEFINITION: A staining phenomenon occurring after the initial application of the stain, where the stain seeps back to the surface of the wood. This may happen at board seams, with open-grain species, tight grain, knots, or burls.

- A change in moisture content and/or jobsite environmental conditions causing higher moisture content levels within the flooring. The resulting swelling of the flooring can force out any undried stain residual within, or between boards.
- Jobsite conditions too hot or too cold during stain application may alter the intended application and dry times.

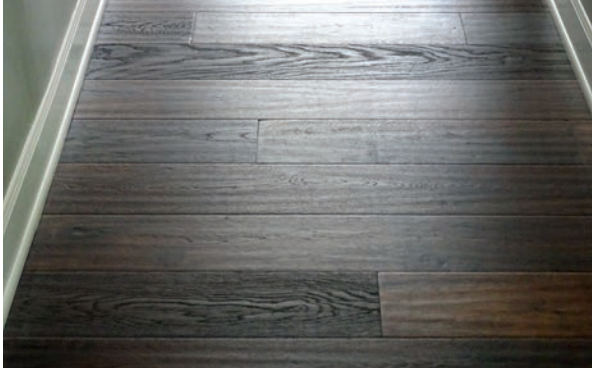
Finish Film-Thickness Discrepancy

DEFINITION: A discrepancy in the depth of the film of finish applied to a wood floor. Mil/film thickness of finish can be evaluated, but should not determine acceptability.

- Inadequate sanding process, including skipping grits, or final sanding with too-coarse of grit abrasive.
- Not following the finish manufacturer's recommendations (spread rate, application method, number of coats, etc.).
- A normal consequence of penetrating oil or other non-film-forming finish systems.
- Perception due to the soft grain characteristics of ring porous (open grain) species (oak, ash) not completely filled. This is a natural occurrence, which varies from board to board, and does not compromise the integrity of the floor.
- Perception due to the natural characteristic and intentional appearance of wire brushed, distressed, reclaimed, or sculpted floors.
- Customer expectations.

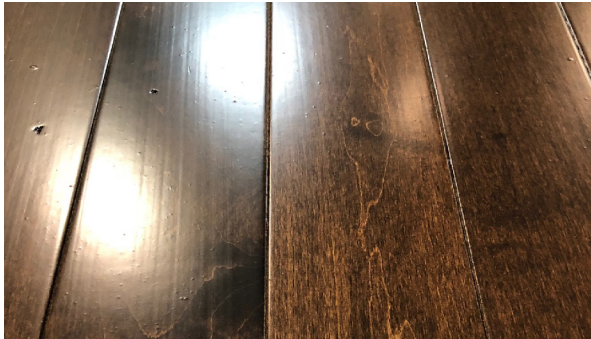
Applicator/Finish Streaks

DEFINITION: Visible ridges, lines, or marks left on the wood floor, representing the application tool used from any stage of the finishing process.

- Improper finish application (not feathering out or coating cross-grain).
- Improper applicator used to apply the finish.
- Using an applicator that has hardened spots in the fibers.
- Inconsistent finish film thickness/improper coverage rates, where finish was applied too heavy or too thin.
- Matting agents in the finish not mixed adequately, resulting in sheen streaks.
- Expired finish or expired hardeners/crosslinkers affecting the application and flow of the finish.
- Finish stored or exposed to extreme temperatures outside of the manufacturer recommendations.

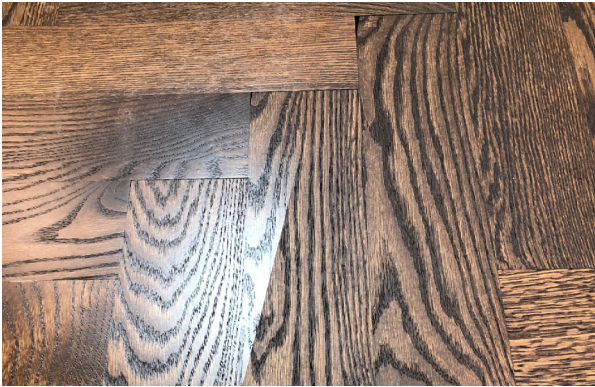
Holidays/Skips

DEFINITION: An exposed area of uncoated wood or the undercoating, when the intention was to coat the entire area.

- Inconsistent finish, sealer, or colorant application.

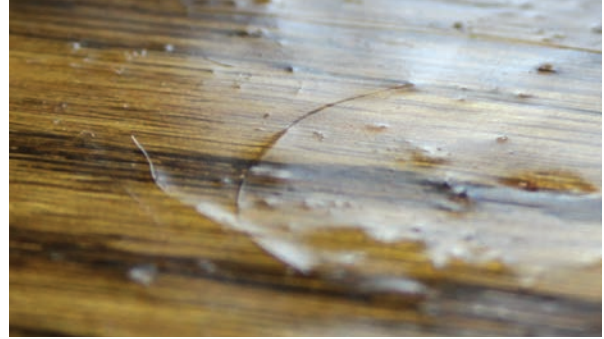
Debris in Finish

DEFINITION: A raised bump in the film of finish often consisting of dust, hair, applicator fibers, foreign contaminants, solid finish particles, or other artifacts. Due to the nature of most coating environments, minimal amounts of debris within reason can be expected in any coat of finish.

- Flooring surface, facility (window sills, countertops, door jams), or mechanic (shoes, clothing) inadequately cleaned prior to final coat application.
- Insufficient removal of already-existing debris prior to subsequent coats.
- Uncontrolled air movement and airborne debris landing in the final coat of finish as it is drying.
- Unfiltered, improperly mixed, contaminated finish or dried finish film particles within the finish.
- Finish applicator fibers or contaminated applicator.
- Normal debris that may be found on most jobsites that, regardless of process, will exist under, within, or on, a newly applied coat of finish.

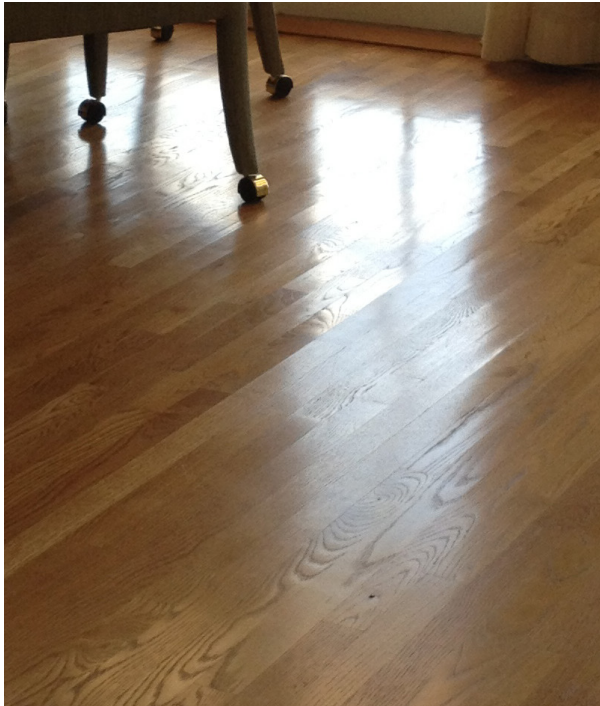
Uneven Sheen/Gloss Levels

DEFINITION: The sheen or gloss level of the final coat of finish varies from one area of the floor to another. As film-forming finish products decrease in gloss, they increase in amounts of matting agents. Lower sheen products have the most matting agent, and thus, can more-easily manifest uneven sheen levels. Sheen/gloss levels should not be assessed until all final coats have been applied and are fully cured.

- Application-related:
 - Contaminated finish applicator.
 - Improper mixing of finish prior to application (matting agents not adequately mixed into the film-finish).

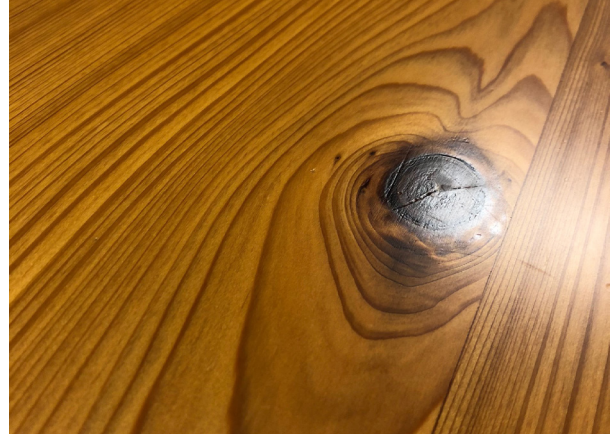
Sticky Board Syndrome

DEFINITION: Wood floor finishes that do not dry, adhere, cure properly, or appear the same on specific areas of a board or individual boards.

- Species with high concentrations of tannic acid, a pH imbalance, natural oils, or sap from a variety of species may adversely affect the finish's ability to properly dry and cure.
- Knots on species such as pine or Australian cypress affecting the ability of the finish to properly dry and cure.
- Contamination within the wood or between boards affecting the ability of the finish to properly dry and cure.
- Insufficiently cured UV finishes (factory-finished or site-finished).

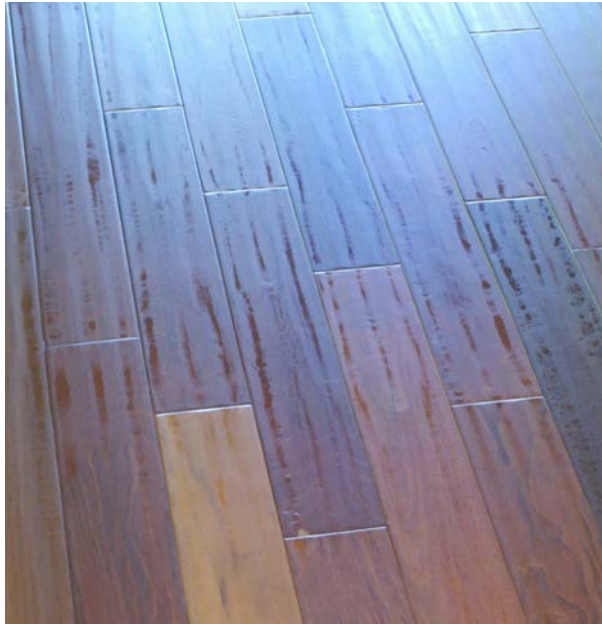
Cloudy Finish

DEFINITION: An unintended white, milky, or cloudy appearance of an otherwise transparent, clear finish.

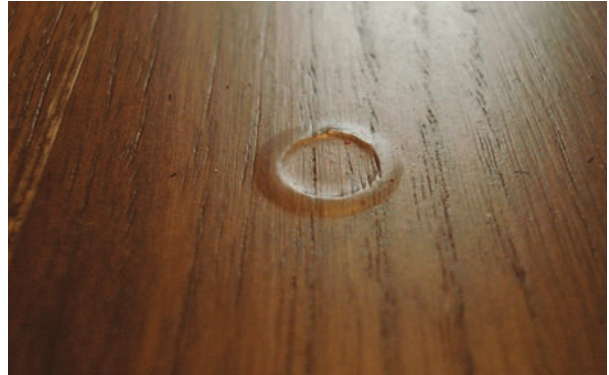
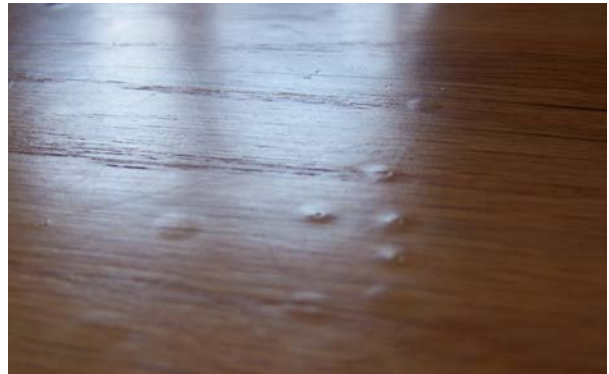
Craters/Fisheyes

DEFINITION: A visible finish imperfection that manifests by the crawling of wet finish film into a single area or pattern resembling small dimples or bowl-shaped depressions, sometimes accompanied by a particle in the center.

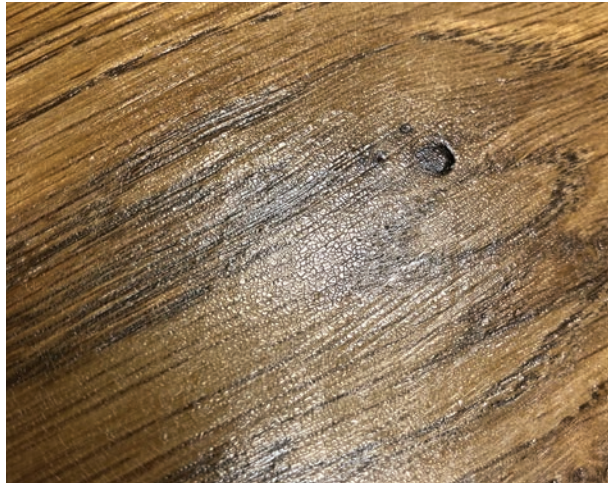
Crazing/Alligatoring

DEFINITION: A visible finish imperfection that appears as a network of very small, fine cracks or fissures in the surface of the finish film, which sometimes resembles the skin of an alligator or crocodile.

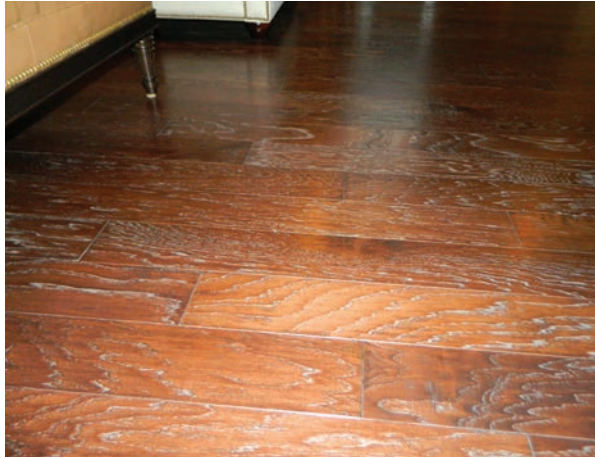
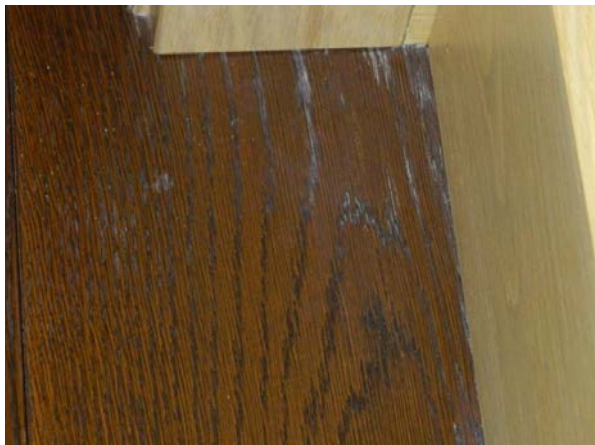
Open-Grain Contamination

DEFINITION: An accumulation of contaminants in open voids or characters, such as in textured wood, the soft grain/springwood, open knots, splits/checks, etc., on the surface of the installed floor.

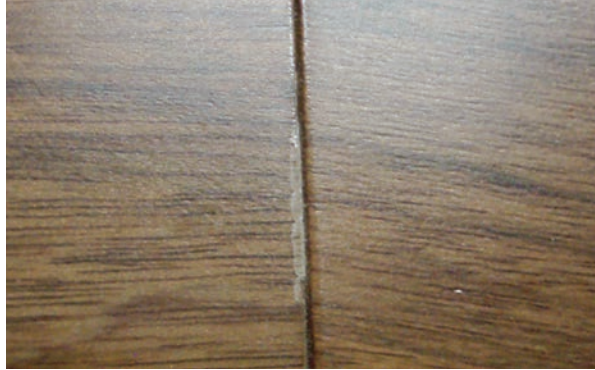
DEFINITION: The loss of film-finish adhesion to the flooring surface or between coating layers.

Chipping/Flaking Finish - The condition that occurs when a dried film of finish separates from the previously applied finish in the form of chips or flakes.

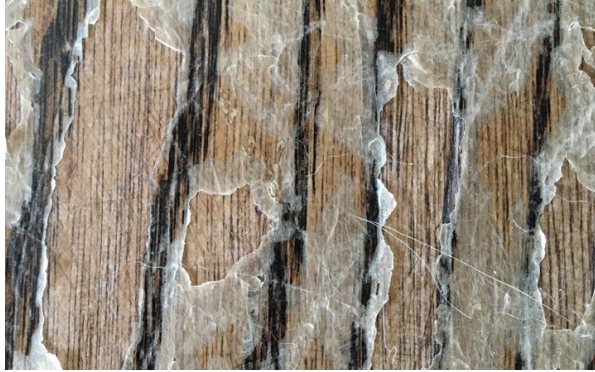
Finish Adhesion Failure

Peeling Finish - The condition that occurs when a dried film of finish separates from the underneath surface in the form of large pieces or sheets.

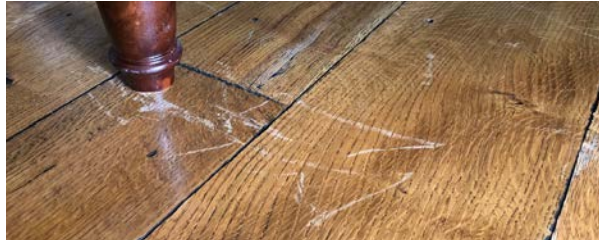
- **Scratches** - caused by applied horizontal and vertical forces.

- Finish systems may be marred or scuffed, either from chemicals or from heat generated by sliding objects across them. These may look like scratches, but are not.
- Surface scratches are typically only in the finish coats. A fingernail can't feel the ridge.
- Deep scratches are typically through the finish coats and have torn the wood fibers.
- Cross-grain scratches are deep scratches, and are oriented perpendicular to the direction of the flooring, often crossing multiple board widths and have a higher probability of exhibiting wood fiber tear. Deep scratches, usually termed "gouges," are typically through the finish coats and have torn the wood fibers.
- As scratch damage increases in severity, so does the likelihood that the damage will also include denting.
- **Indentations** - notches, grooves or depressions on the surface of the flooring.

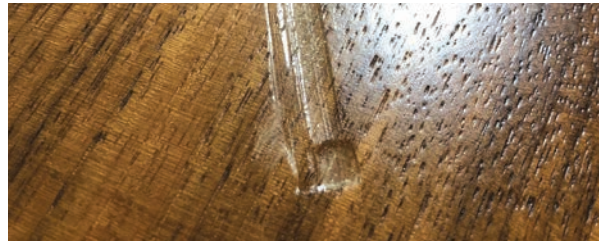
- Indentations are caused by applied vertical and/or horizontal forces on the flooring surface.
- When only vertical forces have been applied (dropping an object) these depressions are typically isolated to the shape of the portion of the dropped object that contacted the floor.
- Indentations may not always be accompanied with finish tear/fracture.

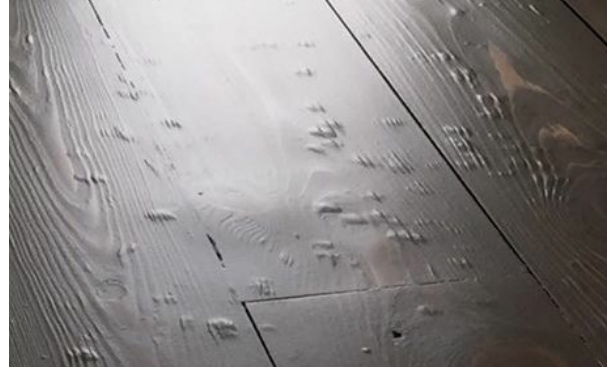
- **Wood bruises** - from a previous force or trauma to the surface of the boards that is not normally noticeable during the installation or handling of the product. This damage can become exposed with an increase in moisture, such as with the introduction of water through water-popping, water-based finishes, water-based stains, or similar reactive conditioners.
