Energy Storage Materials

State-of-electrode (SOE) analytics of lithium-ion cells under overdischarge extremes

Hanwei Zhou^a, Conner Fear^a, Judith A. Jeevarajan^{b,*}, Partha P. Mukherjee^{a,*}

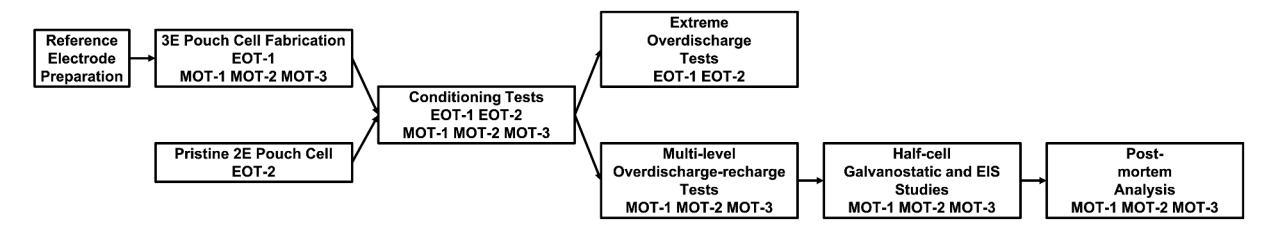
Fig. 1. Testing matrix of the overdischarge study.

A series of well-designed experiments were carried out to fundamentally understand the overdischarge degradation mechanisms of Liion cells. Testing procedures are comprehensively illustrated in Fig. 1, while Table 1 summarizes the testing conditions of all different cells in this study. Experimental details are specifically discussed from Sections 2.1–2.7.

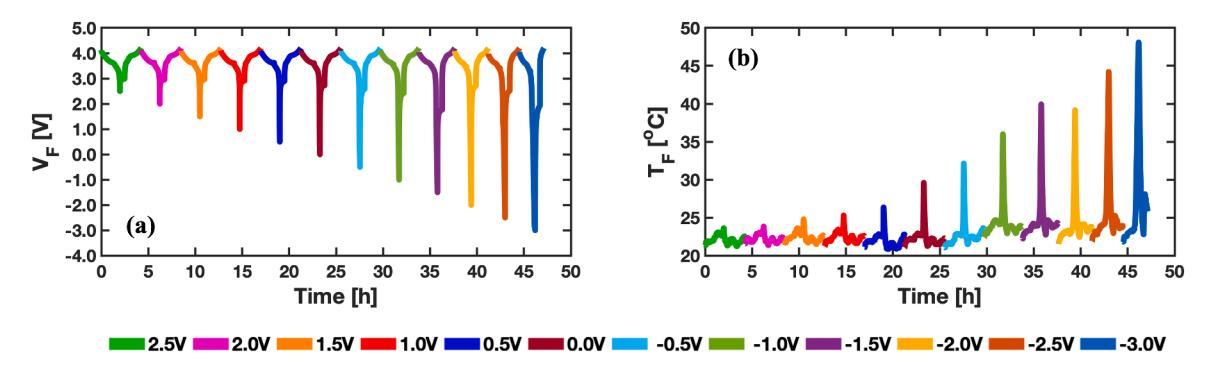
Fig. 2. Time-dependent full-cell voltage and temperature profiles of MOT-2 during the multi-level overdischarge-recharge tests. Cell IR was measured at 70% DOD of each cycle, and post-mortem analysis was implemented at the end of all cycles.

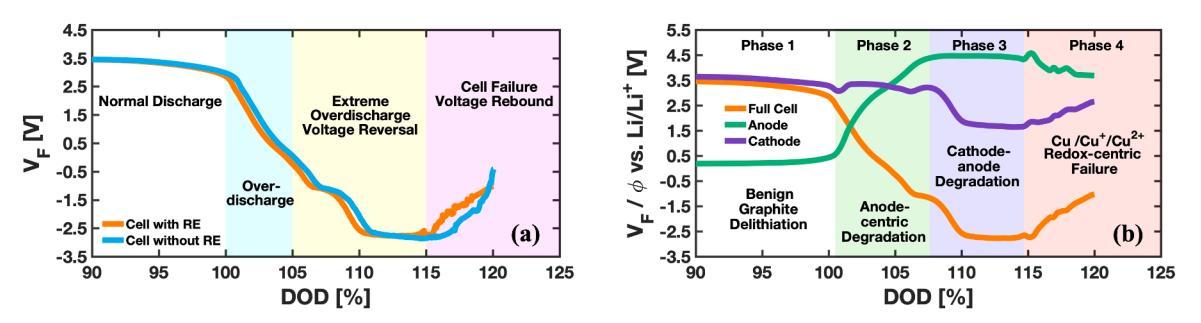
Fig. 3. Cell performances during extreme overdischarge tests: (a) Full cell voltage profiles with RE and without RE. (b) Full cell voltage, anode potential, and cathode potential profiles of the cell with RE.

Full cell voltages of EOT-1 and EOT-2 during extreme overdischarge tests are delineated in Fig. 3(a) to better understand the impact of RE instrumentation on cell performance. Although the full cell voltage of EOT-1 is slightly shifted compared to that of EOT-2, both present synchronized characteristics. Their behaviors start to diverge after around 115% DOD due to massive Cu deposition and micro ISC that make the full cell voltage unstable. Therefore, the RE introduction is a reliable technique to decipher the complex overdischarge mechanisms without significantly changing the electrochemical signatures of the cell.

Electrode potentials and full cell voltage of EOT-1 are illustrated in Fig. 3(b) to present electrochemical signatures of the graphite anode and NCA cathode. Four phases could be defined according to the revealed degradation mechanisms. Phase 1 occurs before 100.5% DOD, where deintercalation of lithium from the graphite anode and intercalation into the NCA cathode occur in a highly reversible manner, as intended during regular cell operation. Phase 2 is defined between 100.5 and 107.6% DOD, where full cell voltage rapidly drops from 2.56 to -1.18 V, primarily attributed to a rapid increase of graphite anode potential from 0.57 to 4.38 V vs. Li/Li⁺. Simultaneously, NCA cathode potential

experiences two concaves and subtly changes from 3.12 to 3.21 V vs. Li/ Li⁺, showing the negligible contribution to the decline of full cell voltage. Hence, Phase 2 is dictated by anode-centric degradation with SEI layer decomposition and copper dissolution from the current collector resulting from an excessively high anode potential. Between 107.6% DOD and 114.7% DOD, graphite anode potential remains around 4.5 V vs. Li/Li⁺, indicating that the copper oxidation reaction keeps dominant at the anode. The decline of full cell voltage from -1.18 V to the minimum point of -2.78 V is attributed to the drop of cathode potential from 3.21 V to the minimum value of 1.64 V vs. Li/Li⁺. Therefore, cell degradation in Phase 3 is dictated by copper dissolution from the anode current collector and copper deposition on the surface of the cathode. Beyond 114.7% DOD, an increase of cathode potential and a decrease of anode potential result in a rebound of full cell voltage against the minimum plateau. The full cell voltage and electrode potentials start to behave capriciously with frequent data noise, suggesting the formation of inter-electrode micro ISC. As a result, Phase 4 is governed by redox-centric failure due to the overwhelming propagation of Cu-based depositions on both electrodes and separators, which is substantiated by the visual inspections of the opening EOT-1 shown in Fig. S6.

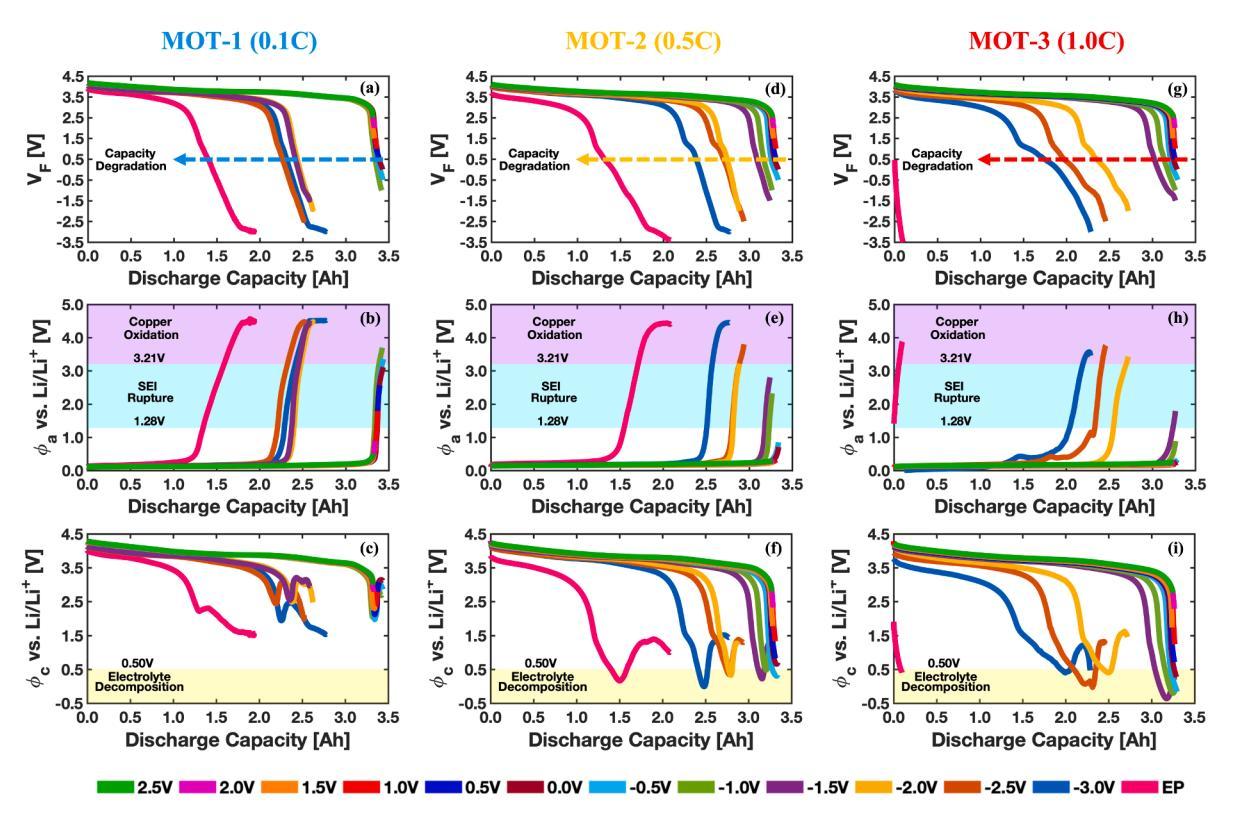
Fig. 4. Discharge phase profiles: full cell voltage and electrode potentials of 3E cells during multi-level overdischarge-recharge tests. (a) Full cell voltage at 0.1C. (b) Anode potential at 0.1C. (c) Cathode potential at 0.1C. (d) Full cell voltage at 0.5C. (e) Anode potential at 0.5C. (f) Cathode potential at 0.5C. (g) Full cell voltage at 1.0C. (h) Anode potential at 1.0C. (i) Cathode potential at 1.0C.

Overdischarge performances of MOT-1, MOT-2, and MOT-3 are presented in Fig. 4 to understand cell degradation behaviors at different full-cell cutoff limits and various operating C-rates. Fig. 4(a)–(c) show the profile of full cell voltage, anode potential, and cathode potential of MOT-1 operated at a 0.1C rate, respectively. In Fig. 4(a), the cell suffers negligible capacity degradation from 3.43 Ah to 3.42 Ah before the cutoff limit of -1.0 V. However, the cell capacity rapidly drops to a lower value between 2.77 Ah and 2.52 Ah when the cutoff limit is between -1.5 and -3.0 V, indicating a moderate capacity loss and a significant deterioration of the state of health (SOH). The cell demonstrates a substantial fade of discharge capacity to 1.94 Ah when overdischarge to the

cutoff limit of EP and could not be recharged afterward. Meanwhile, profiles of electrode potentials provide insights into how the electrochemical behaviors of graphite anode and NCA cathode significantly change with the decay of the cell characteristics. Following differential voltage analysis (DVA) on the anode potential shown in Fig. S4, the onset points of SEI breakdown and copper oxidation from the graphite anode are assumed to be 1.28 V vs. Li/Li⁺ and 3.21 V vs. Li/Li⁺, respectively. The rationale for these peak assignments is supported by similar values reported in peer studies [18,20,22,23] and by the fact that MOT-1 suffers substantial capacity fade as soon as the anode potential exceeds 3.21 V vs. Li/Li⁺. Therefore, in Fig. 4(b), we could infer that the SEI breakdown happens at the full cell cutoff limit of 1.0 V and the copper oxidation occurs at the full cell cutoff limit of -0.5 V. The anode potential reaches the plateau of 4.44 V vs. Li/Li⁺ at the cutoff limit of -1.5 V. introducing a large amount of unfavorable copper dissolution into the system. Behaviors of cathode potentials in Fig. 4(c) show consistent behavior before the cutoff limit of -1.0 V. The sharp voltage drop at the end of discharge indicates the complete lithiation of the NCA. Beyond this cutoff limit, fluctuations in the cathode potential are observed, which may be caused by loss of electrochemically active surface area (ECSA) and porosity in the cathode microstructure resulting from copper deposition.

Fig. 4(d)–(f) show the profiles of full cell voltage, anode potential, and cathode potential of MOT-2 operated at a 0.5C rate. In Fig. 4(d), the cell shows a mild capacity fade from 3.34 to 3.24 Ah when overdischarged to various lower cutoff limits before -1.5 V. A moderate capacity degradation is observed from 2.94 to 2.77 Ah when the cutoff limit is lowered from -1.5 to -3.0 V, and deep overdischarge to the cutoff limit of EP results in a substantial capacity loss down to 2.09 Ah. Following our previous discussion about the onset of SEI breakdown and copper oxidation, in Fig. 4(e), we can infer that the former happens at the full cell cutoff limit of -1.0 V and the latter occurs at the full cell cutoff limit of -2.0 V. The maximum plateau of the anode potential at 4.45 V vs. Li/

Li^+ is obtained with the cutoff limit of -3.0 V and EP, indicating a dominant reaction of copper dissolution from the anode side to accelerate the cell failure. Overall, the cathode potential at various cutoff limits in Fig. 4(f) drops to lower values than MOT-1 due to greater overpotential and ohmic polarization under a higher C-rate. The cathode potential shows genuine profiles before the cutoff limit of -1.5 V. However, a minimum point and rebound are observed after the cutoff limit of -2.0 V. Similar mechanisms such as loss of ECSA and porosity due to copper blocking in the cathode microstructure are likely causes of such deformation of cathode profiles, while the possibility of additional phase transformations between copper deposition and lithium intercalation cannot be excluded. Besides, low values of cathode potential may go beyond the electrochemical stability window of electrolyte carbonates to result in electrolyte decomposition and passive layer formation, which is assumed to take place below 0.50 V vs. Li/Li⁺ [1].

Full cell voltage, anode potential, and cathode potential of MOT-3 operated at a 1.0C rate are displayed in Fig. 4(g), Fig. 4(h), and Fig. 4 (i), respectively. In Fig. 4(g), the cell experiences an insignificant capacity drop from 3.29 Ah to 3.27 Ah as the overdischarge voltage limit is lowered before -1.5 V, while the shift of full cell voltage at the same discharge capacity indicates an increase of ohmic polarization and overpotential. An abrupt capacity loss from 2.72 to 2.29 Ah occurs when the cutoff limit is lowered from -2.0 to -3.0 V, and the cell fails to recharge after overdischarge to the cutoff limit of EP. Following our previous discussion about the onset of SEI breakdown and copper oxidation, in Fig. 4(h), we could infer that the former happens at the full cell cutoff limit of -1.5 V and the latter occurs at the full cell cutoff limit of -2.0 V. No stable plateau is observed in the anode potential profiles for all cases of overdischarge cutoff limits. The maximum anode potential is 3.77 V vs. Li/Li⁺ at the cutoff limit of -2.5 V, significantly lower than the maximum values of 4.45 V vs. Li/Li⁺ in MOT-2 and 4.52 V vs. Li/Li⁺ in MOT-1. It suggests less copper dissolution in MOT-3 given the reduced anode potential and less time spent in the copper oxidation regime. The cathode potential in Fig. 4(i) shows natural profiles before the cutoff limit of -1.5 V with greater ohmic polarization and overpotential than MOT-2. Their shapes are remarkably stretched and deformed between the cutoff limit of -2.0 and -3.0 V, probably due to similar degradation mechanisms such as loss of ECSA and porosity in the cathode microstructure resulting from copper deposition. The decomposition and reduction of electrolyte carbonates may occur when the cathode potential goes below 0.50 V vs. Li/Li⁺ [1].

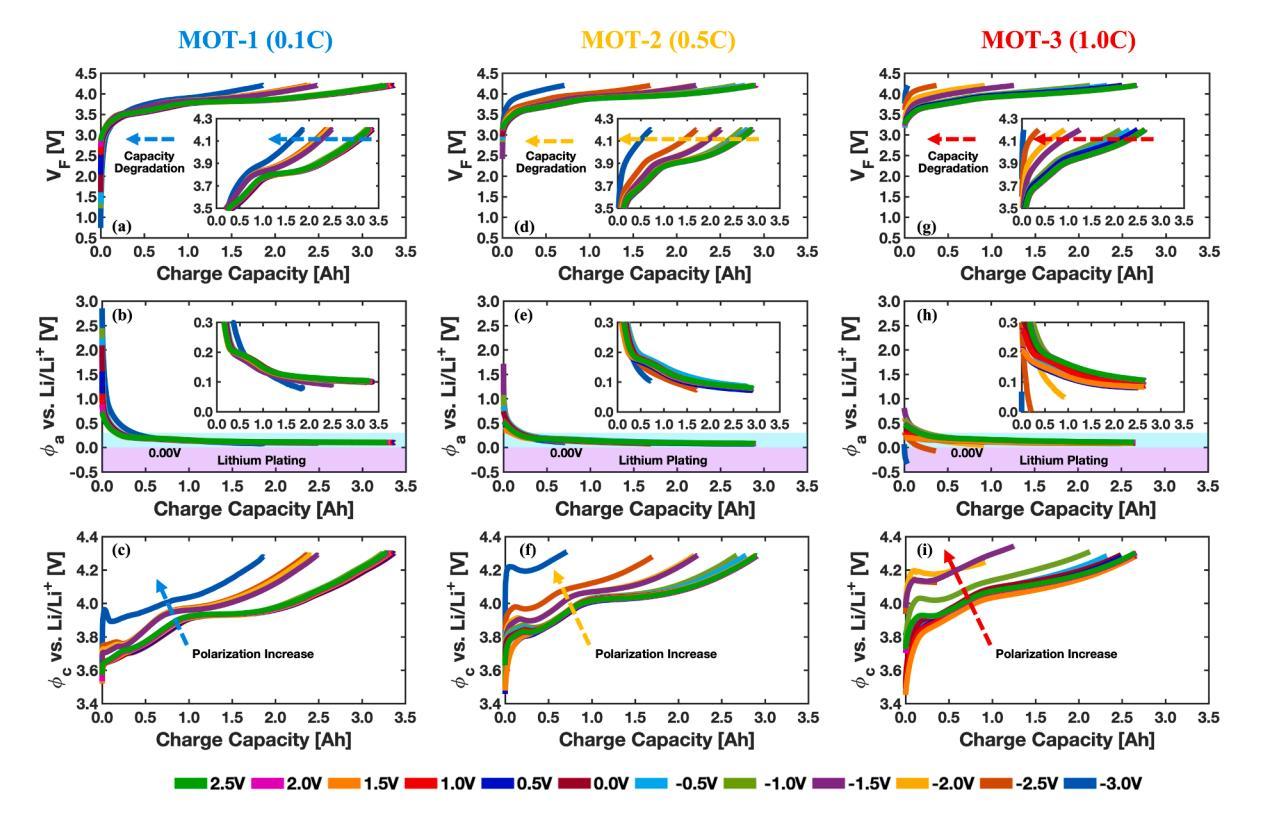
Fig. 5. Charge phase profiles: full cell voltage and electrode potentials of 3E cells during multi-level overdischarge-recharge tests. (a) Full cell voltage at 0.1C. (b) Anode potential at 0.1C. (c) Cathode potential at 0.1C. (d) Full cell voltage at 0.5C. (e) Anode potential at 0.5C. (f) Cathode potential at 0.5C. (g) Full cell voltage at 1.0C. (h) Anode potential of at 1.0C. (i) Cathode potential at 1.0C.

Charge phases of MOT-1, MOT-2, and MOT-3 are illustrated in Fig. 5 to reveal the recharge capabilities of cells after being subjected to different overdischarge cutoff limits and various operating C-rates. Fig. 5(a)–(c) present the full cell voltage, anode potential, and cathode potential of MOT-1 charged at a 0.1C rate. In Fig. 5(a), the cell could be charged to the capacity between 3.28 and 3.35 Ah before the overdischarge cutoff limit of -1.0 V, then a faster degradation is noticed. A moderate capacity fade is observed between the cutoff limit of -2.5 and -1.5 V, where the cell could be recharged with capacity recordings between 2.36 and 2.48 Ah. A substantial capacity loss appears at the cutoff limit of -3.0 V, at which only 1.86 Ah recharge capacity could be obtained. In Fig. 5(b), behaviors of the anode potential are consistent until the cutoff limit of -1.0 V. The minimum value decreases to 0.09 V vs. Li/ Li⁺ when the cutoff limit declines from -1.5 to -2.5 V and further drops to 0.08 V vs. Li/Li⁺ when the cutoff limit is -3.0 V. This change corresponds to the moderate and substantial capacity fade of the cell. It suggests an increased anode resistance probably due to the reduced contact area between the active material and current collector resulting from the dissolution of the copper current collector and a loss of ECSA because of copper deposition. It is worth noting that the anode potential remains above 0.0 V vs. Li/Li⁺ despite the degeneration of Li-ion intercalation kinetics, indicating no occurrence of unfavorable lithium plating. Profiles of cathode potentials in Fig. 5(c) do not significantly change until the cutoff limit of -3.0 V. The growing cathode resistance, overpotential, and ohmic polarization probably contribute to the overshoot of cathode potential at an initial stage and the loss of characteristic plateaus between 1.0 and 1.5 Ah charge capacity.

Fig. 5(d)-(f) present the full cell voltage, anode potential, and cathode potential of MOT-2 charged at a 0.5C rate. In Fig. 5(d), charge capacity fades mildly from 2.91 to 2.68 Ah before the overdischarge cutoff limit of -1.0 V. A moderate capacity degradation from 2.22 to 1.70 Ah is observed when the cutoff limit is lowered from -1.5 to -2.5 V. The cell suffers from a substantial capacity loss at the cutoff limit of -3.0 V, where only 0.71 Ah charge capacity could be obtained. The profile of anode potential in Fig. 5(e) is very similar for all cycles before the cutoff limit of -2.0 V. The minimum anode potential decreases to 0.07 V vs. Li/ $\rm Li^+$ at the cutoff limit of -2.5 and 0.10 V vs. $\rm Li/\rm Li^+$ at the cutoff level of -3.0 V, suggesting an increase in anode resistance and a degeneration of Li-ion intercalation and diffusion kinetics. Still, anode potentials remain above 0.0 V vs. Li/Li⁺ for all full cell cutoff limits, indicating that the adverse lithium plating reaction does not occur. The profile of cathode potential in Fig. 5(f) presents a characteristic plateau between charge capacity of 1.0 and 1.5 Ah and does not show significant variations before the cutoff limit of -2.5 V, except for an increasing voltage overshoot at the beginning of charge. However, at the cutoff limit of -3.0 V, the cathode potential instantly spikes to above 4.2 V vs. Li/Li⁺, indicating a severe resistance increase on the cathode side. Copper deposition and excessive interphase formation on the NCA particles likely contribute to the dramatic performance loss.

Full cell voltage, anode potential, and cathode potential of MOT-3 charged at a 1.0C rate are delineated in Fig. 5(g), Fig. 5(h), and Fig. 5 (i), respectively. In Fig. 5(g), the cell suffers a mild capacity fade from 2.67 to 2.13 Ah as the overdischarge limit is lowered before -1.0 V. A moderate capacity degradation from 1.26 Ah to 0.92 Ah is observed when the cutoff limit is lowered from -1.5 to -2.0 V. A substantial capacity loss appears when the cutoff limit is lowered from -2.5 to -3.0 V, during which the charge capacity declines from 0.37 to 0.04 Ah and indicates the non-functionality of the cell. The anode potential in Fig. 5

(h) behaves coherently before the cutoff limit of -1.5 V. However, the minimum anode potential falls to 0.05 V, -0.07 V, and -0.34 V vs. Li/Li+ at the cutoff limits of -2.0 V, -2.5 V, and -3.0 V, respectively. The anode potential below 0.0 V vs. Li/Li⁺ demonstrates the onset of adverse lithium plating, suggesting that the reaction rate of lithium ions on the graphite surface has exceeded the intercalation or diffusion limits of graphite particles as a result of severe anode degradation. This observation reveals that if the cell is repeatedly overdischarged and recharged at a high C-rate, it is more likely to introduce thermally and electrochemically unstable lithium plating to undermine the safety performance of Li-ion batteries. The profile of cathode potential in Fig. 5(i) remains consistent before the cutoff limit of -1.0 V, except for a growing overshoot at the initial stage due to higher cathode resistance, overpotential, and ohmic polarization. Profiles of the cathode potential lose their characteristic plateau between 1.0 Ah and 1.5 Ah charge capacity when the cutoff limit is below -1.5 V.

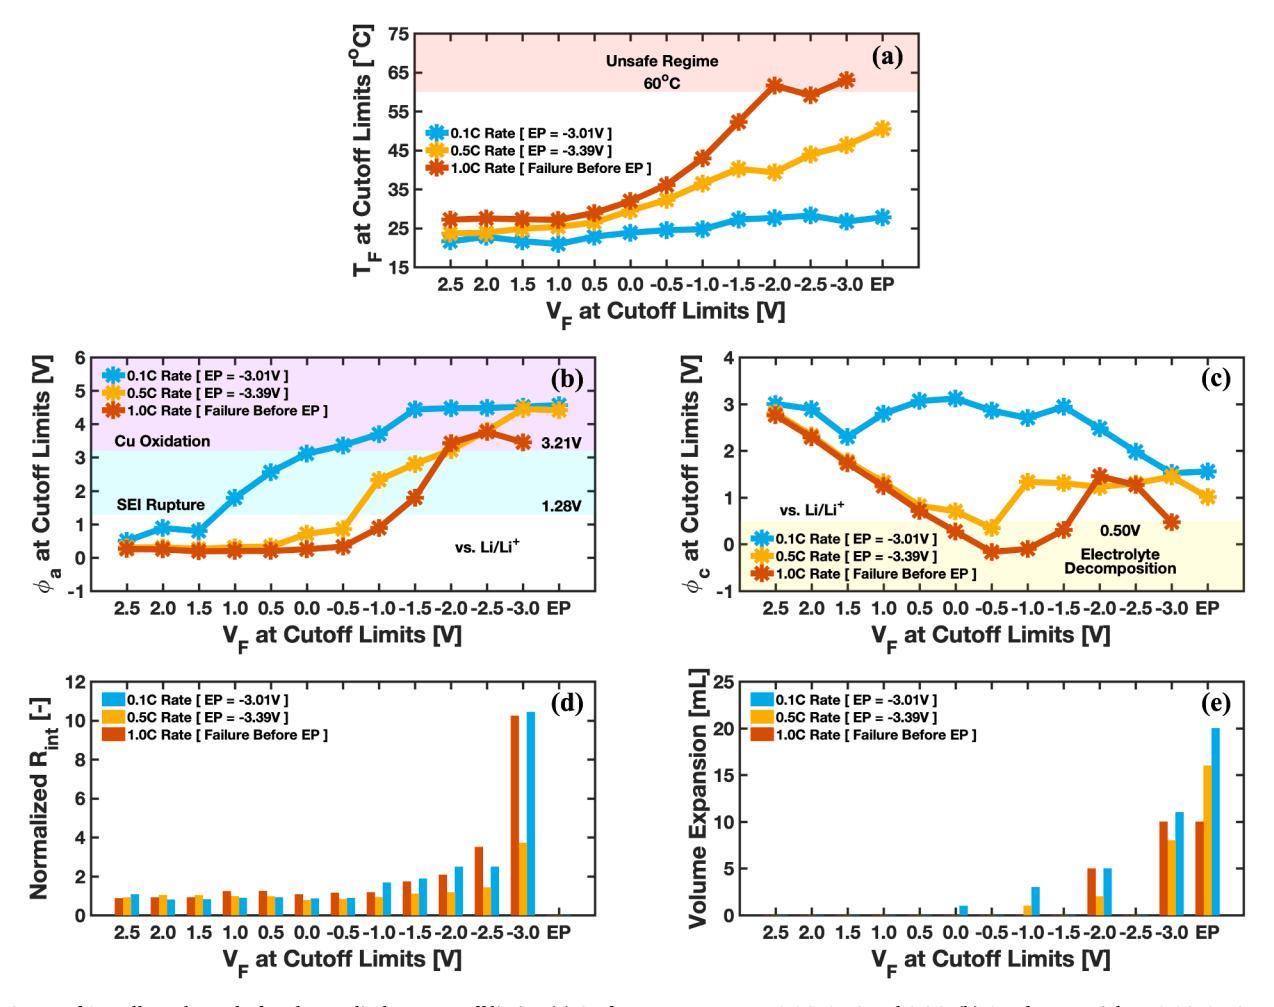
Fig. 6. States of 3E cells at the end of each overdischarge cutoff limits: (a) Surface temperature at 0.1C, 0.5C and 1.0C. (b) Anode potentials at 0.1C, 0.5C and 1.0C. (c) Cathode potentials at 0.1C, 0.5C and 1.0C. (d) Normalized IR at 0.1C, 0.5C and 1.0C. (e) Volumetric expansion at 0.1C, 0.5C and 1.0C.

Key electrochemical and physical parameters of MOT-1, MOT-2, and MOT-3 during the multi-level overdischarge-recharge studies are statistically interpreted. Cell surface temperature, anode potential, cathode potential, and normalized IR are recorded at the end of each discharge phase, while cell volumetric expansion is measured at the end of every two discharge phases. Fig. 6(a) shows how the exterior temperatures of MOT-1, MOT-2, and MOT-3 increase when they are deeply overdischarged with different C-rates. MOT-3, operated at a 1.0C rate, shows

the most significant temperature rise to 63.0 °C at the cutoff limit of -3.0 V. It exceeds the safety limit of 60 °C after the cutoff limit of -2.0 V, which threatens the thermal stability of the cell. MOT-2, operated at a 0.5C rate, reaches a maximum temperature of 50.5 °C at the cutoff limit of EP, while MOT-1 shows the mildest temperature rise to 27.8 °C at the cutoff limit of EP. The additional heat generation during overdischarge abuses could be caused by extreme ionic concentration polarization [22], strong internal exothermic reactions such as SEI layer breakdown at a high anode potential [35], and micro internal short circuits due to the inter-electrode copper bridge formation [21]. A state-of-the-art research investment also discussed the possibility that it is caused by the formation of aluminum reduced from the alumina coating layers on the separator [26]. Our investigations in Fig. 6(a) demonstrate that the heat generation of the overdischarged cell is highly dependent on lower cutoff limits of full-cell voltages and operating C-rates. Joule's law states that a high current will lead to more heat generation. The internal resistance of the overdischarged cell will also significantly increase due to internal gas generation caused by SEI layer collapse, electrode impedance rise driven by SEI layer breakdown or CEI layer growth with lithium or copper depositions, and interfacial electrolyte consumptions accelerated by extreme electrode potentials. The temperatures observed under various overdischarge conditions are generally not exorbitant, with the lowest discharge rate showing an almost negligible increase.

In Fig. 6(b), statistics of anode potential at the end of each cutoff limit reveal new insights into how the onset of SEI breakdown and copper dissolution change with different C-rates. Following our previous discussion, the onset points of SEI breakdown and copper oxidation from

the graphite anode are assumed to be 1.28 V vs. Li/Li⁺ and 3.21 V vs. Li/Li⁺, respectively. Therefore, both processes first occur in MOT-1 operated at a 0.1C rate, where the SEI degradation starts at the full cell cutoff limit of 1.0 V and copper dissolution appears at the full cell cutoff limit of -0.5 V. In contrast, the onset of SEI breakdown and copper dissolution in MOT-2 operated at a 0.5C rate is delayed to the cutoff limits of -1.0 V and -2.0 V, respectively, and the onset of SEI breakdown and copper dissolution in MOT-3 operated at a 1.0C rate is further postponed to the cutoff limit of -1.5 V and -2.0 V, respectively. These observations suggest that the onset of overdischarge-induced degradation resulting from SEI collapse and copper oxidation could be delayed by high-rate operation.

Meanwhile, Fig. 6(c) reveals behaviors of cathode potentials at the end of each cutoff limit. The cathode potential of MOT-1 operated at a 0.1C rate stays above 2.0 V vs. Li/Li⁺ until the cutoff limit of -2.5 V. Nevertheless, the cathode potential of MOT-2 operated at a 0.5C rate drops early and reaches a minimum value of 0.34 V vs. Li/Li⁺ at the cutoff limit of -0.5 V, while the cathode potential of MOT-3 operated at a 1.0C rate starts to decline at the beginning of overdischarge abuse and reaches a minimum value of -0.17 V vs. Li/Li⁺ at the same cutoff limit of -0.5 V. These observations suggest that the cathode potential will be driven to low values under high-rate overdischarge, which is likely to cause an extra CEI evolution to increase the cathode resistance and make transport kinetics of the cell cathode-limited.

The normalized IR of MOT-1, MOT-2, and MOT-3 at each cutoff limit is presented in Fig. 6(d) based on the average values of IR during each conditioning test. The normalized IR of MOT-1, operated at a 0.1C rate, starts to increase at the cutoff limit of -1.0 V and reaches a maximum

value of 10.43 at the cutoff limit of -3.0 V. Similarly, the normalized IR of MOT-3, operated at a 1.0C rate, begins to increase at the cutoff limit of -1.5 V and reaches the maximum value of 10.24 at the cutoff limit of -3.0 V. The IR rise of MOT-2, operated at a 0.5C rate, is much milder, reaching a maximum value of 3.71 at the cutoff limit of -3.0 V. These observations indicate that operating at a moderate C-rate might decelerate the overdischarge-induced resistance evolution at the full cell scale. Volumetric expansions of MOT-1, MOT-2, and MOT-3 at every two cutoff limits are illustrated in Fig. 6(e). The cell swelling first appears in MOT-1 when the cutoff limit is 0.0 V and keeps increasing to the maximum value of 20 mL at the cutoff limit of EP. The next cell to swell is MOT-2 when the cutoff limit is -1.0 V and keeps rising to a peak value of 16 mL at the cutoff limit of EP. In contrast, the volumetric expansion of MOT-3 starts when the cutoff limit is -2.0 V and reaches a maximum value of 10 mL at the cutoff limit of -3.0 V. Based on these statistics, we notice that the cell volumetric expansion matches the onset of SEI breakdown and the resulting internal gas generation. Therefore, highrate overdischarge could delay the onset of cell swelling due to hysteresis SEI breakdown and gas generation side reactions. However, it does not necessarily mean that a high-rate operation is the best strategy to minimize overdischarge-induced hazards due to a significant temperature evolution. A trade-off balance between cell swelling and selfheating needs to be deliberated before determining the optimal charge and discharge rates.

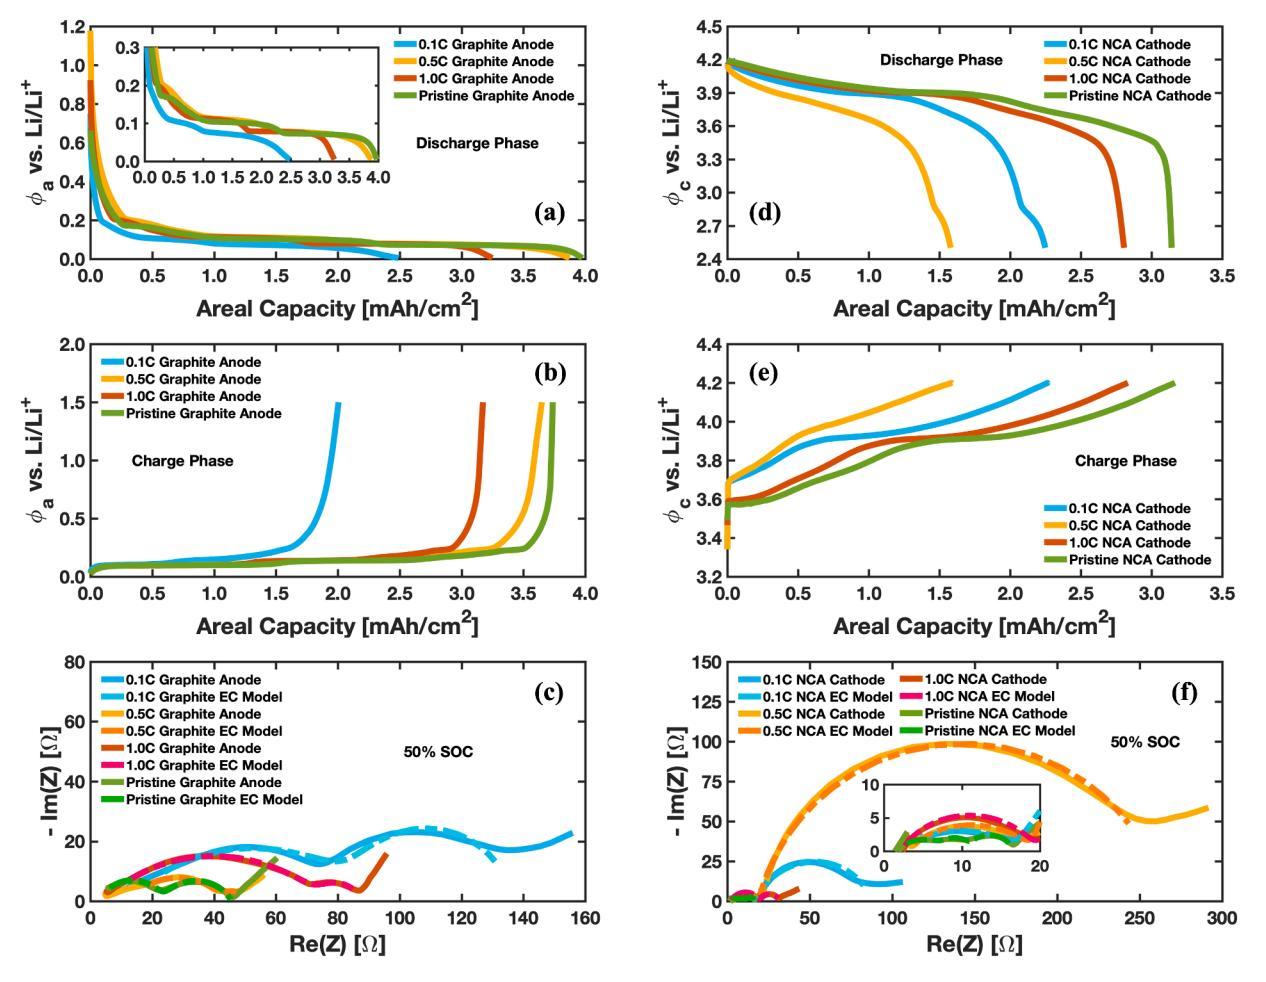
Fig. 7. Capacity and impedance characteristics of 0.1C Graphite Anode, 0.5C Graphite Anode, 1.0C Graphite Anode, and Pristine Graphite Anode: (a) Discharge phase. (b) Charge phase. (c) EIS profiles at 50% SOC. Capacity and impedance characteristics of 0.1C NCA Cathode, 0.5C NCA Cathode, 1.0C NCA Cathode, and Pristine NCA Cathode: (d) Discharge phase. (e) Charge phase. (f) EIS profiles at 50% SOC.

Electrode samples from the three multi-level overdischarge test cells were harvested and assembled into coin cells with a lithium counter electrode. The capacity degradation and impedance evolution of the graphite anodes and NCA cathodes after overdischarge failure at different C-rates are illustrated in Fig. 7 compared to their performance at pristine status. Discharge phases of half cells constructed from 0.1C graphite anode (HC-1), 0.5C graphite anode (HC-2), 1.0C graphite anode (HC-3), and pristine graphite anode (HC-4) are presented in Fig. 7 (a). The embedded subplot shows the local zoom-in view below 0.3 V vs. Li/Li⁺ to better visualize the details of intercalation plateaus. HC-1, containing the 0.1C graphite anode, shows the lowest areal capacity of 2.49 mAh/cm². HC-3, containing the 1.0C graphite anode, demonstrates a moderate areal capacity of 3.25 mAh/cm², while HC-2, containing the 0.5C graphite anode, has the highest areal capacity of 3.87 mAh/cm^2 . However, they are less than the maximum areal capacity of 3.98 mAh/ cm² obtained from the pristine graphite anode. Therefore, we could infer that a moderate C-rate is likely to minimize the capacity degradation of graphite anode during overdischarge abuses. The capacity loss of the 0.1C graphite anode might be attributed to the delamination of the graphite coating layer from the current collector due to severe copper dissolution and the resulting loss of active material (LAM). In contrast, the capacity fade of the 1.0C graphite anode might be attributed to the loss of Li-ion intercalation sites due to widespread lithium plating on the copper deposition. Charge phases of 0.1C graphite anode (HC-1), 0.5C graphite anode (HC-2), 1.0C graphite anode (HC-3), and pristine graphite anode (HC-4) are presented in Fig. 7(b) with areal capacity retentions of 2.00 mAh/cm², 3.65 mAh/cm², 3.17 mAh/cm² and 3.74 mAh/cm², respectively. It is worthwhile to notice that there is an evident deviation between discharge and charge capacities of 0.1C graphite anode, suggesting a reduced Coulombic efficiency and a LAMdictated inconsistent electrode performance caused by severe detachment between the graphite coating layer and copper current collector.

The impedance spectroscopy and EC model fitting of the 0.1C graphite anode (HC-1), 0.5C graphite anode (HC-2), 1.0C graphite anode (HC-3), and pristine graphite anode (HC-4) are presented in Fig. 7 (c). Two primary semicircles characterizing interfacial and charge transfer resistances and a straight tail reflecting diffusion kinetics of graphite can be observed in all three cases [46-48]. The interfacial and charge transfer resistance values are estimated through EC model fitting and summarized in Table 2. An SEI resistance of 20.10 Ω and charge transfer resistance of 22.45 Ω are obtained from the pristine graphite anode as a baseline impedance. The 0.5C graphite anode shows the lowest impedance evolution among all three cases, with an SEI resistance of 32.03 Ω and low charge transfer resistance of 5.81 Ω , to which some conductive surface depositions may contribute. This result is consistent with the fact that the 0.5C graphite anode has the maximum capacity retention. The 0.1C graphite anode and the 1.0C graphite anode share similar SEI resistances of 76.90 Ω and 71.89 Ω , but the former shows a higher charge transfer resistance of 47.36 Ω than the latter one of 11.97 Ω . Given the severe and moderate capacity fade on 0.1C and 1.0C graphite anodes, these observations further suggest that SEI

Discharge phases of 0.1C NCA cathode (HC-5), 0.5C NCA cathode (HC-6), 1.0C NCA cathode (HC-7), and pristine NCA cathode (HC-8) are presented in Fig. 7(d). The 0.5C NCA cathode has a minimum areal capacity of 1.58 mAh/cm². The 0.1C NCA cathode retains a moderate areal capacity of 2.25 mAh/cm², and the 1.0C NCA cathode holds the highest areal capacity retention of 2.81 mAh/cm². However, they are less than the maximum areal capacity of 3.14 mAh/cm² obtained from the pristine NCA cathode. Therefore, we can infer that a high-rate overdischarge mitigates the capacity degradation of the NCA cathode. Charge phases of 0.1C NCA cathode (HC-5), 0.5C NCA cathode (HC-6), 1.0C NCA cathode (HC-7), and pristine NCA cathode (HC-8) are presented in Fig. 7(e) with the areal capacities being 2.27 mAh/cm^2 , 1.59 mAh/cm², 2.83 mAh/cm², and 3.17 mAh/cm², respectively. The areal charge capacity matches the areal discharge capacity for all four cases, contrasting with the significant mismatch observed in the 0.1C graphite anode. This high Coulombic efficiency indicates the maintenance of integrity and robustness of the positive electrode under these overdischarge conditions.

The impedance spectroscopy and EC model fitting of 0.1C NCA cathode (HC-5), 0.5C NCA cathode (HC-6), 1.0C NCA cathode (HC-7), and pristine NCA cathode (HC-8) are presented in Fig. 7(f). Two primary semicircles characterizing CEI and charge transfer resistance and one straight tail reflecting diffusion kinetics of NCA particles could be identified [49,50]. Their values are estimated through EC model fitting and summarized in Table 2. CEI resistance of 2.82Ω and charge transfer resistance of 5.63Ω are obtained from pristine NCA cathode as a baseline impedance. The CEI resistances of the 0.1C NCA cathode, 0.5C NCA cathode, and 1.0C NCA cathode are 15.66 Ω , 16.39 Ω , and 17.38 Ω , respectively, showing a continuous growth with an increase of C-rates. These results match the observation in Fig. 6(c), suggesting that a high-rate overdischarge will lead to a low cathode potential to result in CEI evolution and impedance rise. The charge transfer resistances of the 0.1C NCA cathode, 0.5C NCA cathode, and 1.0C NCA cathode are 70.14 Ω , 246.7 Ω , and 12.09 Ω , respectively. Given their capacity retention in Fig. 7(d) and (e), these observations indicate that the evolution of charge transfer resistance on NCA cathodes can also correlate to electrode capacity degradation.
