**Kubota Canada Ltd. recalls reserve coolant tank caps for various Ride-On Mowers, Utility Tractors and Zero Turn Mowers**

Coolant tank caps for Kubota Ride-on Mowers, Utility Tractors and Zero Turn Mowers

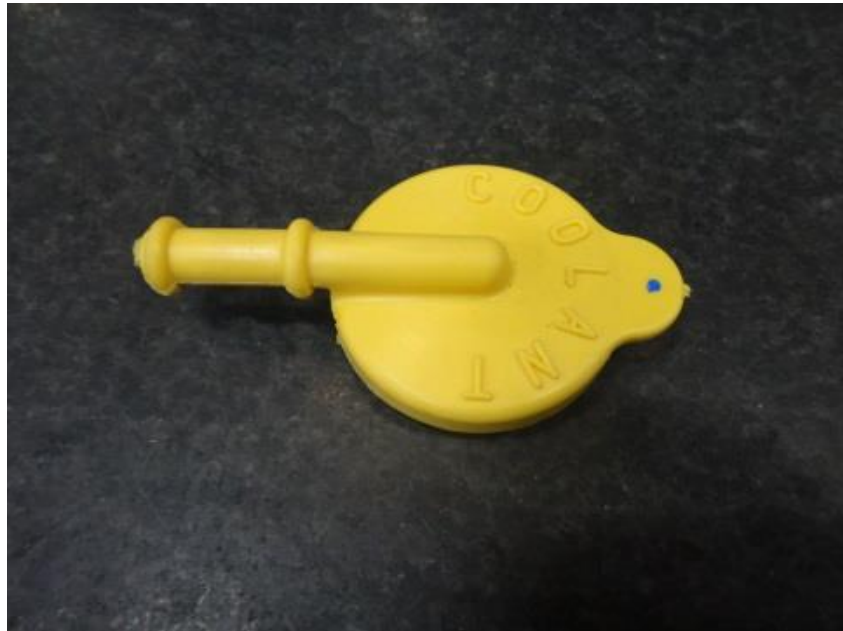
**Replacement coolant cap**

**Consumers should immediately stop using the recalled Kubota Ride-on Mowers, Utility Tractors and Zero Turn Mowers. Customers are to be mailed a new cap by**

**Kubota Canada along with installation instructions. Consumers may also contact an authorized Kubota dealer for a free inspection and repair of the cap.**

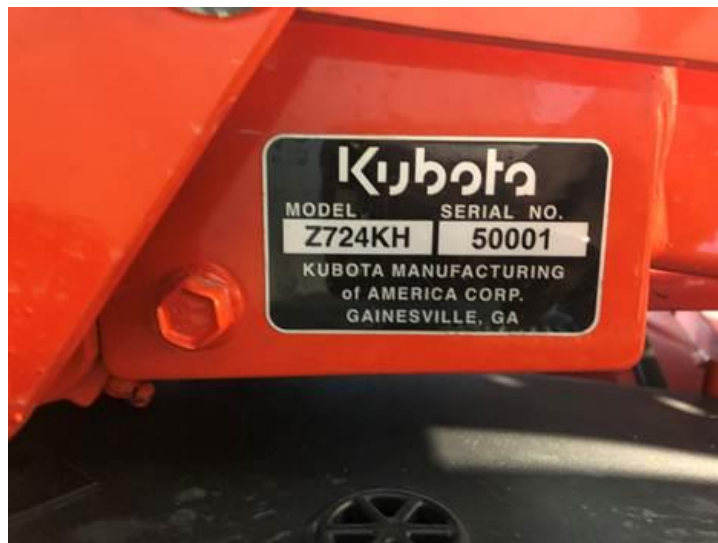
This recall involves model year 2014 to 2018 Kubota BX compact utility tractors, ZD and ZG diesel and gasoline-powered zero turn mowers, and GR ride-on mowers. The model number is printed on the side of the unit. Kubota is printed on the side of the mowers and tractors. The data plate contains the serial number and is also located on the side of the unit. The affected units are orange and black.

**Data plate with model and serial number**

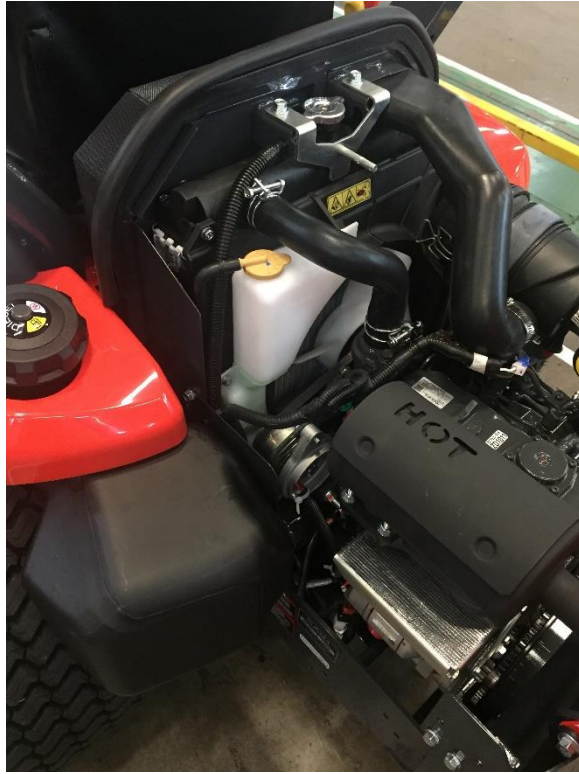
Kubota has discovered that under some overheat conditions, the cap of the radiator coolant reserve tank, if restricted, can come off and high temperature coolant may spray out, posing a burn hazard.

**White coolant reserve tank with a yellow cap**
