# ProMILL Duo™ Dual Casing Isolation Solution for a Complex Two Cap Rock Project

Ensured rock-to-rock barrier restoration for fluid pressure isolation in the annulus between dual casing strings

## Complex Remediation for Dual-Casing Isolation

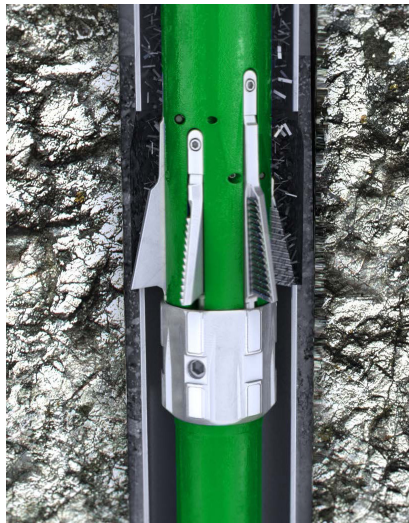
For each dual-casing window, the milling sequence was executed as follows:

- **Inner Casing Milling** – The operation commenced with the 5500 K-Mill cutting and milling the 7 in casing.
- **Cement Removal and Casing Cleaning** – The 5500 ProMILL® underreamer was deployed to remove residual cement and clean the 9 $\frac{5}{8}$  in casing ID.
- **Outer Casing Milling** – The 9 $\frac{5}{8}$  in casing was then section milled as required.
- **Rock-to-Rock Barrier Restoration** – The 5500 ProMILL underreamer enlarged the cementation zone to 13.5 in in the open hole, exposing fresh formation to facilitate effective rock-to-rock bonding across both cap rocks.

Both dual-casing milling operations were successfully executed, restoring cap rock integrity and achieving the customer's permanent barrier isolation requirements at these critical geological depths.
