CASE STUDY: BG PLATINUM® FUEL SYSTEM SERVICE

VEHICLE:
2018 Chevrolet Silverado, 6.2L
43,872 miles (70,605 km)

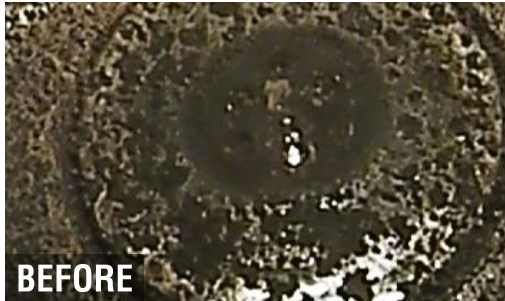
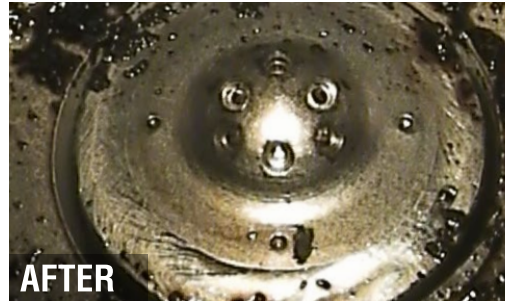
INJECTOR

NOTE: The following images on this vehicle were captured prior to running a full tank of fuel. BG Platinum® 44K® and the residual intake cleaning chemistry will continue to clean after the service has been completed.

Following platform-specific instructions, the BG Platinum® Fuel System Service will remove deposits from the backs of intake valves, combustion chambers, and injector tips.
