CASE STUDY: BG PLATINUM® FUEL SYSTEM SERVICE

VEHICLE:
2019 BMW X3, 3.0L Twin Turbo
15,867 miles (25,535 km)

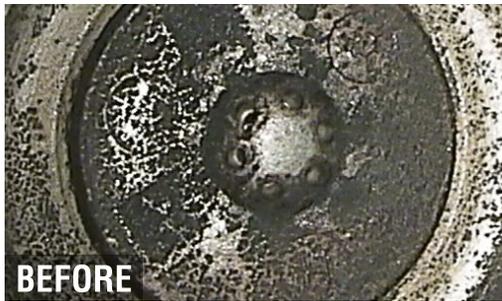
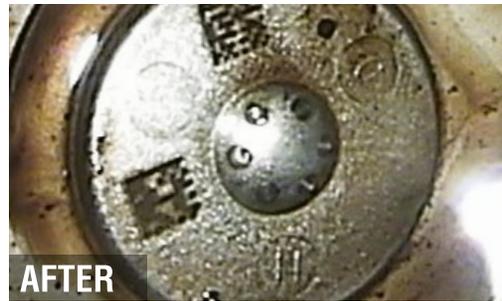
INJECTOR

Note: The following images on this vehicle were captured prior to running a full tank of fuel. **BG Platinum® 44K®** and the residual intake cleaning chemistry will continue to clean after the service has been completed.

Following platform-specific instructions, the BG Platinum® Fuel System Service will remove deposits from the backs of intake valves, combustion chambers, and injector tips.
