# CASE STUDY: BG PLATINUM® FUEL SYSTEM SERVICE

**VEHICLE:**  
**2017 Nissan Titan, 5.6L**  
**18,439 miles (29,675 km)**

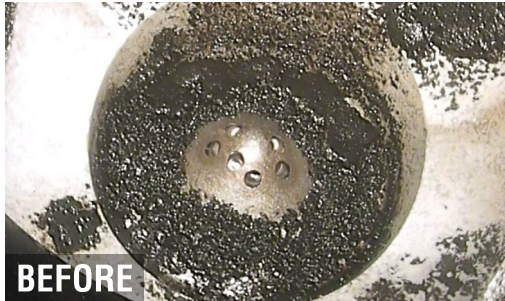
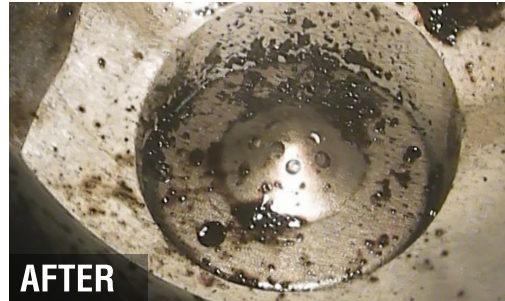
INJECTOR

NOTE: The following images on this vehicle were captured prior to running a full tank of fuel. BG Platinum® 44K® and the residual intake cleaning chemistry will continue to clean after the service has been completed.

Following platform-specific instructions, the BG Platinum® Fuel System Service will remove deposits from the backs of intake valves, combustion chambers, and injector tips.
