CASE STUDY: BG PLATINUM® FUEL SYSTEM SERVICE

VEHICLE:
2015 GMC Terrain, 3.6L
123,306 miles (198,442 km)

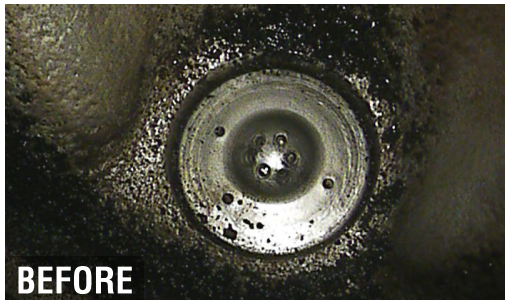
INJECTOR

NOTE: The following images on this vehicle were captured prior to running a full tank of fuel. BG Platinum® 44K® and the residual intake cleaning chemistry will continue to clean after the service has been completed.

Following platform-specific instructions, the BG Platinum® Fuel System Service will remove deposits from the backs of intake valves, combustion chambers, and injector tips.
