Underwriters  
Laboratories

## Impact of Ventilation on Fire Behavior in Legacy and Contemporary Residential Construction

**Steve Kerber, PE**

Issue Date: December 14, 2010

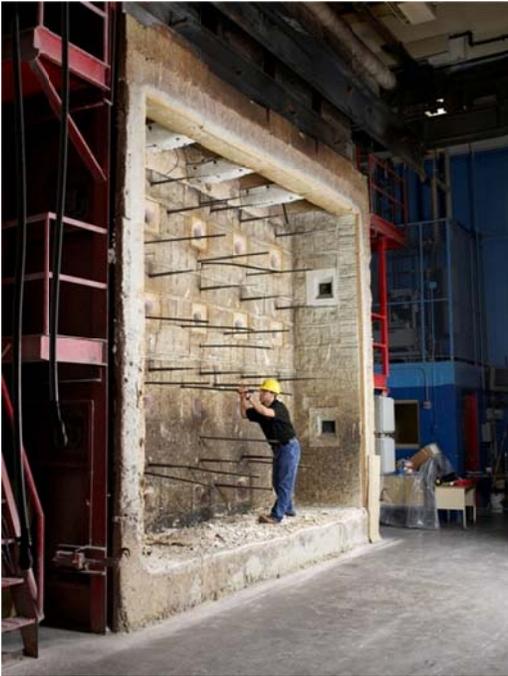
**Figure 2. The Panel Furnace**

The panel furnace (Figure 2) was originally developed to determine the fire endurance rating of wall assemblies. A representative section of a wall, 10 by 10-ft, is constructed. One side of the assembly is heated to temperatures up to 2000 °F for up to 4 hours. During the test, the wall must contain the fire and limit the temperature rise on the unheated side of the assembly. After the fire test, a water hose stream test is conducted to determine a wall’s ability to resist damage from mechanical and thermal stresses. Water is flowed onto the wall using a hose to apply a uniform force to the entire wall assembly and to cool the assembly rapidly. The wall may not develop any holes during this test.

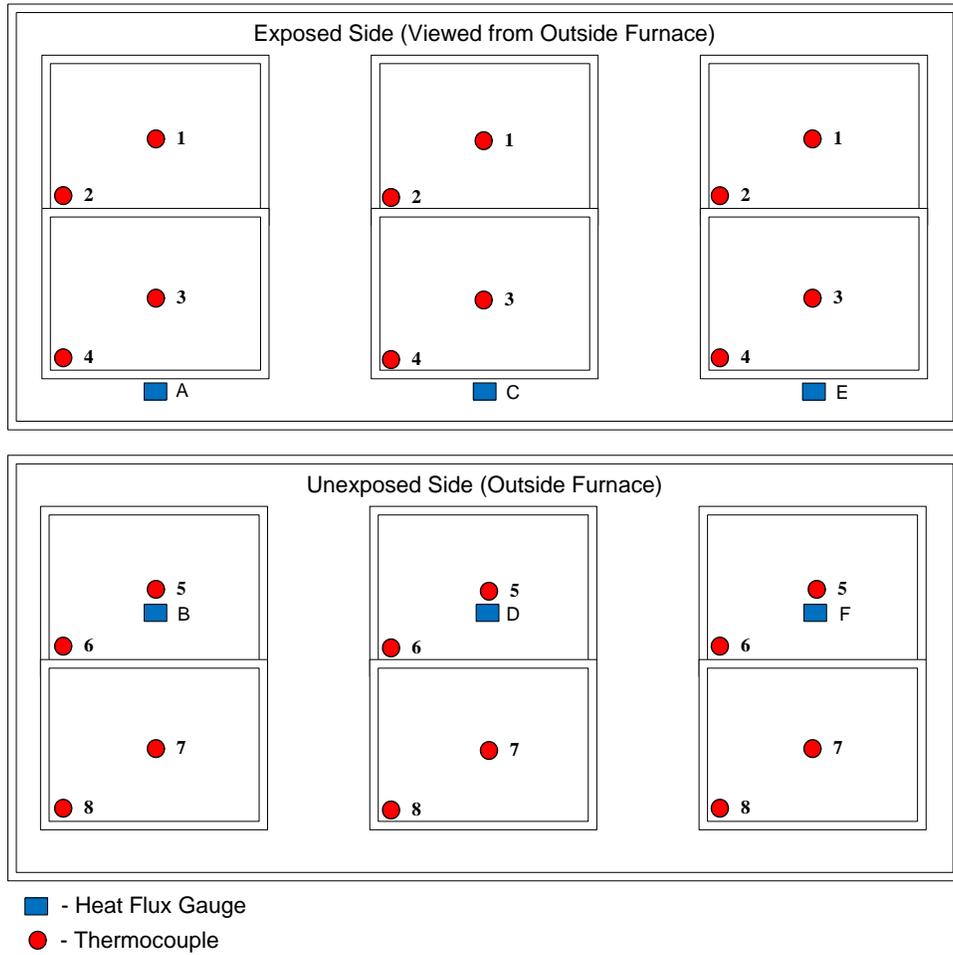
**Figure 14. Window Instrumentation locations**

Video cameras were placed with a field of view that focused on each window or door. A thermal imaging camera was placed to look at the entire frame.

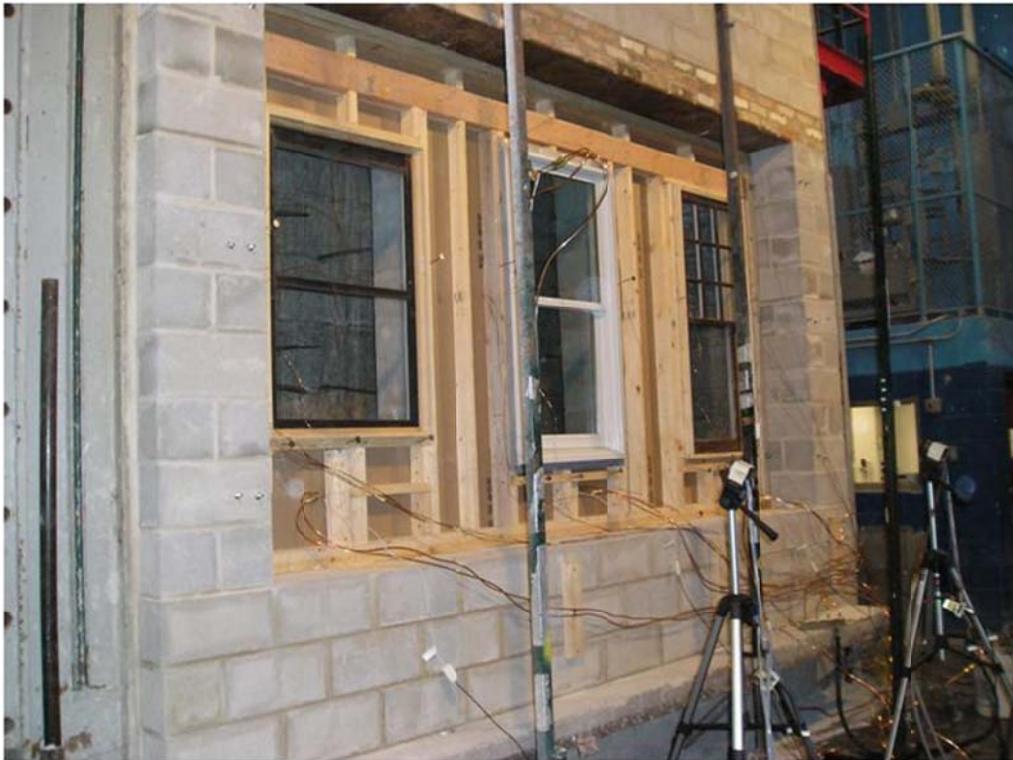
**Figure 16. Experiment 1 Setup**

Observations during Experiment 1 are detailed in Table 2. Observations are from the unexposed side unless otherwise noted. The average furnace temperature is graphed versus time in Figure 17. Window temperatures are graphed in Figure 18 through Figure 20. The heat flux for all three windows is graphed versus time in Figure 21.

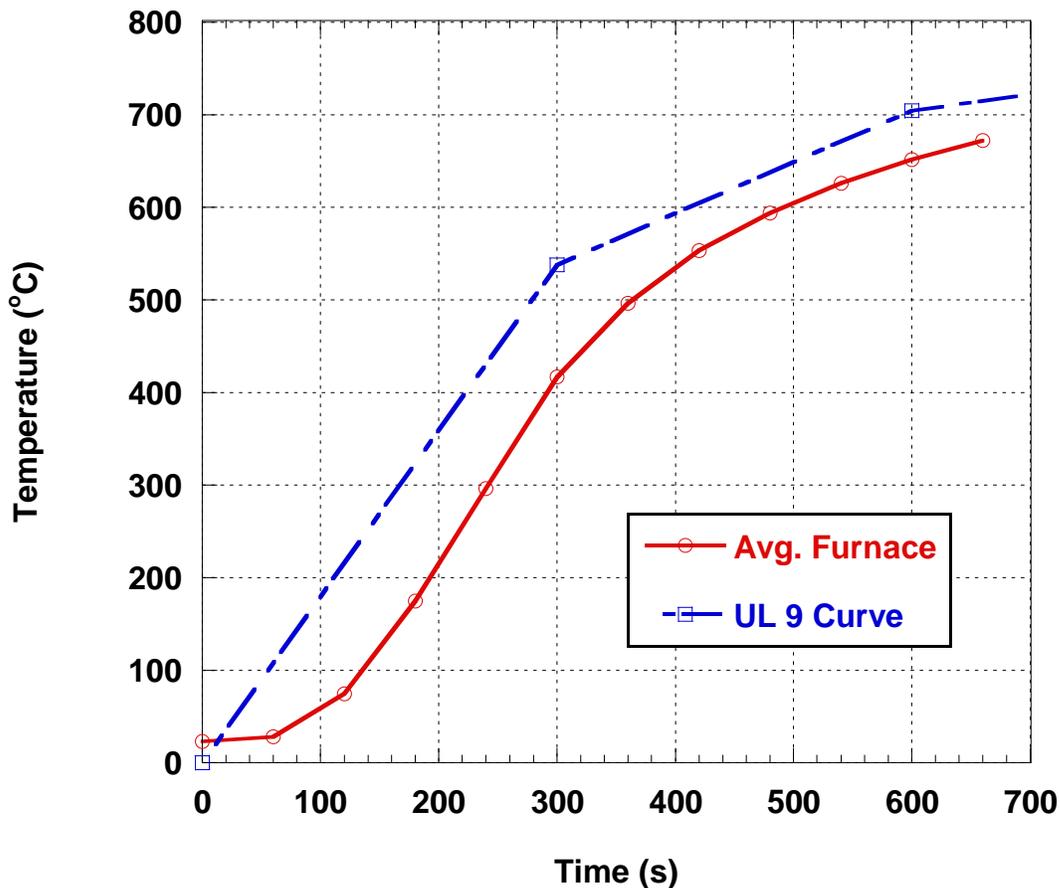
**Figure 17. Average Furnace Temperature**

11:49	Sample C, top sash had slid down to the bottom of the window assembly.
12:00	Gas off.
12:08	Sample C, the top sash, which had slid to the bottom, had fallen out of the assembly

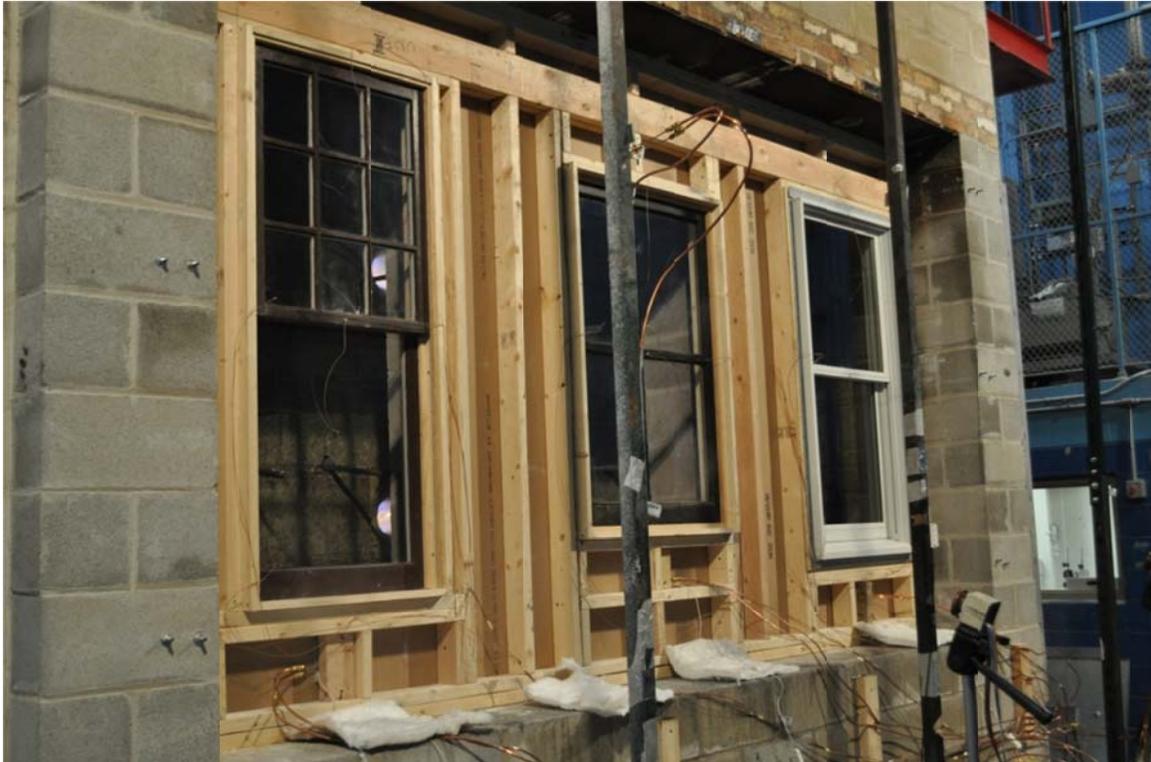
**Figure 22. Experiment 2 Setup**

Observations during Experiment 2 are detailed in Table 3. Observations are from the unexposed side unless otherwise noted. The average furnace temperature is graphed versus time in Figure 23. Window temperatures are graphed in Figure 24 through Figure 26. The heat flux for all three windows is graphed versus time in Figure 27.

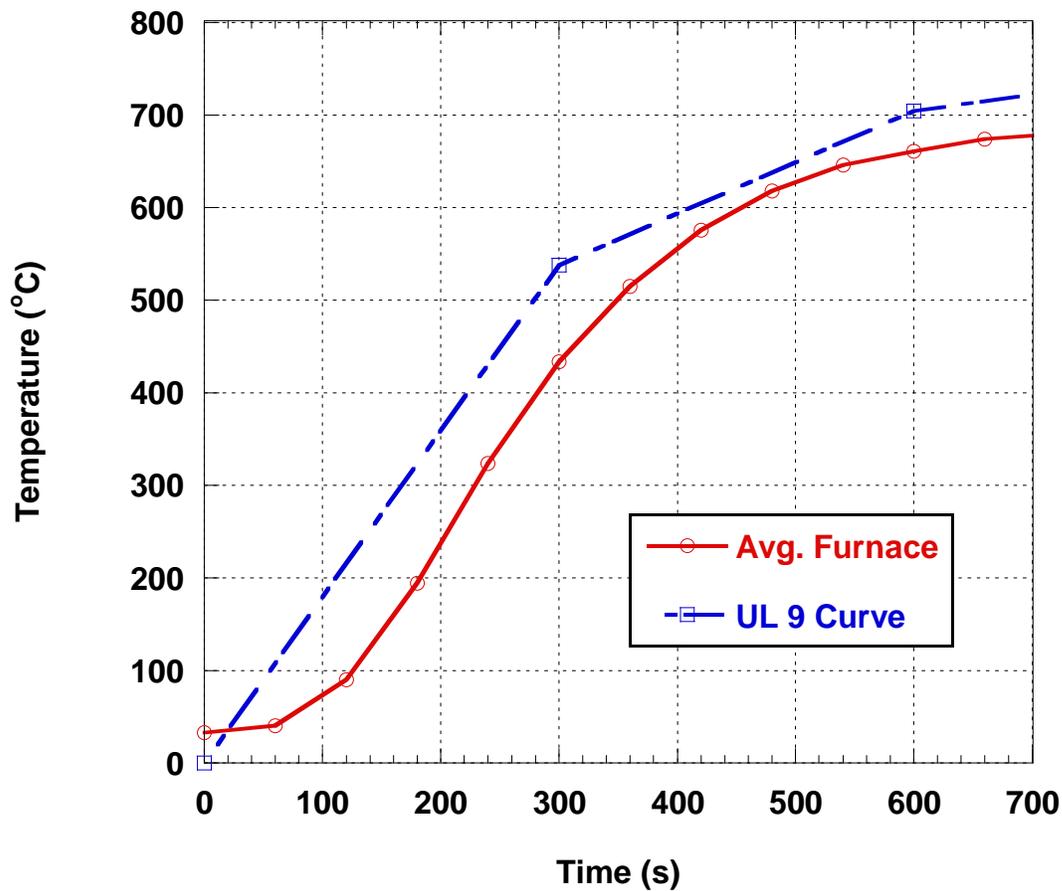
**Figure 23. Average Furnace Temperature**

Time (min:sec)	Observations
0:00	Gas on
0:45	Sample B, had begun to smoke.
1:14	Samples A and C, had begun to crack on the top panes.
1:33	Sample B, top exposed internal pane had broken out.
1:47	Sample B, interior top pane had fallen into the furnace.
1:51	Sample B, interior bottom pane had fallen into the furnace.
4:38	Sample B, top exterior pane had broken out.
6:41	Sample B, bottom exterior pane had broken out.
8:00	Sample A, entire circumference of the frame had begun to burn.
10:06	Sample A, the top pane had broken out.
10:46	Sample C, top sash had started to slip downwards.
12:15	Sample A, the bottom pane had broken out.
14:00	Sample C, the top sash had slid down approximately 25%.
15:00	Gas off.

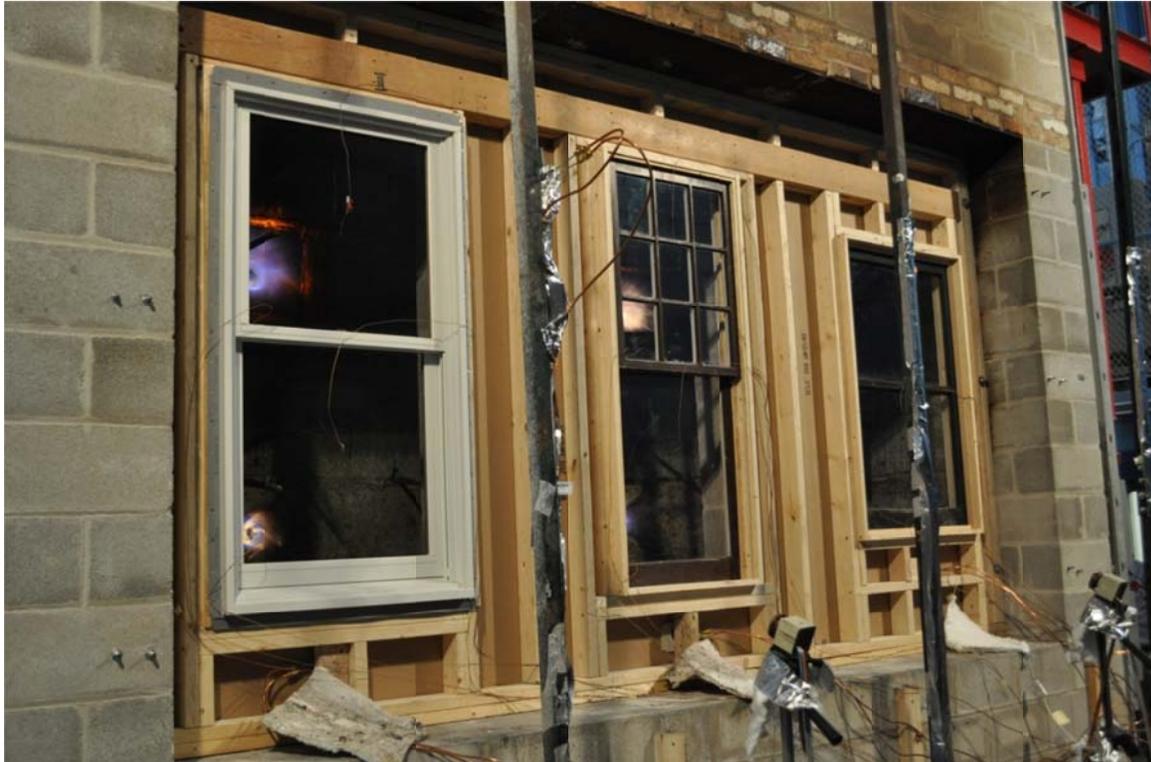
**Figure 28. Experiment 3 Setup**

Observations during Experiment 3 are detailed in Table 4. Observations are from the unexposed side unless otherwise noted. The average furnace temperature is graphed versus time in Figure 29. Window temperatures are graphed in Figure 30 through Figure 32. The heat flux for all three windows is graphed versus time in Figure 33.

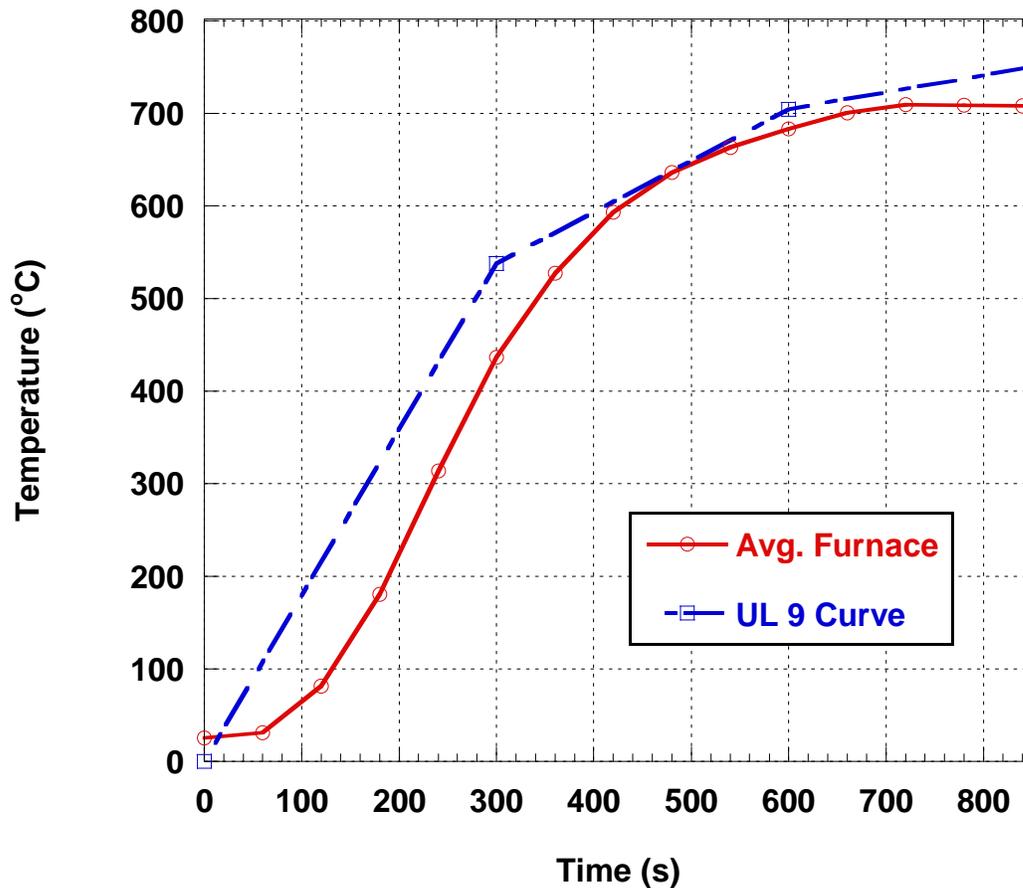
**Figure 29. Average Furnace Temperature**

Time (min:sec)	Observations
0:00	Gas on
1:00	Samples A and C, had begun to crack.
1:22	Sample B, had begun to crack.
1:44	Sample B, bottom exposed internal pane had broken out.
1:48	Sample B, top exposed internal pane had broken out.
3:56	Sample B, top external pane had broken out.
4:07	Sample B, top interior had pane broken out.
4:24	Sample B, top exterior had pane broken out.
7:00	Sample B, top sash had started to slide downwards.
7:46	Sample B, the bottom pane had developed openings.
10:25	Sample A, the top panel had developed an opening
10:46	Sample B, the bottom pane had broken out.
11:42	Sample A, the unexposed, exterior frame had ignited.
12:04	Sample C, the unexposed, exterior frame had ignited.
12:11	Sample A, the top pane had broken out.
14:19	Sample A, the bottom pane had broken out.
15:00	Gas off.

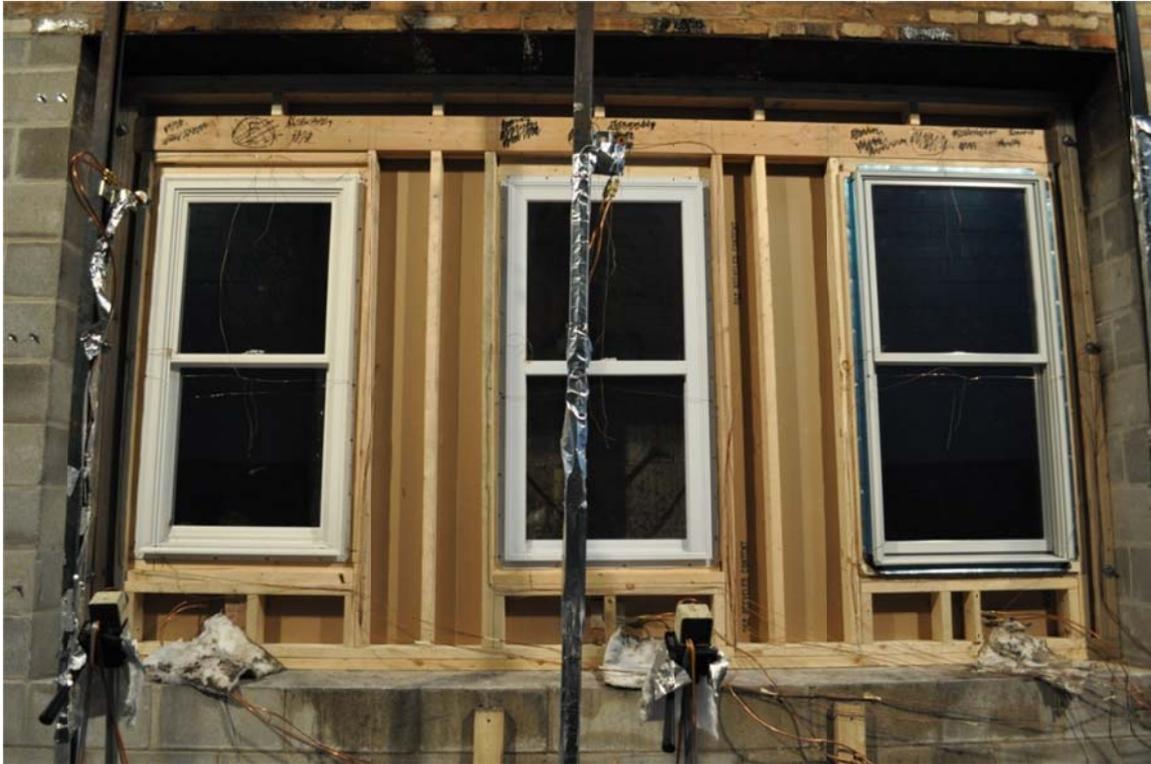
**Figure 34. Experiment 4 Setup**

Observations during Experiment 4 are detailed in Table 5. Observations are from the unexposed side unless otherwise noted. The average furnace temperature is graphed versus time in Figure 35. Window temperatures are graphed in Figure 36 through Figure 38. The heat flux for all three windows is graphed versus time in Figure 39.

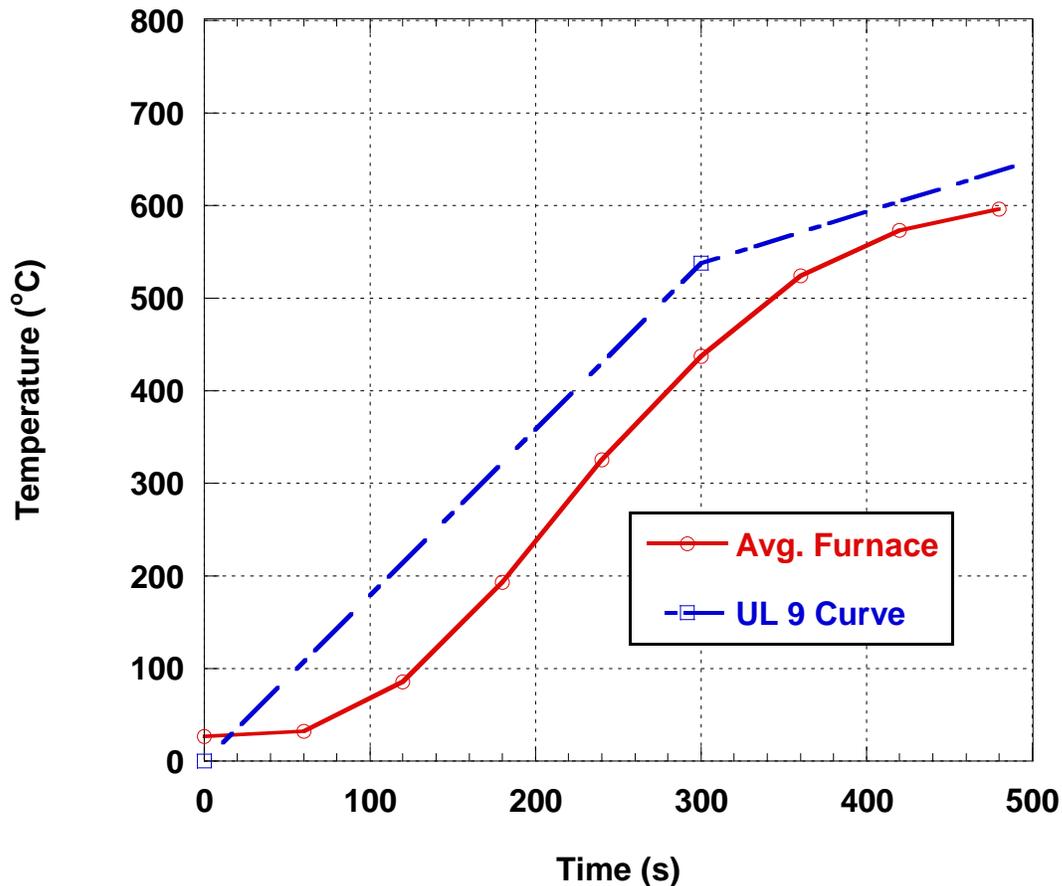
**Figure 35. Average Furnace Temperature**

Time (min:sec)	Observations
0:00	Gas on
0:57	Sample F, had begun to crack.
1:10	Sample E, had begun to crack.
1:15	Sample D, top exposed internal pane had broken out.
1:35	Sample F, top exposed internal pane had broken out.
2:12	Sample D, bottom exposed internal pane had broken out.
2:39	Sample E, bottom exposed internal pane had broken out.
3:39	Sample F, bottom external pane had broken out.
3:58	Sample D, top external pane had broken.
5:10	Sample F, top sash had started to slide downwards.
5:15	Sample D, top sash had started to slide downwards.
5:16	Sample E, bottom external pane had broken out.
5:25	Sample D, the top sash had fallen out of the track.
5:26	Sample E, top exposed internal pane had broken out.
5:47	Sample E, top external pane had broken out. Sample D, bottom exterior pane had broken out.
6:23	Sample D, the bottom pane had broken out.
8:30	Gas off.

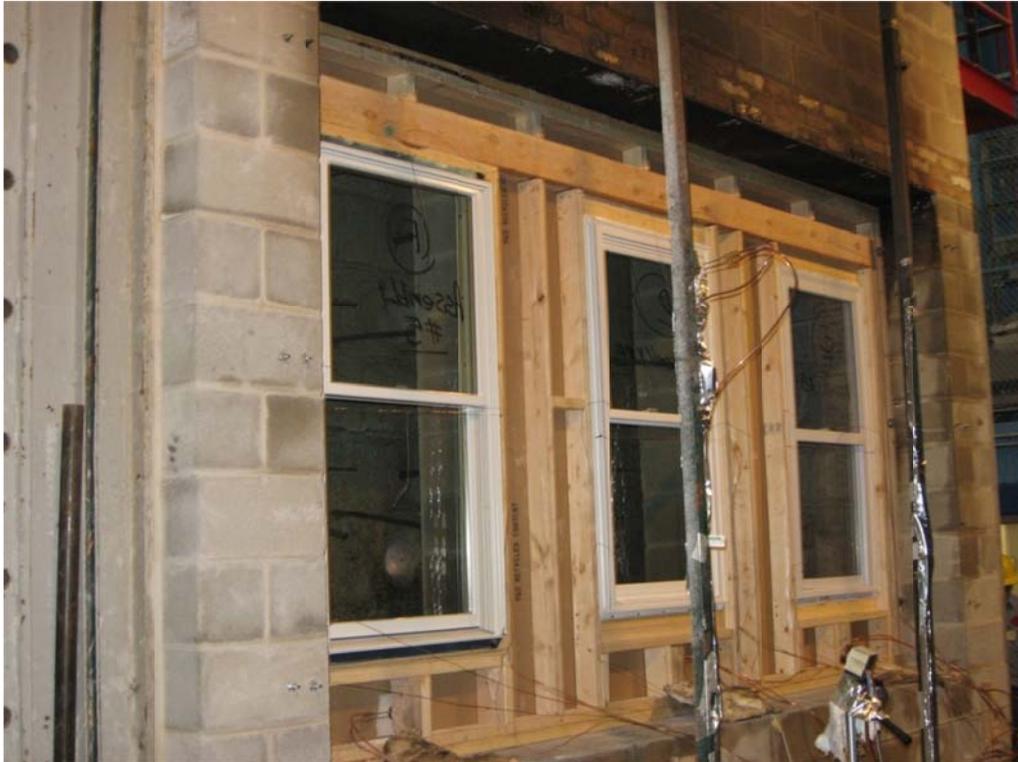
**Figure 40. Experiment 5 Setup**

Observations during Experiment 5 are detailed in Table 6. Observations are from the unexposed side unless otherwise noted. The average furnace temperature is graphed versus time in Figure 41. Window temperatures are graphed in Figure 42 through Figure 44. The heat flux for all three windows is graphed versus time in Figure 45.

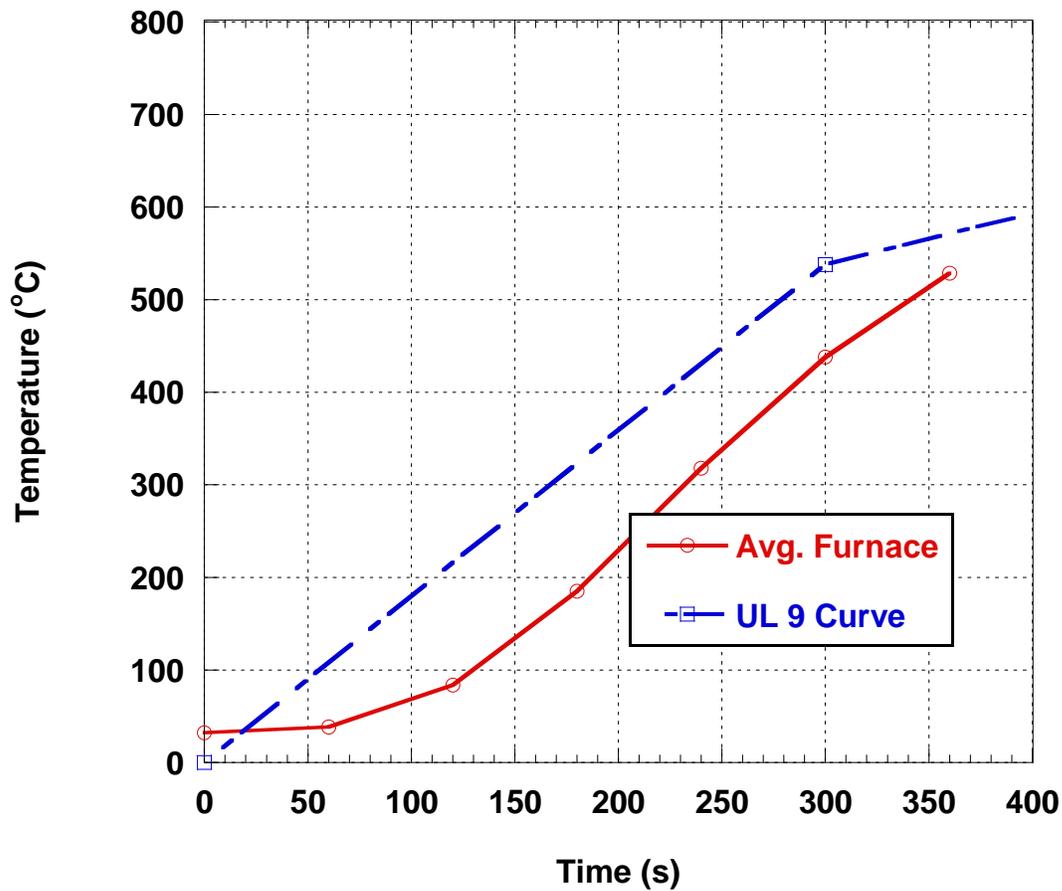
**Figure 41. Average Furnace Temperatures**

Time (min:sec)	Observations
0:00	Gas on
1:00	Sample F, D, E, had begun to crack.
1:27	Sample F, bottom exposed internal pane had broken out.
2:00	Sample F, top exposed internal pane had broken out.
2:30	Sample D, top sash had started to slide downwards.
2:39	Sample E, bottom exposed internal pane had broken out.
3:39	Sample D, top sash had slid all the way down. Some internal pane breakage had occurred.
4:26	Sample E, top external pane and bottom exterior pane had broken out.
4:36	Sample D, bottom external pane had broken out.
5:45	Sample E, top external pane had broken out.
5:49	Sample F, bottom external pane had broken out.
7:00	Gas off.

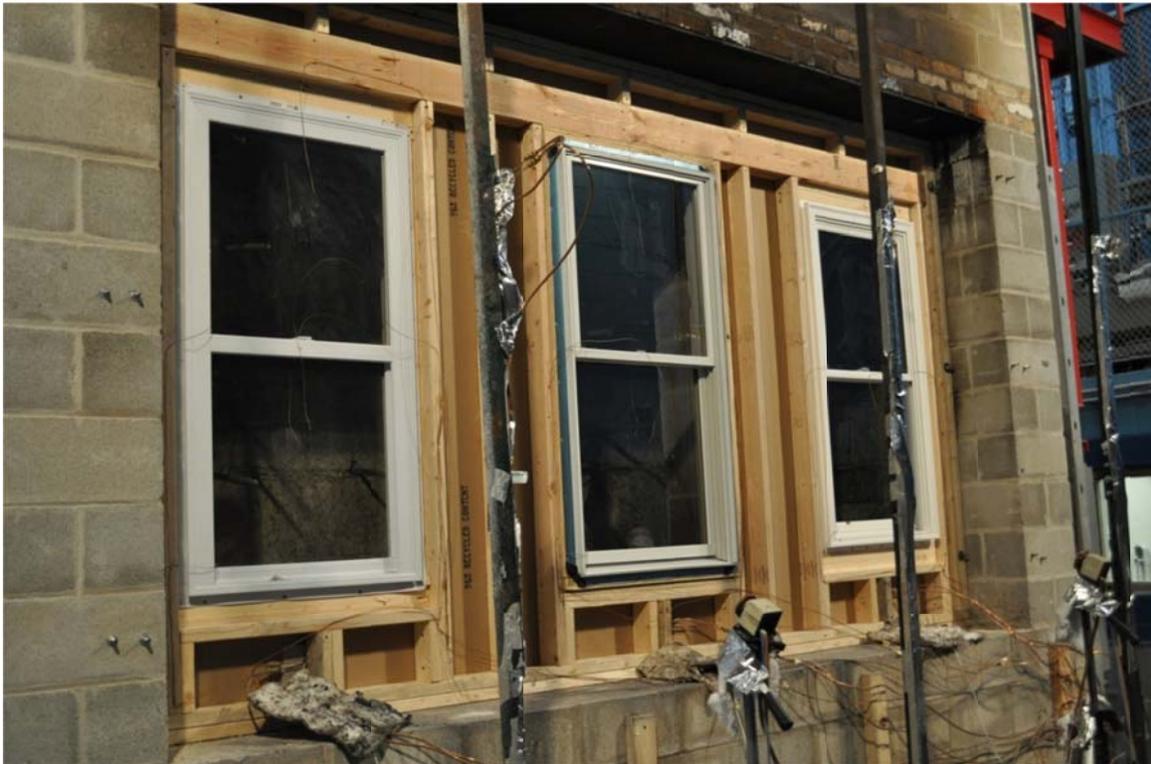
**Figure 46. Experiment 6 Setup**

Observations during Experiment 6 are detailed in Table 7. Observations are from the unexposed side unless otherwise noted. The average furnace temperature is graphed versus time in Figure 47. Window temperatures are graphed in Figure 48 through Figure 50. The heat flux for all three windows is graphed versus time in Figure 51.

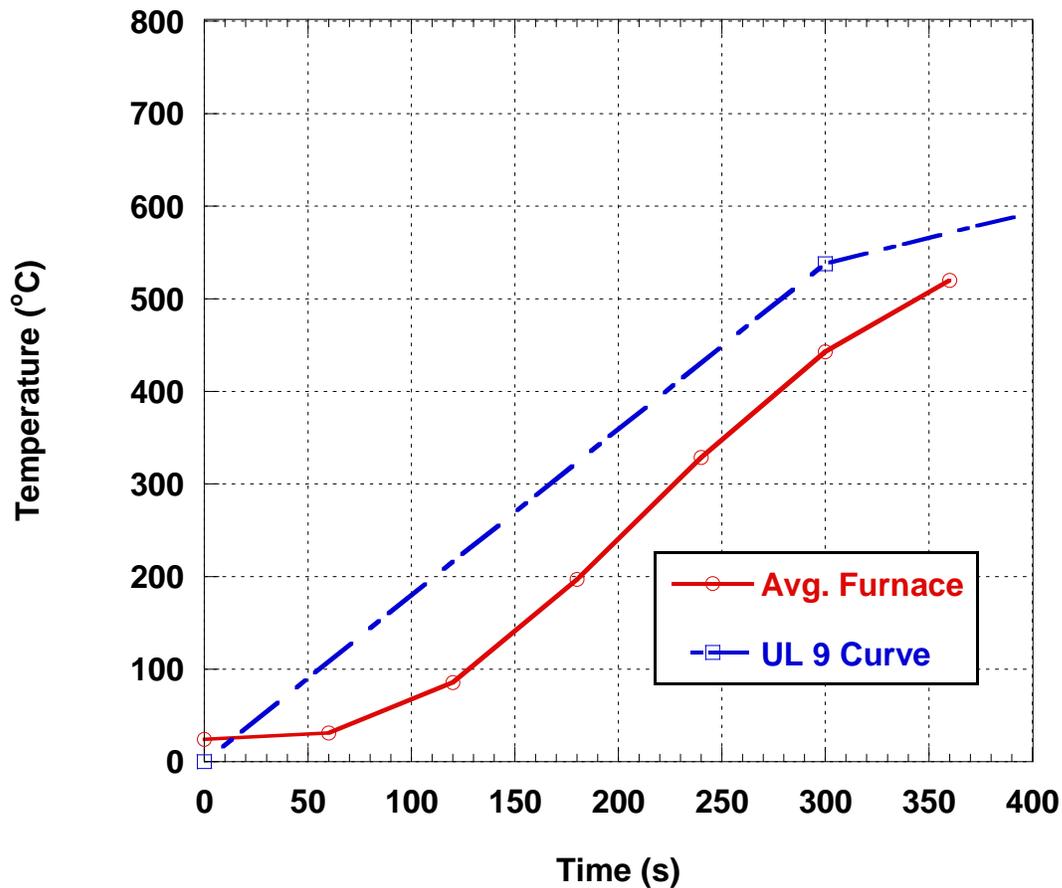
**Figure 47. Average Furnace Temperatures**

Time (min:sec)	Observations
0:00	Gas on
1:05	Sample F, D, E, had begun to crack.
1:40	Sample F, top exposed internal pane had broken out.
2:12	Sample D, top exposed internal pane had broken out.
2:20	Sample F, bottom exposed internal pane had broken out.
3:51	Sample E, bottom exposed internal pane had broken out.
4:02	Sample F, bottom external pane had broken out.
4:22	Sample F, top external pane had broke and had created an opening.
5:05	Sample D, top sash had slid all the way down.
5:12	Sample D, bottom external pane had broken out.
5:22	Sample D, top external pane had started to break out.
5:55	Sample E, bottom external pane had broken out.
6:01	Sample F, top external pane had fallen from the sash.
6:27	Sample E, top external pane had broken out.
7:00	Gas off.

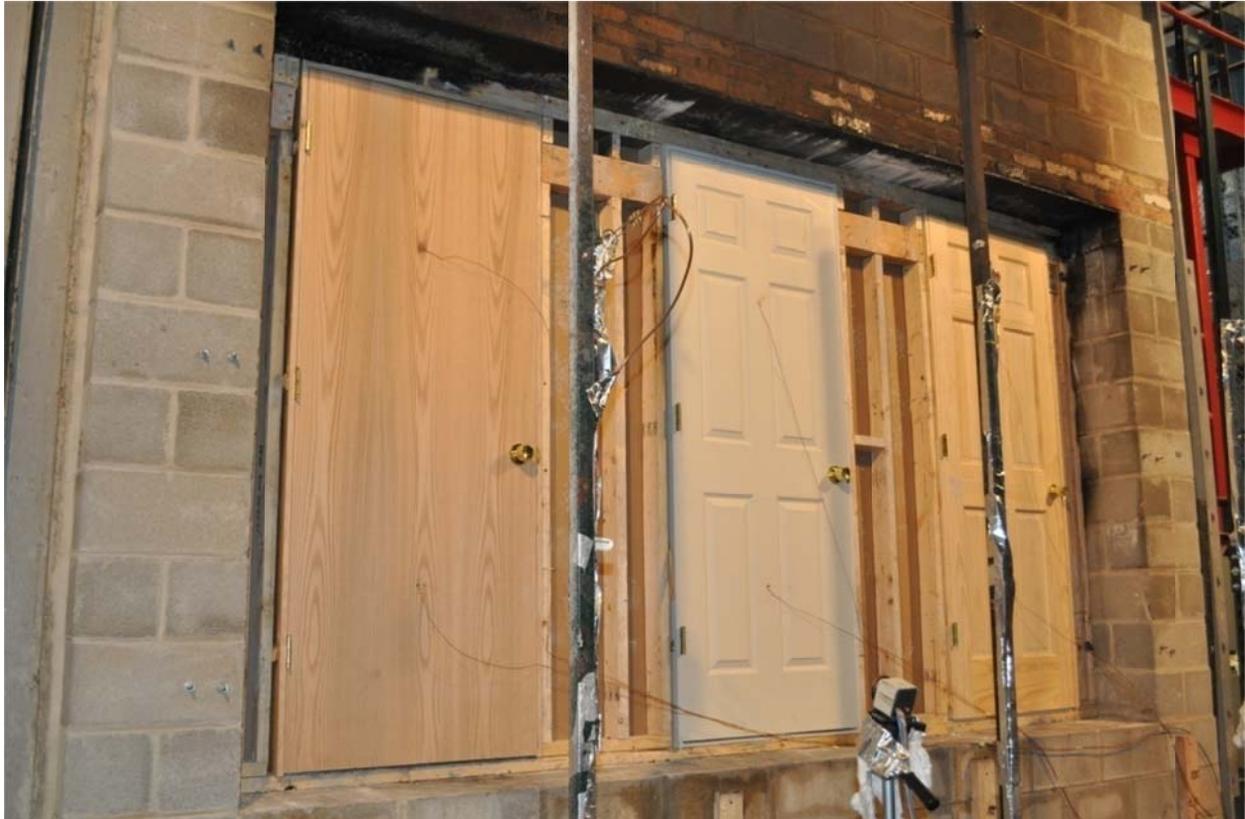
**Figure 52. Experiment 7 Setup**

Observations during Experiment 7 are detailed in Table 8. Observations are from the unexposed side unless otherwise noted. The average furnace temperature is graphed versus time in Figure 53. Door temperatures are graphed in Figure 54 through Figure 56. The heat flux for all three doors is graphed versus time in Figure 57.

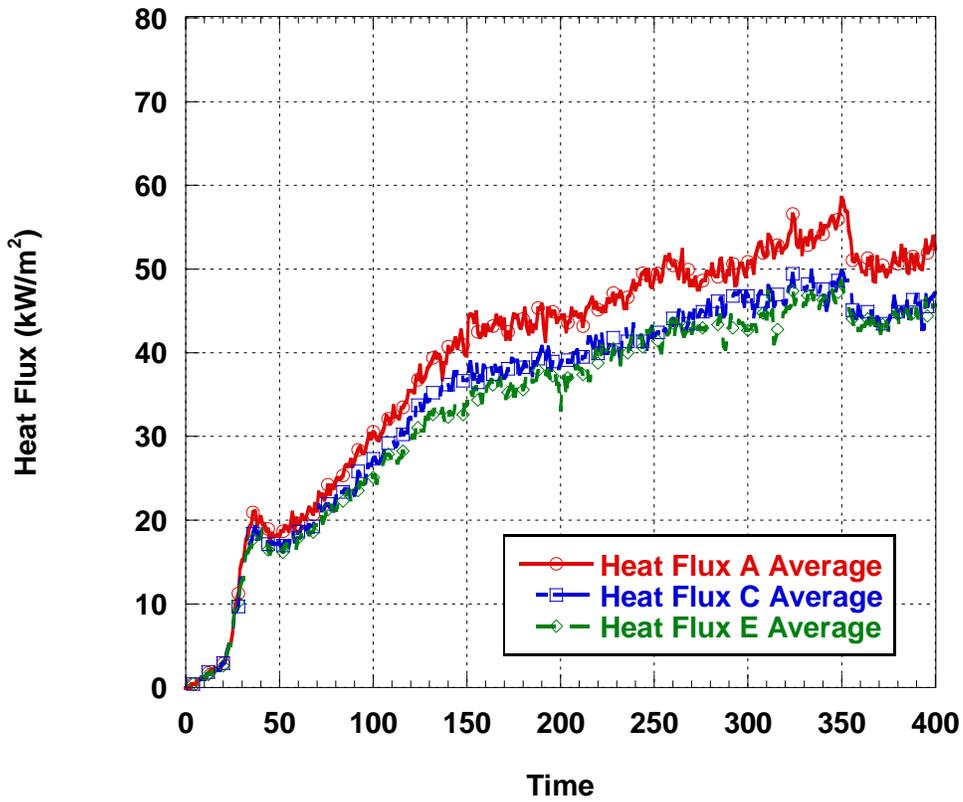
Another measure of repeatability used was the heat flux to the window assemblies. Figure 59 through Figure 61 show the heat flux for the gauges that were located 10 inches below the windows for every experiment. These graphs show good repeatability between experiments. Figure 62 shows the average heat flux for the same 3 gauges. Heat flux gauge A had the highest average while heat flux gauges C and E had very similar fluxes. The heat fluxes for all of the gauges for every experiment are within 20%.

Figure 62. Average Heat Flux for Experimental Series

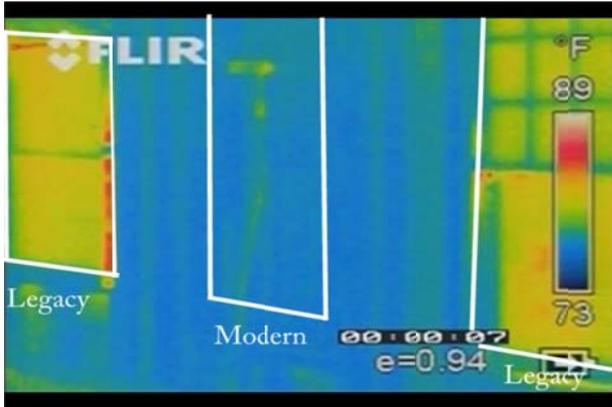
The temperature inside the modern window at 1 minute and 30 seconds is in excess of 315°C (600 °F) but is not detectable on the outside with a thermal imaging camera. This is important to understand for thermal imaging cameras being used for “size-up” of structure fires. The first elevated temperature (red in the images) detected by the thermal imaging camera came after window failure. Even slight temperature differentials noticed with the camera when looking at modern windows may be indicative of elevated temperatures in the structure.

Figure 76. 7 seconds after ignition

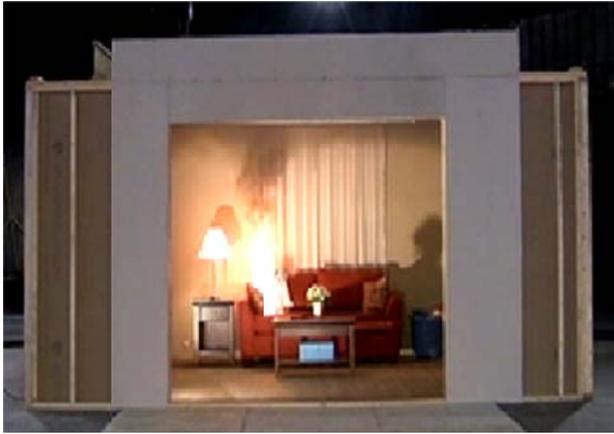
The modern room was ignited and the fire spread to the sofa cushion and pillow by the one minute mark. By two minutes the fire involved approximately one third of the top of the sofa and spread to the lamp shade. At three minutes the top of the entire sofa was on fire and the carpet began to burn adjacent to the sofa. The modern room transitioned to flashover in 3 minutes and 20 seconds (Figure 114 through Figure 117). The legacy room sofa was also ignited on the left side and it spread to the throw blanket and sofa cushion by one minute. By five minutes the fire involved the left side of the sofa and spread to the curtains burning the left panel away. At ten minutes the entire surface of the sofa was burning and by fifteen minutes the fire involved the entire sofa including the underside. The flames reached the ceiling but did not extend to the adjacent furnishings. The fire burned down and never transitioned to flashover so it was extinguished at thirty minutes after ignition (Figure 118 through Figure 124).

Figure 114. 1 minute after ignition

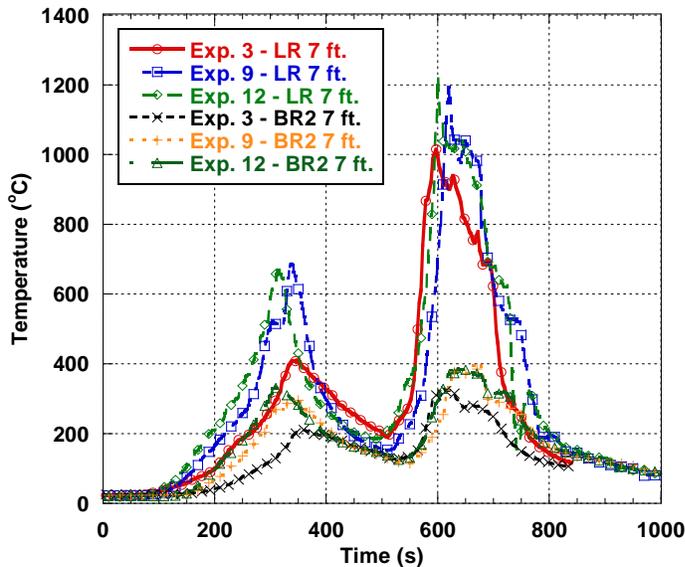
Experiments 3, 9 and 12 followed the same timeline to examine repeatability through the entire experiment. In all three experiments the front door was opened at 8 minutes and the living room window was opened 15 seconds later. The fire was allowed to burn until a post flashover condition was reached. Figure 436 and Figure 437 show the temperature versus time at 7 ft. and 1 ft. above the floor in the living room and bedroom 2. Experiments 9 and 12 were very similar throughout the entire timeline. Experiment 3 develops slower prior to ventilation but responds faster to the window being ventilated. After ventilation all of the experiments have similar temperature rates of change as well as peaks.

Figure 436. Exp. 3, 9, 12 Repeatability -7 ft. Temperatures

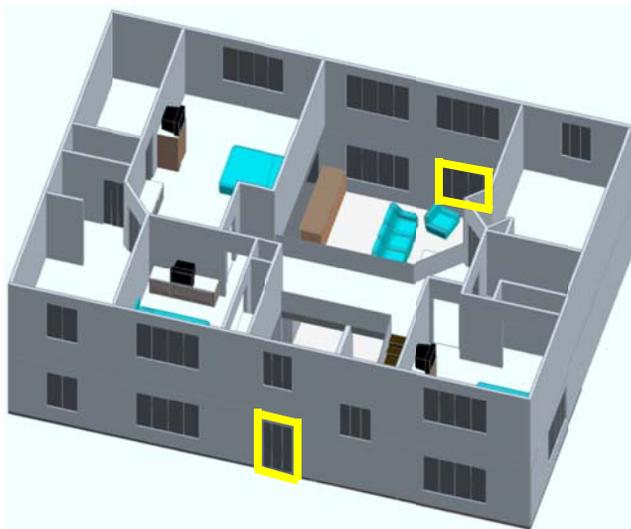
This is a dramatic difference in fire growth. A comparison can be made to a wood burning stove when fresh air is allowed to flow in low and the hot combustion products are allowed to flow out high. Allowing air into a ventilation limited fire low and letting the hot gases out high can create prime conditions for a flashover, even in a large volume like the two story family room. Another point illustrated by this graph is that the family room did not cool much, if at all, when the high window was ventilated. The temperature 1 ft above the floor did not decrease from 125 °C (260 °F) before it increased exponentially to 650 °C (1200 °F). This is counterintuitive to the reason a ventilation opening would be made in the first place. In this case the ventilation limited fire responded so quickly to the additional/needed air that it did not cool the family room.

Figure 473. Ventilating the Family Room Low

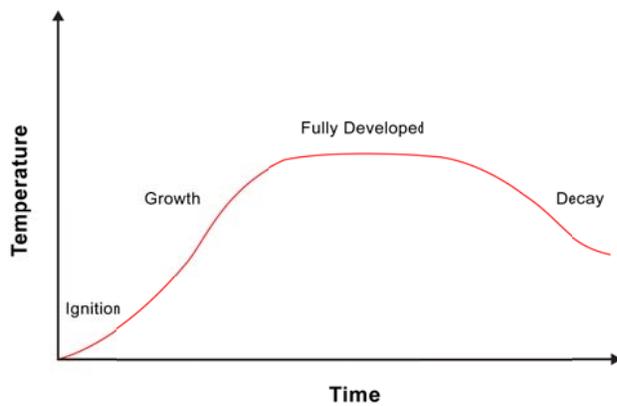
A key element to fire behavior training is the fire growth curve that is used to demonstrate where the different stages occur in relation to each other. The basic fire growth curve shows fire ignition followed by the growth stage, flashover, fully developed stage and finally the decay stage (Figure 476). This curve can be misleading. If an item like a sofa was placed in a large room or outside, where plenty of oxygen is available, then the growth curve will look like Figure 476. A more realistic explanation of the modern fire environment where there is usually not enough oxygen available would be ignition followed by a growth stage, decay stage, ventilation (either by the fire service or by an opening created by the fire like window failure), a second growth stage, flashover, fully developed stage and finally the decay stage. Figure 477 depicts what this would look like. Taking an average of all of the fire room ceiling temperatures for both houses shows the shape of the time-temperature curve for all of the ventilation scenarios (Figure 478).

Figure 476. Basic fire growth curve

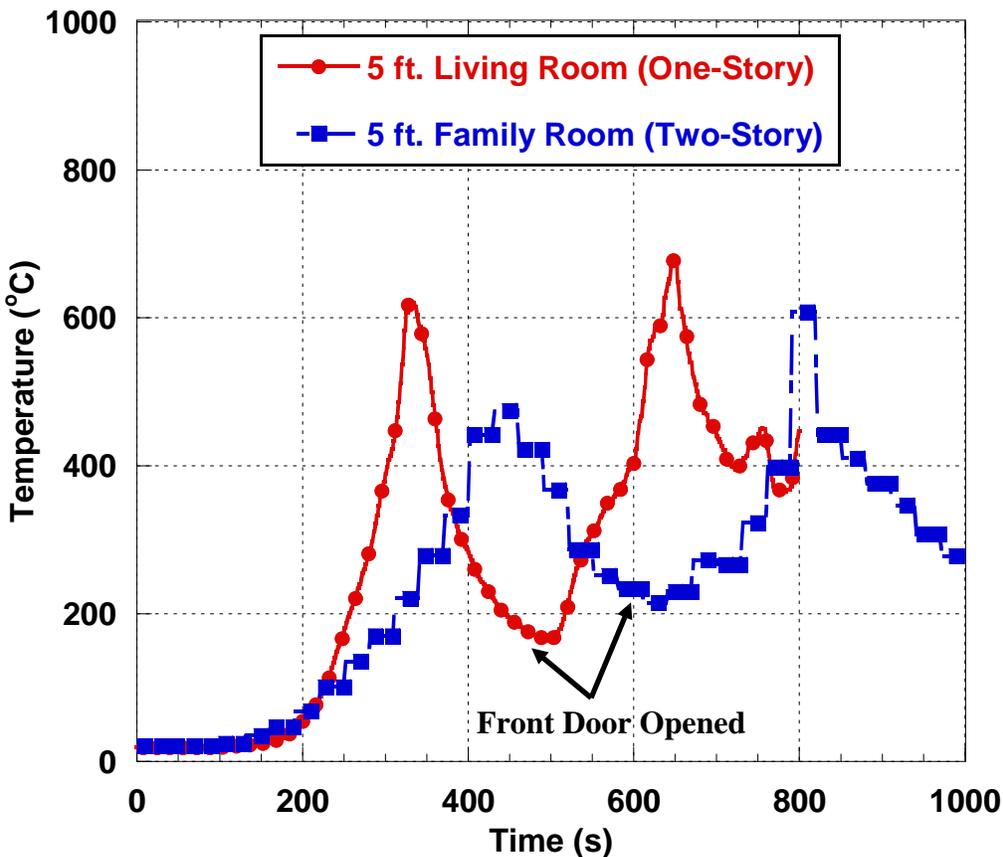
Examining fire room temperatures at 5 ft above the floor in both houses during the experiments where only the front door was opened shows the increase in temperature following ventilation (Figure 479). In the one story experiment (Experiment 1) the temperature was 180 °C (360 °F) at ventilation (480 s), exceeded the firefighter tenability threshold of 260 °C (500 °F) at 550 s and reached 600 °C (1110 °F) at 650 s. In the two story experiment (Experiment 2) the temperature was 220 °C (430 °F) at ventilation (600 s), exceeded the firefighter tenability threshold of 260 °C (500 °F) at 680 s and reached 600 °C (1110 °F) at 780 s. Both of these experiments show that opening the front door needs to be thought of as ventilation as well as an access point. This necessary tactic also needs to be coordinated with the rest of the operations on the fireground. A simple action of pulling the front door closed after forcing entry until access is ready to be made as part of the coordinated attack will limit the air to the fire and slow the potential rapid fire progression.

Figure 479. Living/Family room temperatures during front door only ventilation experiments

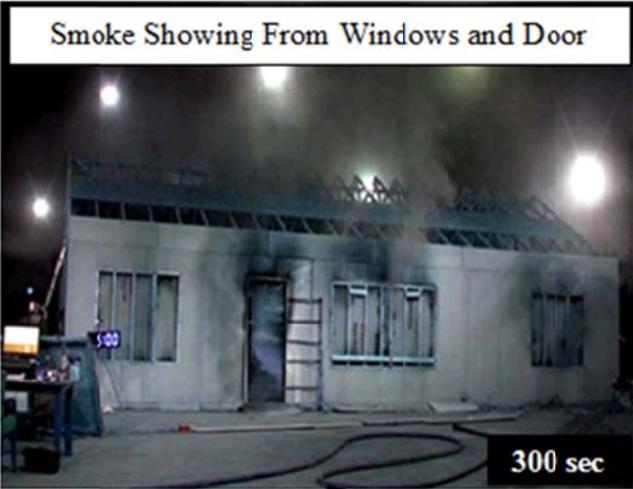
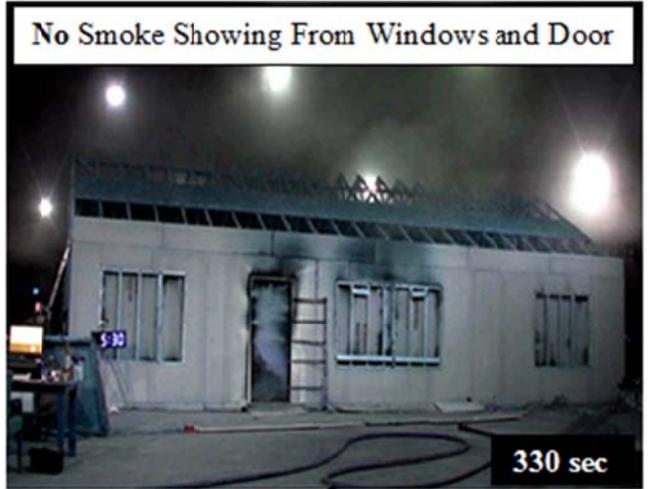
Tactically, this could be very important for the initial crews sizing up a fire. With no smoke showing from the structure complacency could easily set in. It is important to consider that little or no smoke showing does not mean that conditions are safer than having fire showing. Smoke conditions need to be used to try to determine the conditions inside the structure but this should be done with extreme caution because smoke is not always an indicator of what is happening in the structure. With the modern fire environment and response times being what they are, consider that the fire is most likely in the initial decay stage of the fire growth curve and not the incipient stage.

Figure 480. Experiment 5 size-up comparison, smoke vs. no smoke showing

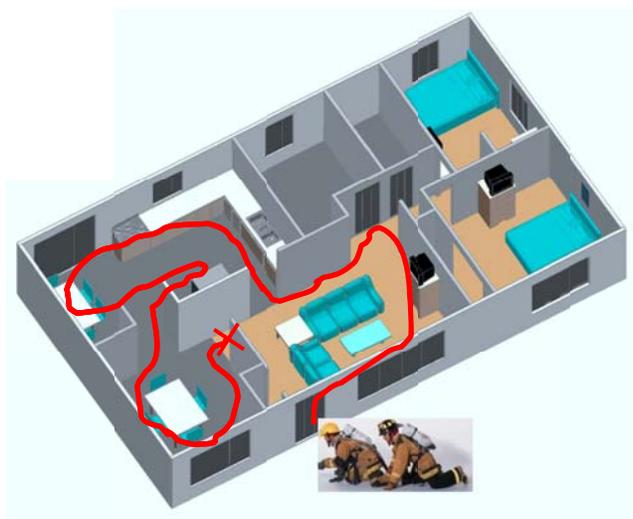
Figure 482 through Figure 489 describe a hypothetical search operation during a fire in the one-story house. The red line in Figure 482 shows their search pattern and timeline of the search. The search team forces open the front door at 8:00 (See Figure 483 and Figure 484 for conditions). They see the amount of smoke coming out of the doorway and they put on their SCBA face pieces. While they are doing this the ventilation team vents the front window at 8:15. The search team then makes entry and begins to search the living room. They see fire on the sofas in the middle of the room but conditions are still tenable for them. They skip the bedrooms and decide to search the left side of the house. They enter the kitchen at 9:00 (See Figure 485 and Figure 486 for conditions) and search it quickly and move into the dining room at 9:30. They make their way around the dining room and make it back to the entrance to the living room at 10:00 (See Figure 487 and Figure 488 for conditions). This shows that 2 minutes is not a lot of time to operate inside a structure and those conditions can go from tenable for a search to untenable very quickly. Figure 489 shows the temperatures at crawling height (3 ft above the floor) for the rooms being searched. This depicts that the rooms were tenable while they were being searched but once the firefighters circle back toward the living room it is untenable and they must find another way out, which at that point the dining room and kitchen become untenable so the only option is to bail out of a window.

Figure 482. Search team path

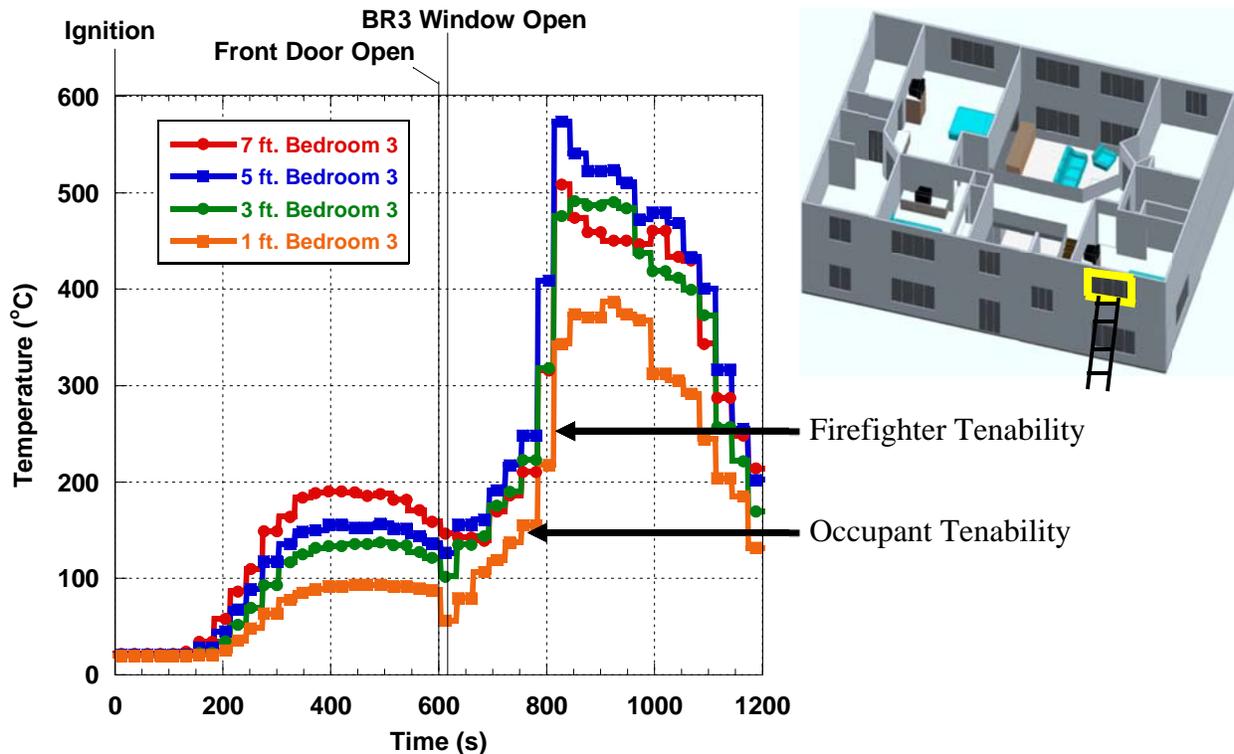
During Experiment 8 the second floor bedroom (Bedroom 3) was ventilated. This tactic could represent a firefighter conducting a VES operation of the bedroom without closing the door to the bedroom. Figure 494 shows the bedroom temperatures versus time with arrows indicating tenability thresholds. If a VES operation were conducted in this bedroom temperatures would increase significantly. The temperature 1 ft above the floor was approximately 60 °C (140 °F) at ventilation and increased to the occupant tenability limit in 2 minutes and to the firefighter tenability threshold in 3 minutes. If the door had been closed the temperatures would not have increased much above 60 °C (140 °F) based on the peak temperature of Bedroom2 (the adjacent bedroom) that had the door closed.

Figure 494. VES bedroom temperatures
