Underwriters  
Laboratories

## Impact of Ventilation on Fire Behavior in Legacy and Contemporary Residential Construction

**Steve Kerber, PE**

Issue Date: December 14, 2010

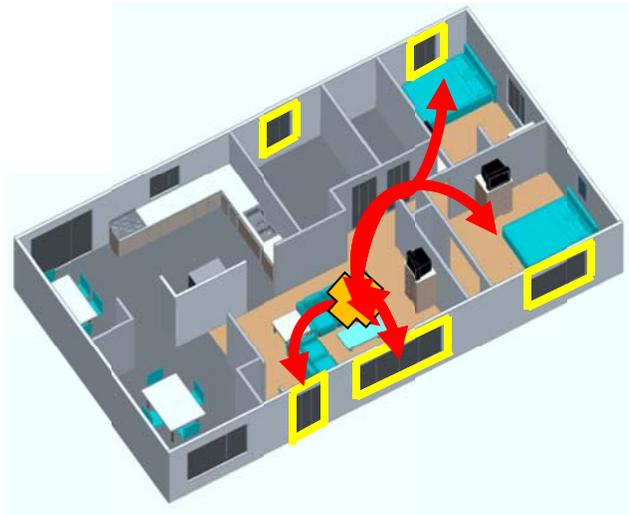
Figure 498. Experiment 14 flow paths

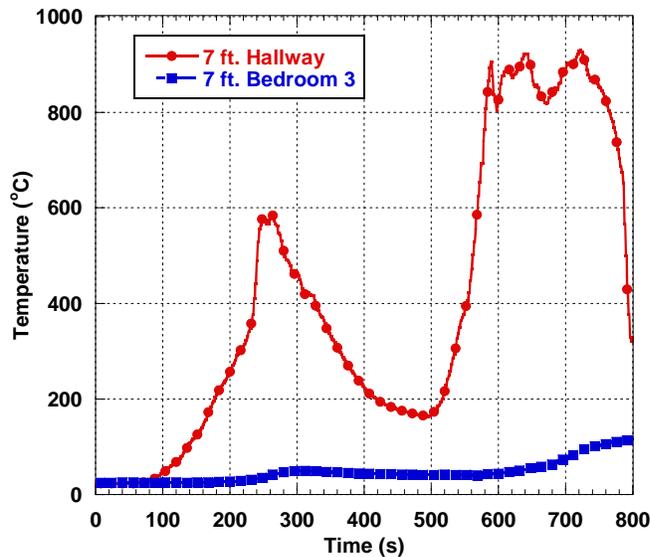
Figure 504. Experiment 14 Hallway and Bedroom 3 Temperatures with Door Closed

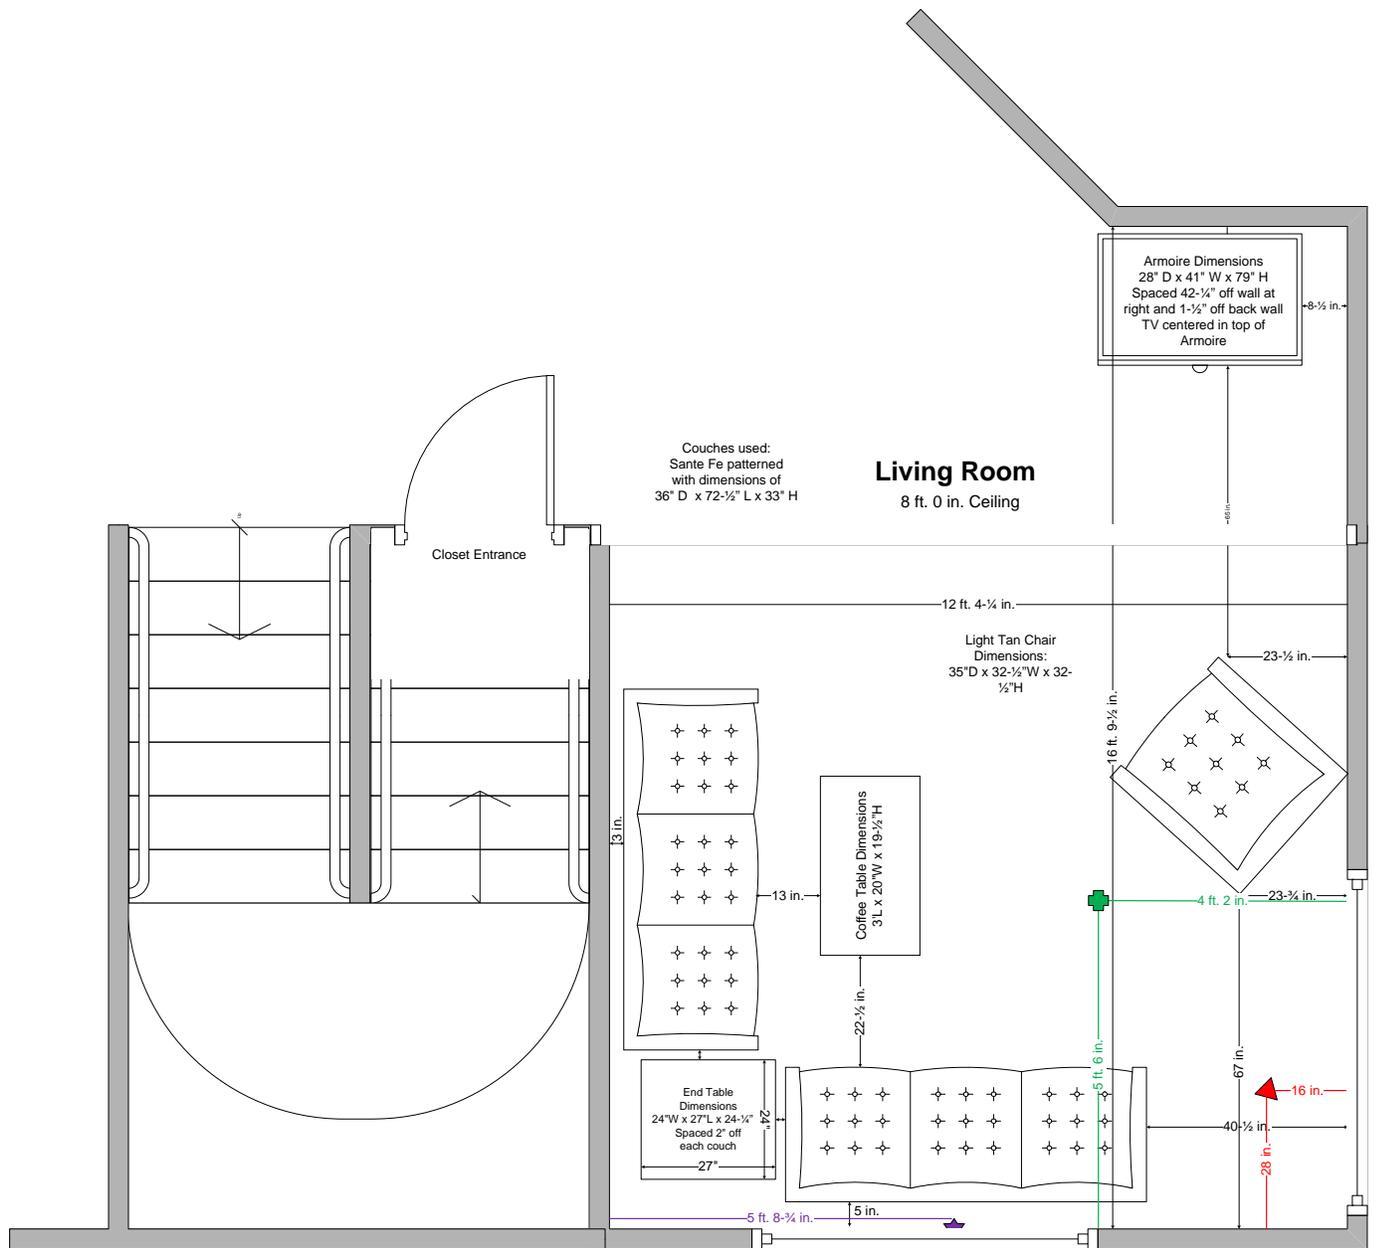
- TC Tree w/4 TC's at 1', 3', 5' and 7' above the floor
- Pen Camera mounted at floor
- Sprinkler (Horizontal Sidewall)

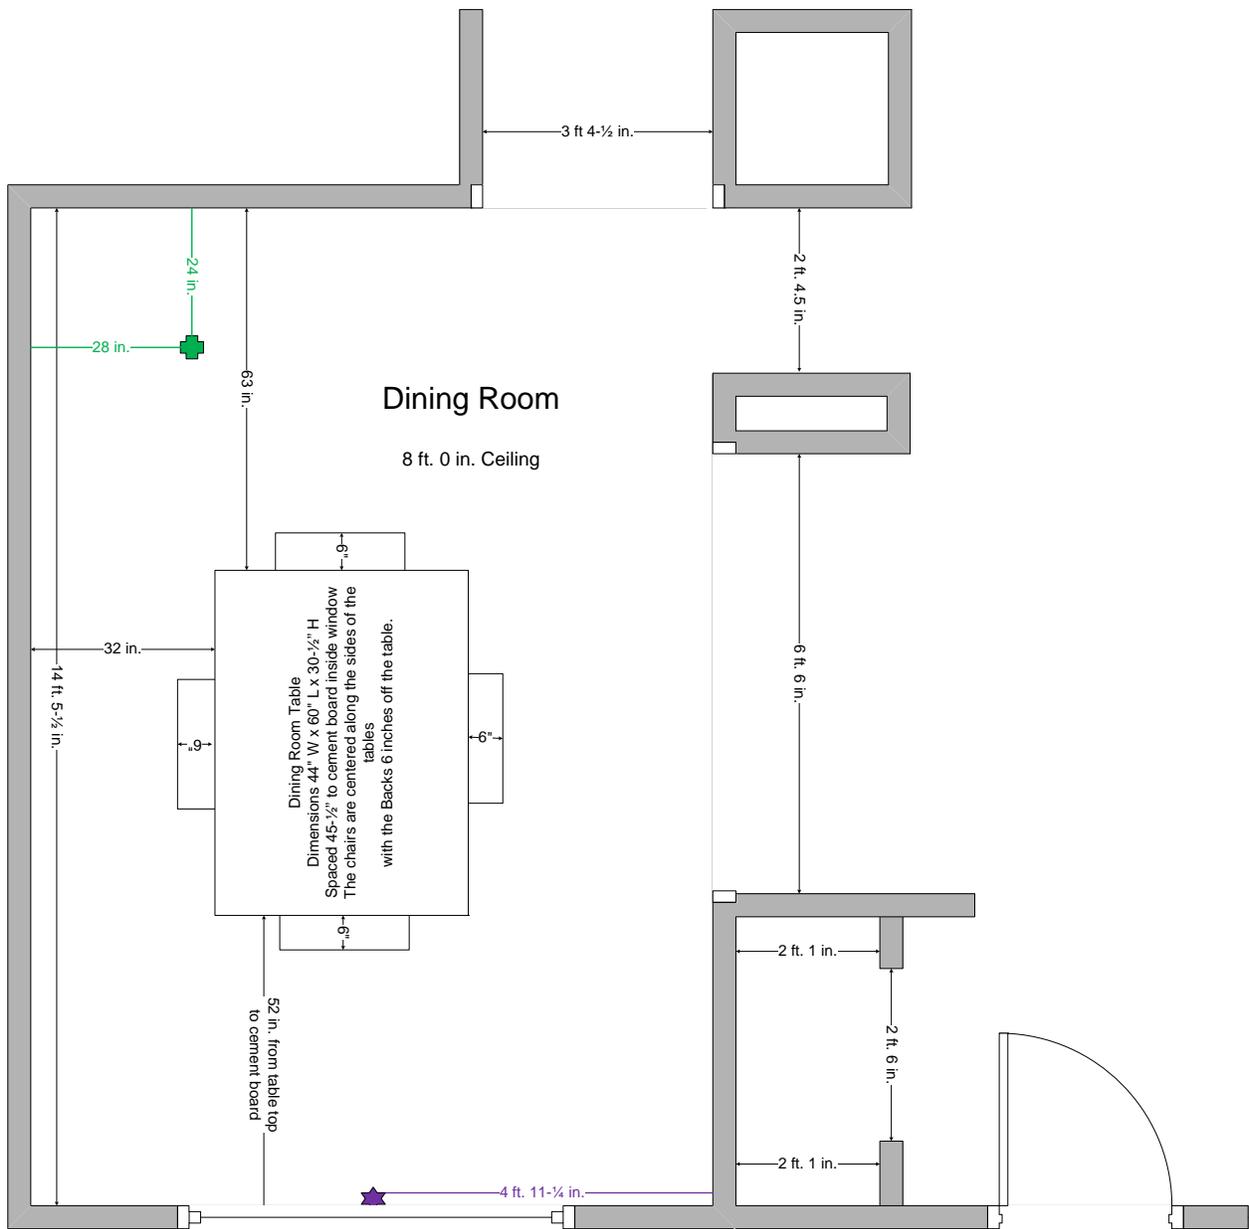
- ▲ Pen Camera at floor level
- ★ Sprinkler (Horizontal Sidewall)
- + TC Tree w/4 TC's  
1', 3', 5' and 7" above the floor
