Alberta, Canada

DuraHard® coatings triple pump run life in extremely abrasive environment

Fewer workovers saves estimated \$170,000 per well plus non-productive time

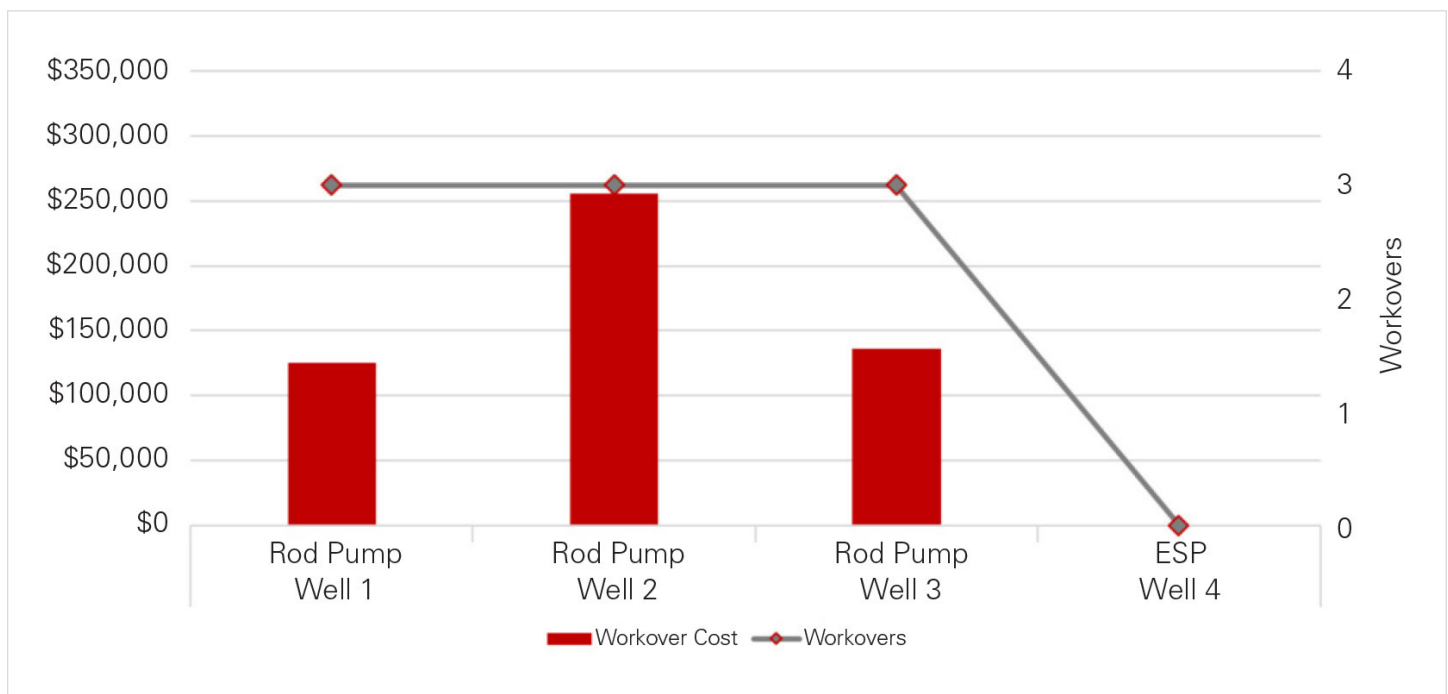
Comparison of ESP and rod lift system

The Summit ESP pump system has been running more than 260 days. It outperformed all three rod pumps on the same pad. Each of the rod pumps had three workovers in their first 260 days, incurring a total direct cost of \$517,000.

Run life for the ESP-based system is at least three times that of the rod pumps. This adds up to an estimated \$170,000 savings in workover costs to this point. In addition, the ESP enables maximum drawdown and higher production rates with its higher flow rates (225m³/d) versus the rod pump (80m³/d max).

Each rod pump workover also incurred an average of six days on non-productive time. At 200 BOE/d per well, each workover cost an estimated 1,200 BOE. With three workovers each during the 260 day period, the rod pump wells incurred non-productive time valued at an estimated 3,600 BOE, or \$180,000 at \$50/B oil price.

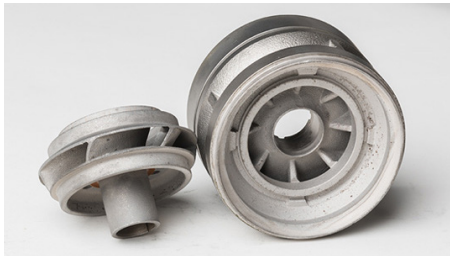
DuraHard® 3 coating

Basic reduced friction and corrosion resistance

Slick, non-stick coating.

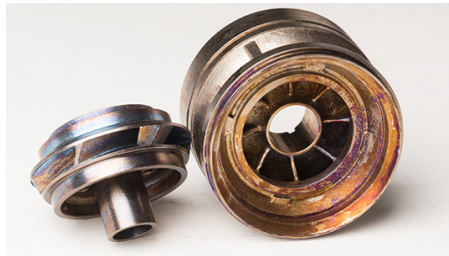
DuraHard 7 Coating

Enhanced abrasion and corrosion resistance

Nickel coating.

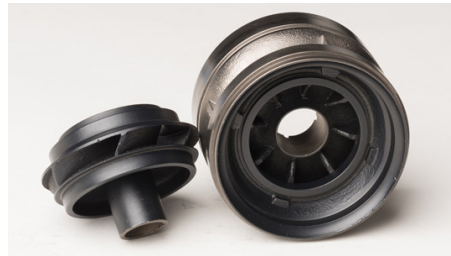
DuraHard 15 Coating

Extreme abrasion and corrosion resistance

Molecular bond coating.

Summit ESP – a Halliburton service, proposed an ESP-based system coated with SF900 Durahard™ 15, its premium molecular bond coating. DuraHard 15 coating provides hardness comparable to carbide materials, but ductile enough to coat and bond steel components.
