# 9483

## High-Performance Dual-Cure Conformal Coating

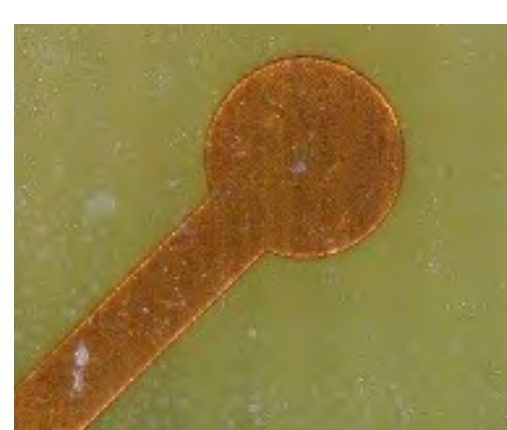
Dymax 9483

**Testing:** Coated boards were placed in a humidity chamber set to 85°C, 85% RH.

**Results:** No delamination or cracking with either coating. The solvent-based polyurethane coating became translucent with severe oxidation on copper.

After 2,000 Hours

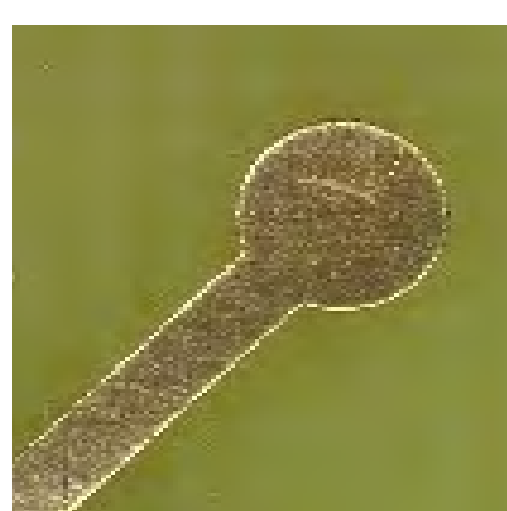
Dymax 9483

**Testing:** Coated boards were exposed to -55°C and +125°C with 30 minutes dwell time at each temperature and 15 second transition time between lowest and highest temperatures. Any cracks or delamination was inspected with magnification.

**Results:** After 1000 cycles, the solvent-borne polyurethane coating became translucent with severe oxidation on copper. No cracks or delamination was observed with 9483.

After 1,000 Cycles

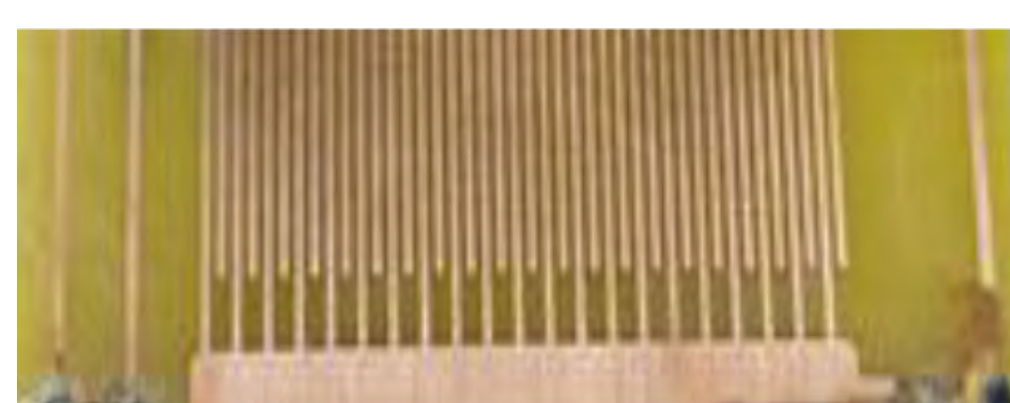
Dymax 9483

**Testing:** Coated boards were exposed to 5% sodium chloride solution at 35°C in a salt spray chamber.

**Results:** 9483 showed no corrosion on the copper. The solvent-based conformal coating showed a significant amount of corrosion on the copper.

After 1,500 Hours
